# HOME INSPECTION REPORT

26 Dacre Cres

Toronto

Inspection Date: March 23 2024

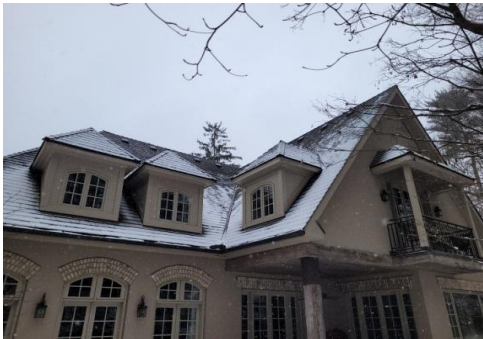
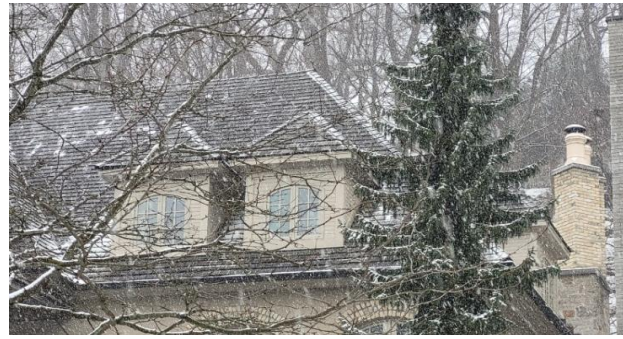
Sloped Surface: [overall surface in good repair](#),  
[limited due to snow](#),  
[monitor and repair/replace shingles as required](#)

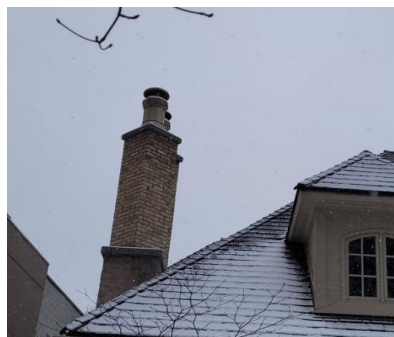
Chimney(s): [overall in good repair](#)

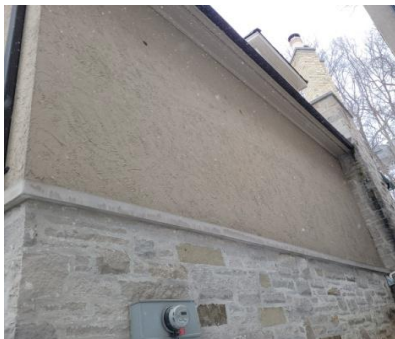
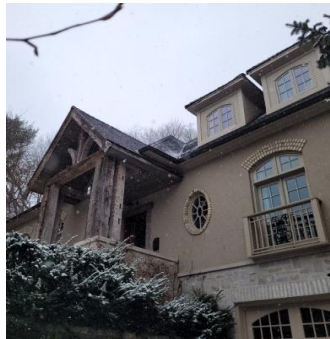
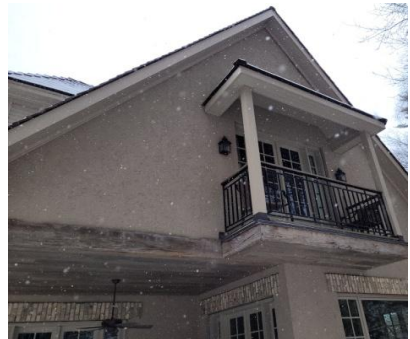
WALL SURFACES: [overall good quality installations](#)

[overall in good repair](#)

DOORS/WINDOWS: [overall in good repair](#)

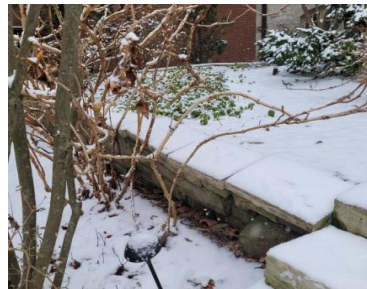
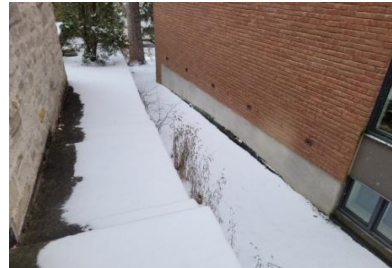
[front yard: retaining wall movement - minor repair](#)

\*\*Walk(s): [east side: should install railings for safety](#)

[PORCH minor mortar maintenance as required](#)

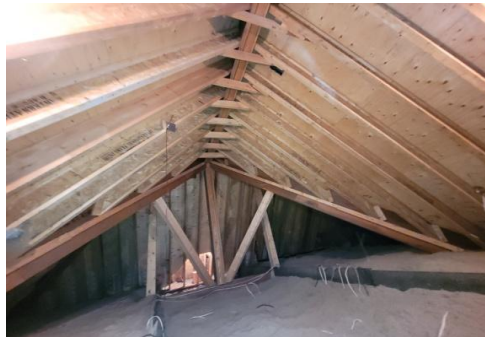
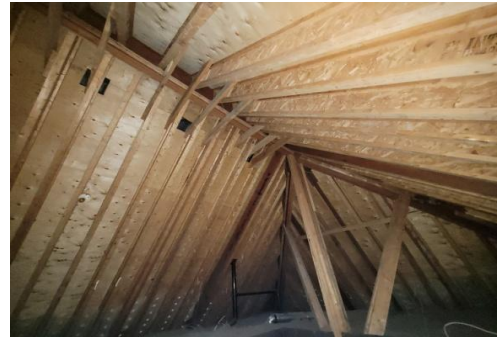
ROOF: overall in good repair  
3rd level potential

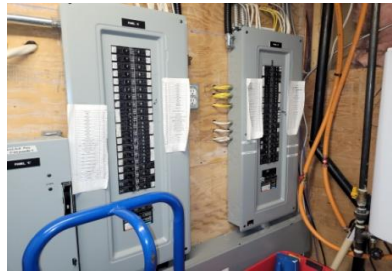
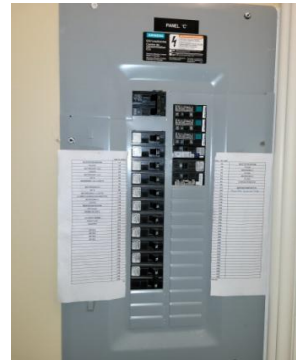
SERVICE ENTRANCE: **overall in good repair**  
 Main Disconnect: **overall in good repair**  
 SERVICE PANEL: **overall in good repair**  
 Auxiliary Panel: **overall in good repair**

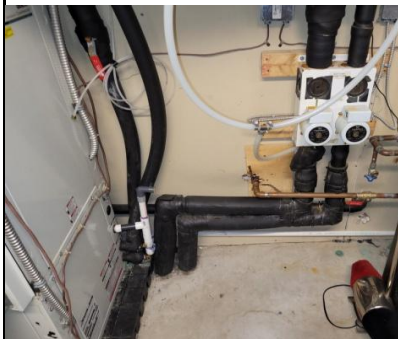
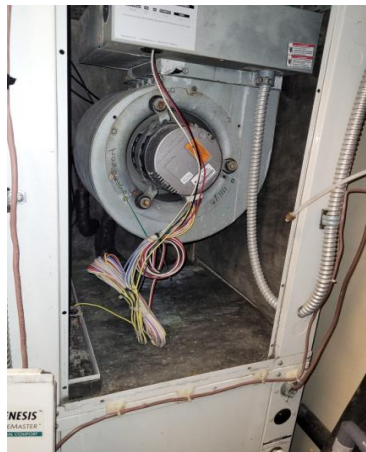
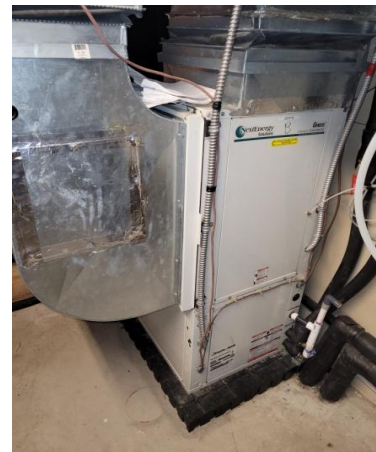
HEAT PUMP: unit provides heating and cooling service annually  
 system uses R-22 refrigerant which has been discontinued  
 budget to upgrade system with R-410a presently in use (consult with technician for further advice)

Air Handlers: 2 units service annually (include back up electric heat)  
 recommend obtaining replacement parts/servicing contract

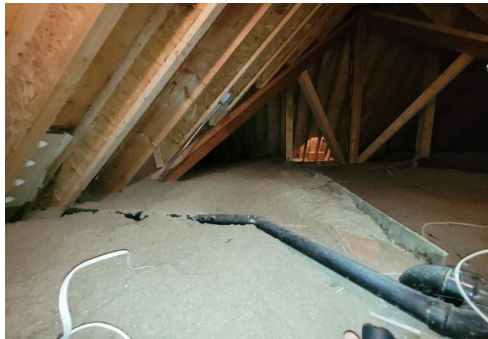
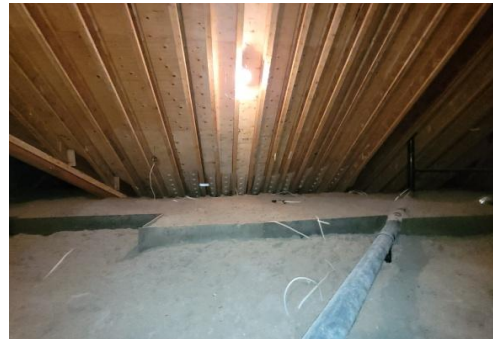
ROOF SPACE: insulation and ventilation is adequate

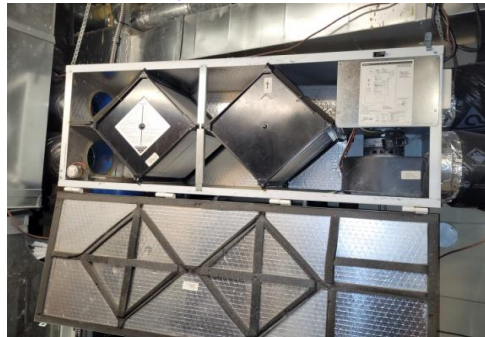
Heat Recover Ventilator: provides house with better air quality and efficiency  
see owners manual for proper use and maintenance  
service annually
