HOME INSPECTION REPORT

26 Edward Horton Cres
Toronto

Prepared by: Bob Papadopoulos P.Eng., RHI *

Inspection Date: Aug 7 2024

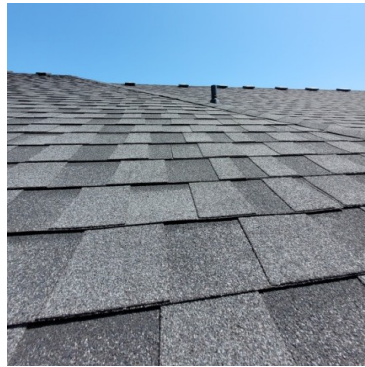
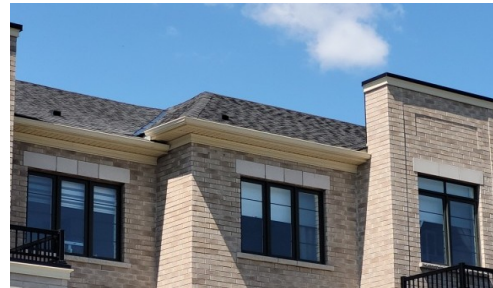
Sloped Surface: [overall surface in good repair](#)

[Note: Recommend Annual Maintenance Contract for Roof Surface, Flashing Details and Chimney\(s\)](#)

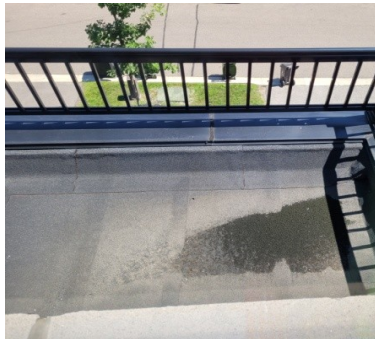
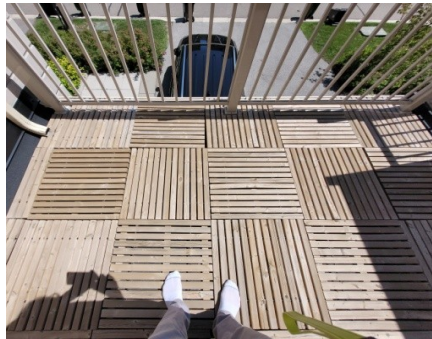
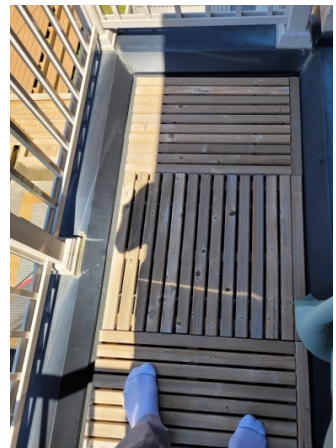
Flat Surface: [overall surface in good repair](#)
[\(underside of deck not visible\)](#)

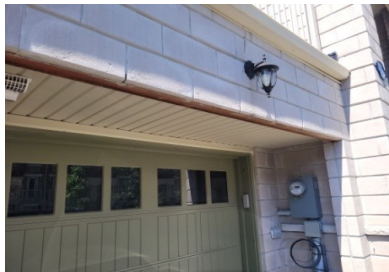
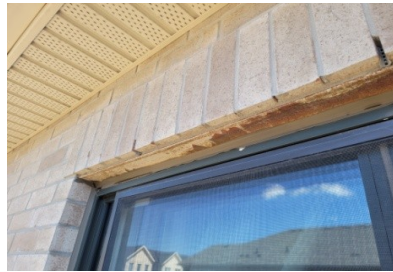
WALL SURFACES: overall in good repair
DOORS/WINDOWS: overall in good repair
general caulking maintenance to some units, paint metal lintels

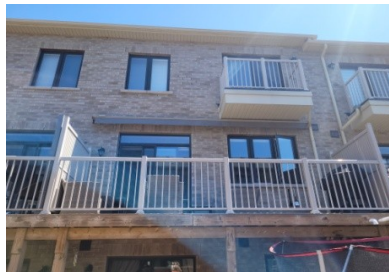
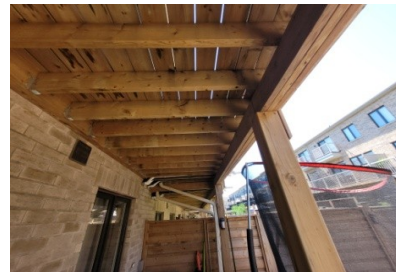
PORCH(es): overall in good repair
DECK overall in good repair

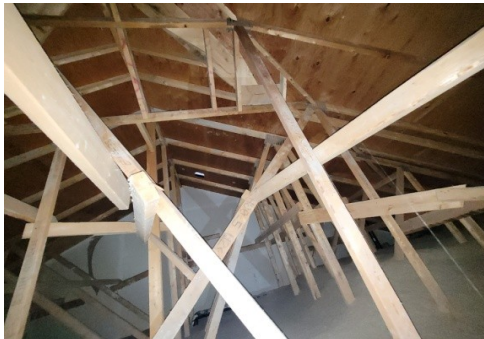
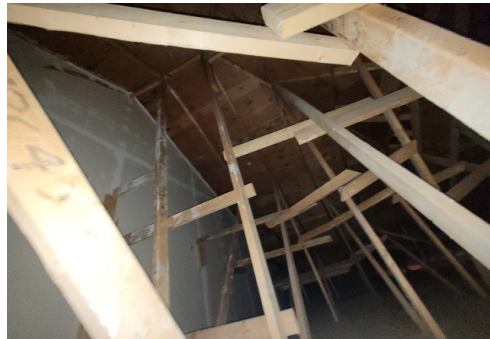
ROOF: overall in good repair

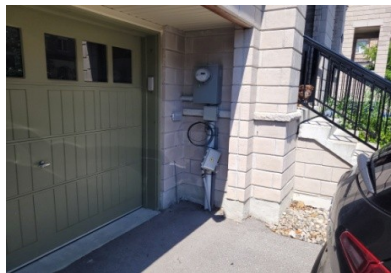
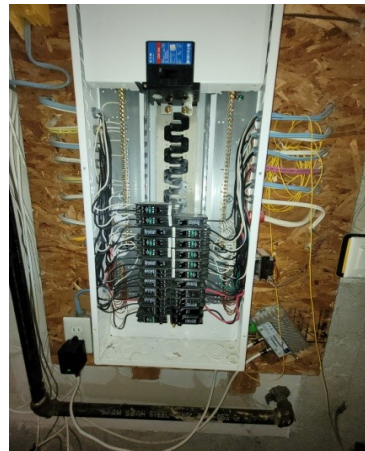
SERVICE ENTRANCE: **overall in good repair**
 SERVICE PANEL: **overall in good repair**

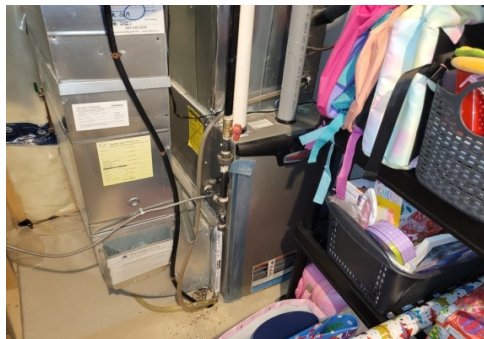
FORCED AIR FURNACE: [service annually](#)
Filter: [replace 1-per-3 months](#)

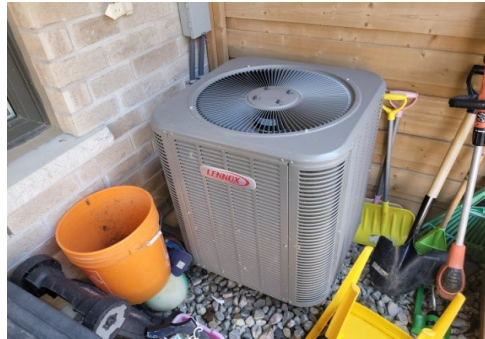
AIR CONDITIONER: [service annually](#)

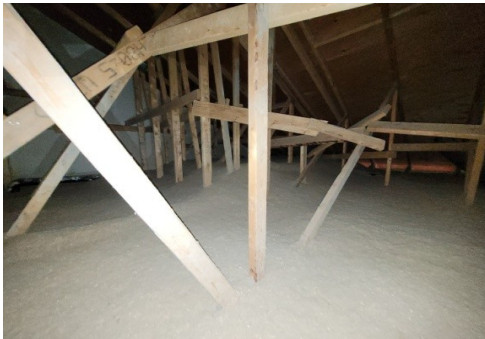
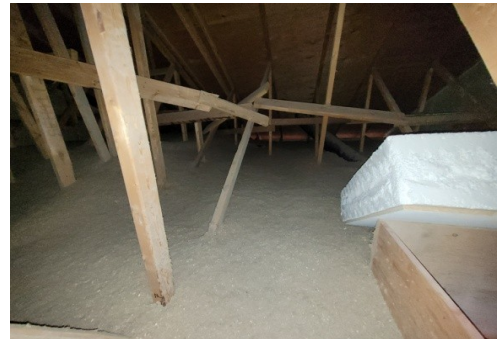
ROOF SPACE: [insulation and ventilation is adequate](#)
