HOME INSPECTION REPORT

33 Methuen Ave
Toronto

Prepared by: Bob Papadopoulos P.Eng., RHI *

Inspection Date: [May 22 2024](#)

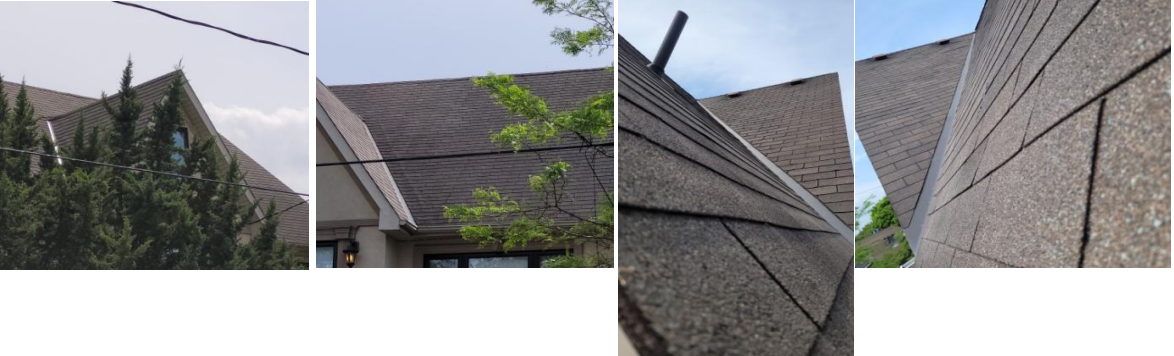
REFERENCE LINK		http://redbrickinspections.ca/docs/2_Roofing_Reference_Guide.pdf		
33 Methuen Ave		ROOFING/Chimneys		May 22 2024
Description				
Roofing Material:	Location:	Leakage Probability:	Chimney(s) Type:	Location:
Asphalt Shingles:	Slope:	Low		
Modified Bitumen:	Flat:	Low	deck	
Asphalt Shingles:	Garage:	High		
Limitations				
Roof Inspected By:	Access Limited By:	Chimney Access Limited By:		
From Grade From Edge	Height			
Observations/Recommendations				
Sloped Surface: overall surface in good repair, some cupping/curling

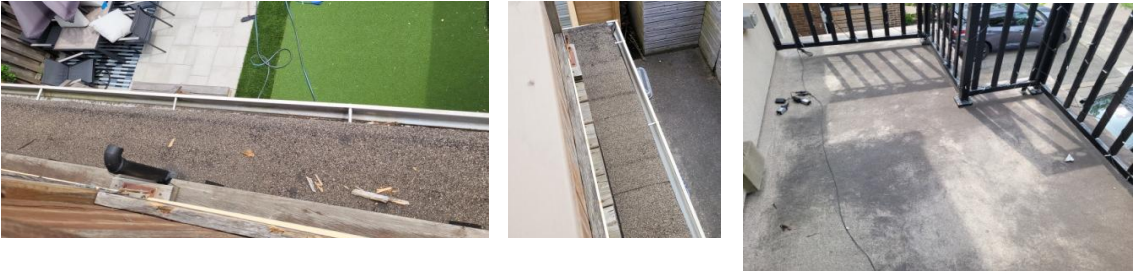
Flat Surface: limited access due to deck though where visible in good repair, loose along edges - monitor/repair as required				
Porch(s): overall surface in good repair, install decking to avoid eroding surface

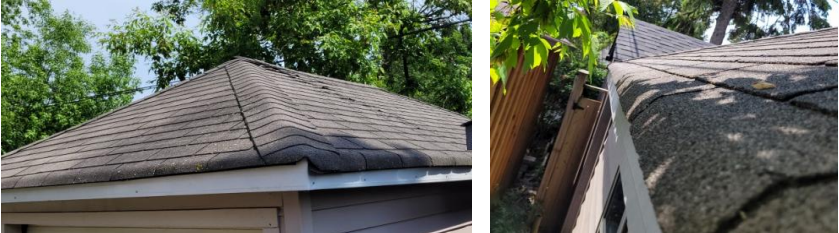
Garage: aging surface, budget to replace within 3 yrs.

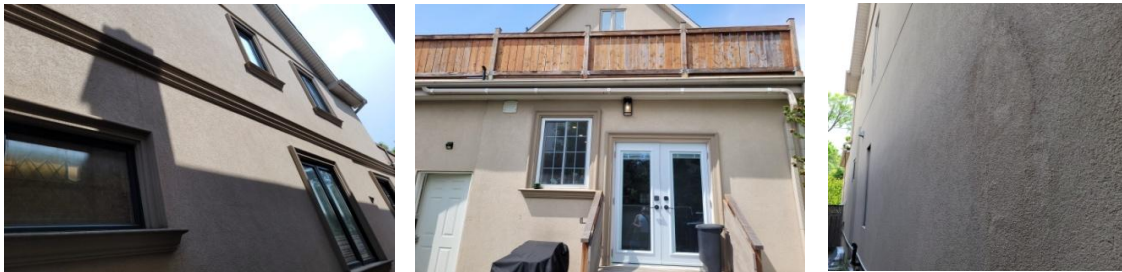
WALL SURFACES: overall in good repair, stucco repair noted on northeast side
DOORS/WINDOWS: overall in good repair

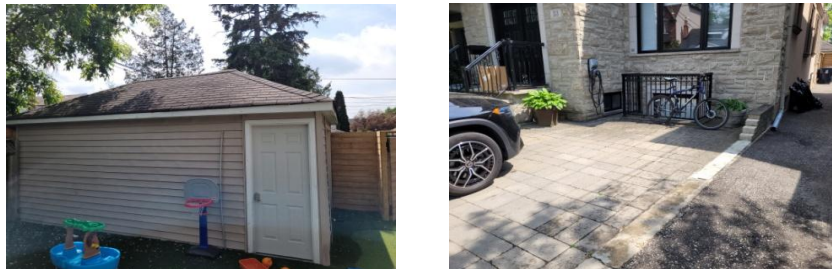
PORCH minor railing repairs required
DECK overall in good repair

DETACHED GARAGE: older, typically ongoing repairs, some repairs noted
bottom perimeter prone to rot - repair as required, budget to repair perimeter
**Walk(s)/Driveway(s): overall in good repair

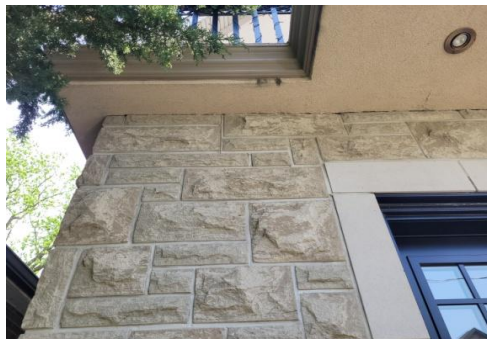
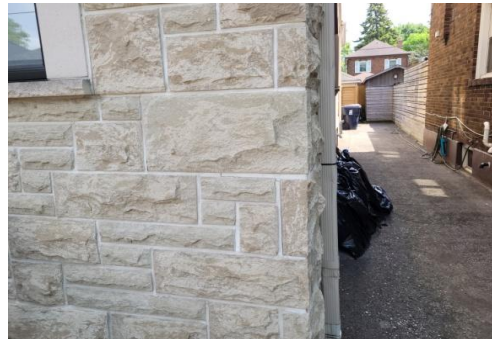
Stone Veneer: minor cracks at front - monitor/repair mortar as required

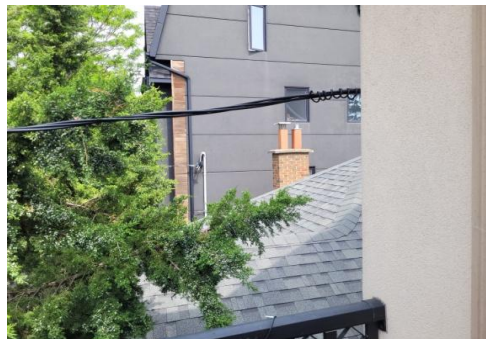
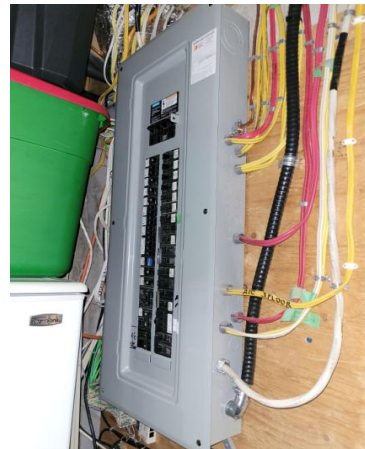
Clearance: **wires close to porch - safety concern**

SERVICE PANEL: overall in good repair
panel obstructed - cover not removed

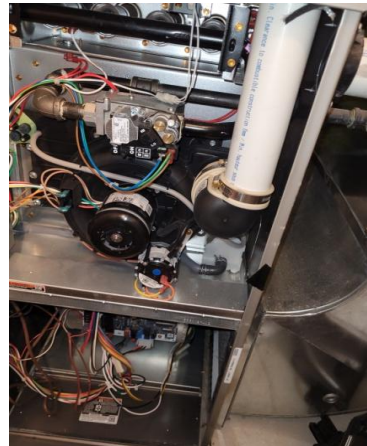
FORCED AIR FURNACE: [service annually](#)
Filter: [replace 1-per-3 months](#)

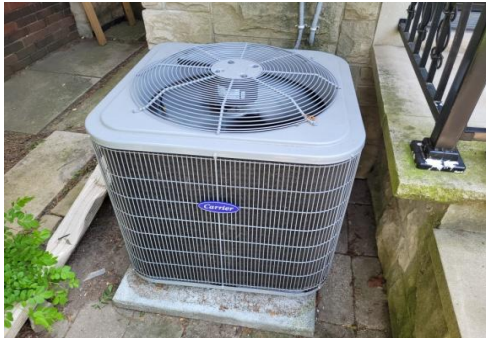
AIR CONDITIONER: [service annually](#)

DUCTLESS A/C: [service annually](#)

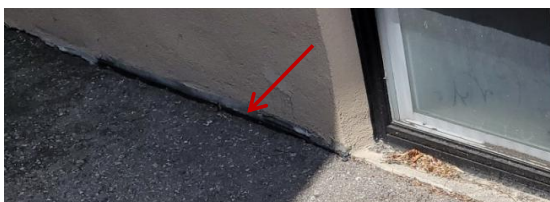
**Basement Leakage: presently no leaking detected with moisture meter random sampling
 appears exterior foundation damp-proofed to minimize leaking risk
 not determined if sump pump present- none found
