HOME INSPECTION REPORT

42 Larkin Ave
Toronto

Prepared by: **Bob Papadopoulos P.Eng., RHI** *

Inspection Date: **Aug 6 2024**

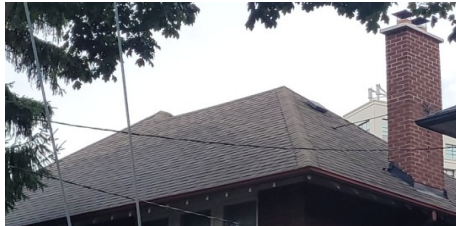
Chimney(s): [rebuilt and in good repair](#)

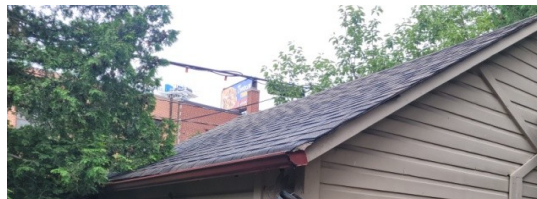
Garage: [overall surface in good repair](#)

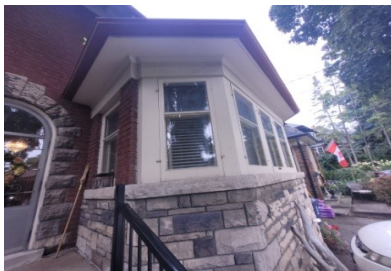
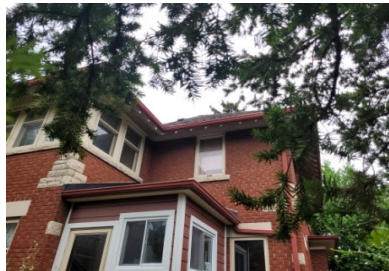
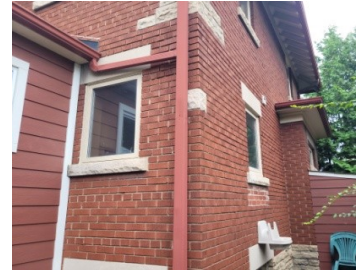
- **Gutters/Downspouts: requires maintenance/cleaning
extend 6-ft away from house
- **Walk(s)/Driveway(s): overall in good repair
- WALL SURFACES:
 - Brick: overall in good repair
 - Wood siding: overall in good repair
- DOORS/WINDOWS: older, overall in good repair

PORCH rusting railings, see Structure Concrete floors

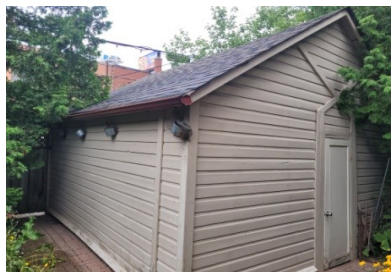
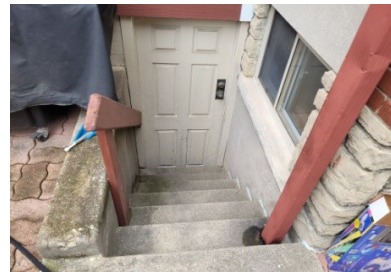
DETACHED GARAGE: older, typically ongoing repairs
bottom perimeter prone to rot - repair as required, budget to repair perimeter

**BASEMENT WALKOUT: overall well built, service drain at bottom landing, replace door
improve railings for safety

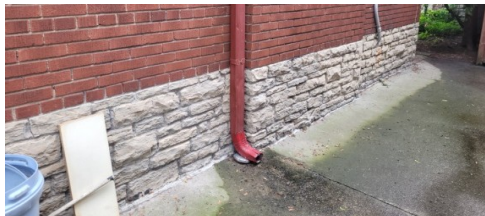
FOUNDATIONS: general mortar repairs as required

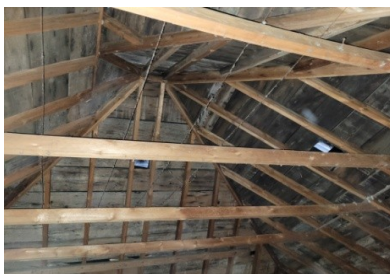
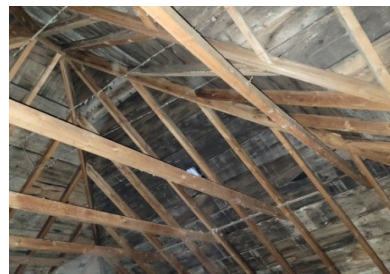
ROOF: overall in good repair

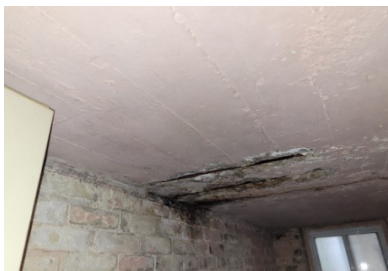
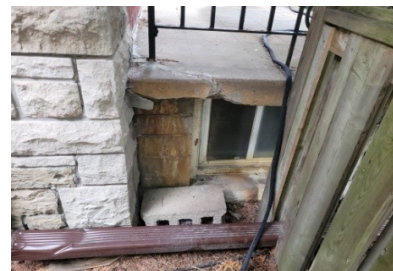
Concrete Floors: front porch, underside spalling- repair and seal top side surface
exterior corner damage- repair

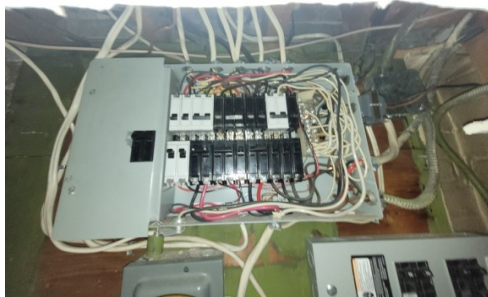
SERVICE ENTRANCE: **anticipate upgrade if renovating**
 Service Size: **anticipate upgrade if renovating to 200 amp when renovating**
 SERVICE PANEL: **crowded though overall in good repair**
anticipate upgrade if renovating to 200 amp when renovating
 Grounding: **replace clamp at water main**

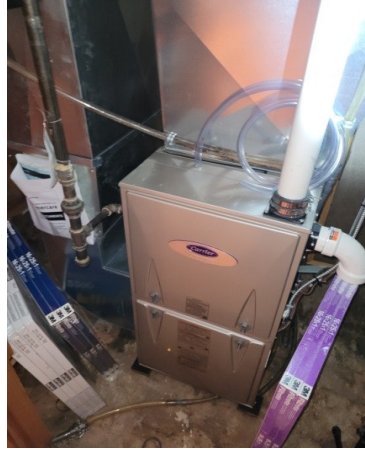
FORCED AIR FURNACE: [service annually](#)

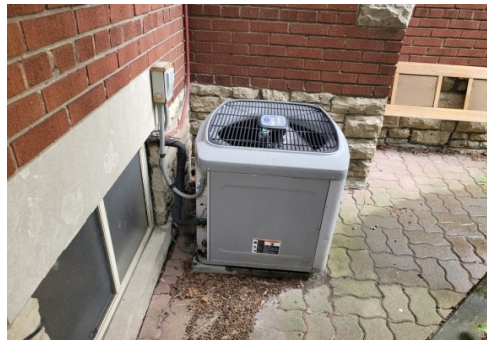
AIR CONDITIONER: **old unit, continue servicing until replacement becomes necessary**

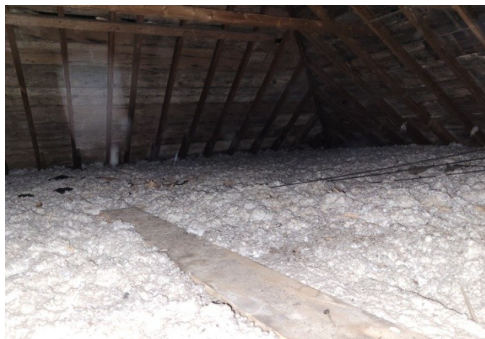
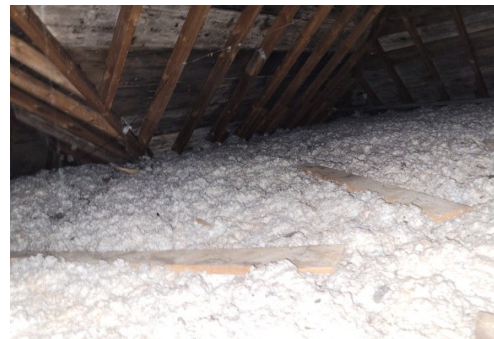
ROOF SPACE: recommend upgrading insulation to improve comfort and efficiency
recommend improving ventilation with soffit vents
insulate and weather-strip access hatch to roof space
