HOME INSPECTION REPORT

54 Rivercrest Rd

Toronto

Inspection Date: July 25 2024

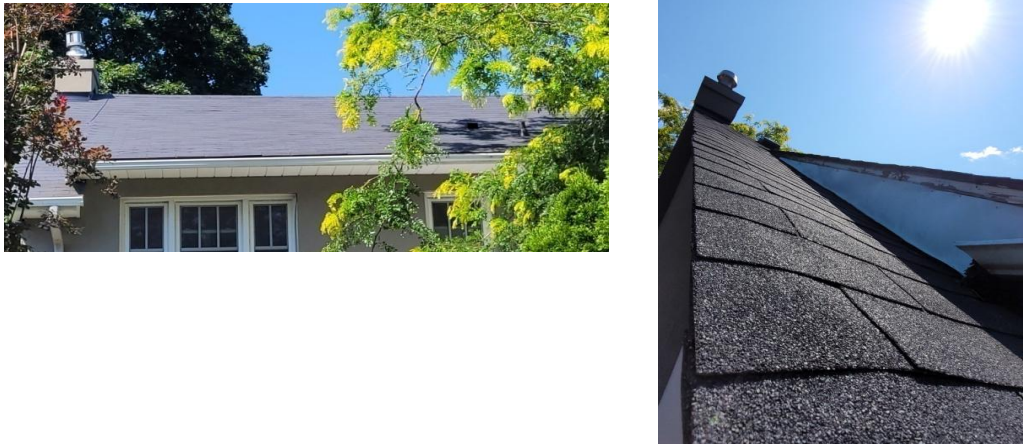
REFERENCE LINK	http://redbrickinspections.ca/docs/2_Roofing_Reference_Guide.pdf			
54 Rivercrest Rd	ROOFING/Chimneys			July 25 2024
Description				
Roofing Material:	Location:	Leakage Probability:	Chimney(s) Type:	Location:
Asphalt Shingles:	Slope:	Low	Brick:	South
Metal:	Overhang:	Low	Brick:	North
Modified Bitumen:	Flat:	Low	garage	
Limitations				
Roof Inspected By:	Access Limited By:	Chimney Access Limited By:		
From Grade	Height	Height		
From Edge	Tree			
Observations/Recommendations				
Tree Branches: retain arbourist for annual monitoring/trimming				
Sloped Surface: overall surface in good repair

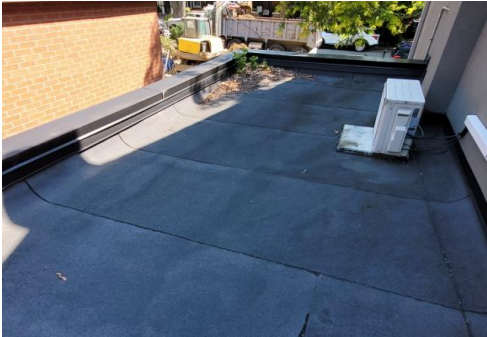
Chimney(s): overall in good repair				
Comments: front door overhang - in good repair				
Flat Surface: overall surface in good repair requires cleaning

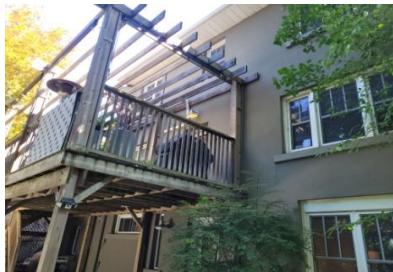
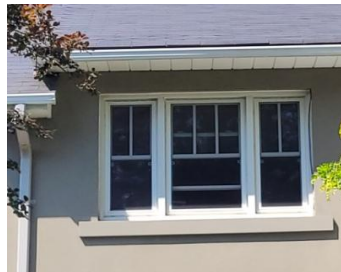
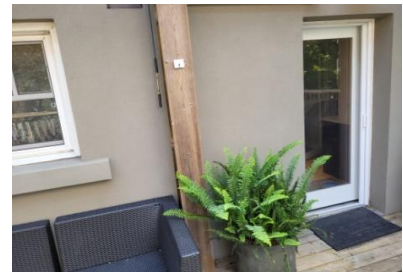
Synthetic Stucco: overall in good repair

DOORS/WINDOWS: overall in good repair

DECK overall in good repair

DOORS/WINDOWS: overall in good repair, driveway drain recently cleaned, overflow pipe should have elbow pipe connected

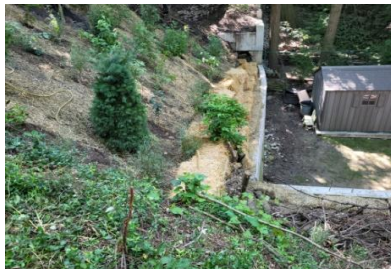
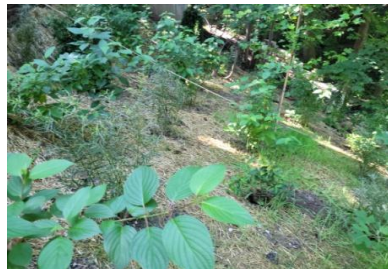
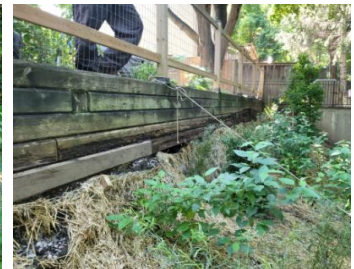
RETAINING WALL: rear yard/slope: concrete newly installed reinforced concrete wall

**Landscaping: rear yard/slope: new landscaping/installation of plants, etc. monitor plants development, monitor slope stability, consider retaining specialist for monitoring

RETAINING WALL: rear yard/slope: wood is older/partly damaged, continue to monitor/repair, budget to replace, install safety rails on wall

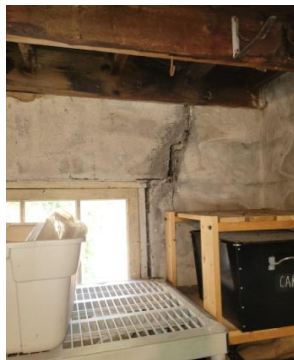
FOOTINGS/FOUNDATIONS GARAGE: north west corner: settlement cracks, reported older and the footing/foundation was underpinned - repair cracks and monitor
 Concrete Floors: GARAGE: this ia a steel reinforced suspended slab, visibility was limited due to storage, recommend further evaluation surface maintenance/treatment on top surface with sealant, monitor

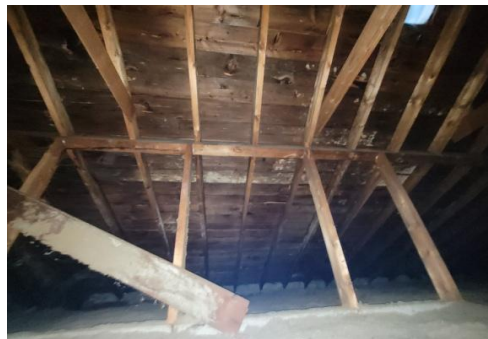
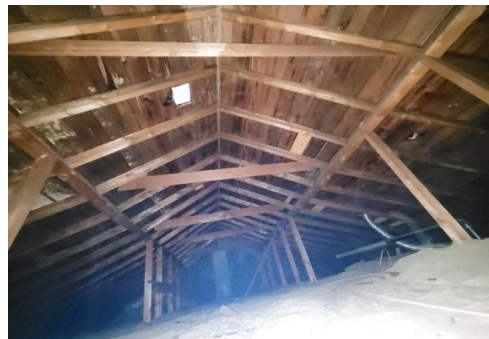
ROOF: overall in good repair

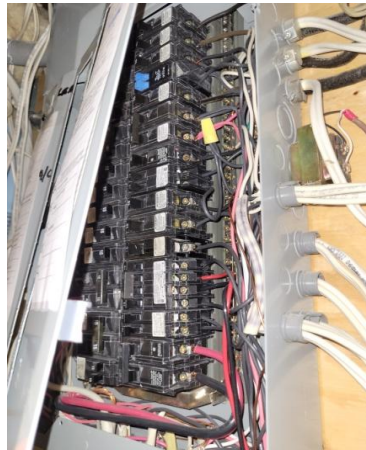
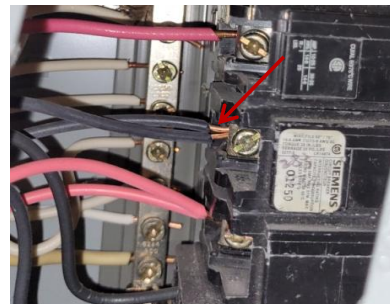
SERVICE ENTRANCE: overall in good repair
 SERVICE PANEL: crowded, double taps (two wires connect to one breaker), install sub-panel or larger panel if required

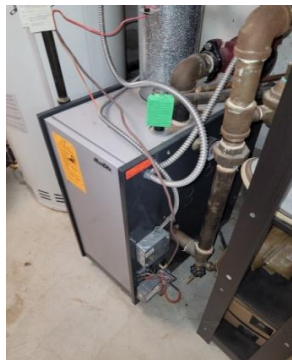
HOT WATER BOILER: [service annually](#)
[annual CO test mandatory for this type of unit](#)
[recommend obtaining replacement parts/servicing contract](#)

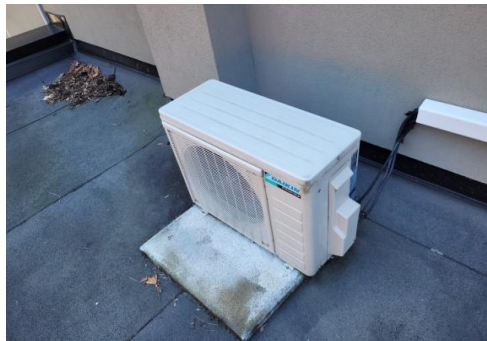
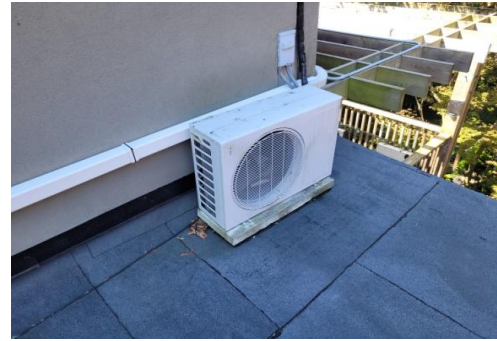
DUCTLESS A/C: [service annually](#)
[one aging unit, continue servicing until replacement becomes necessary](#)

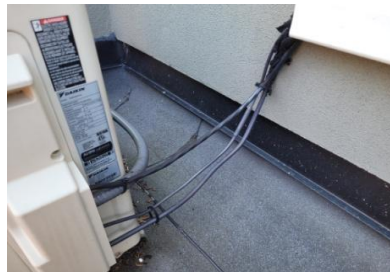
Refrigerant Lines: [repair/replace insulation](#)

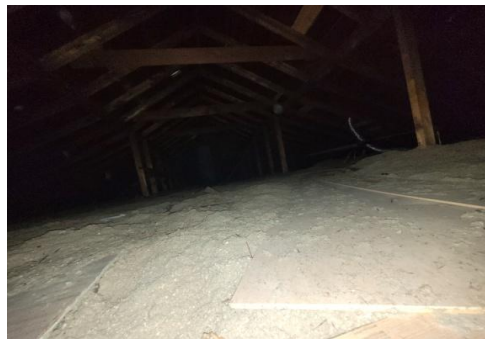
Main Slope Roof: recommend upgrading insulation to improve comfort and efficiency
 recommend improving ventilation with soffit vents

Roof Access Hatch: insulate and weather-strip access hatch to roof space
