HOME INSPECTION REPORT

60 Ellis Park Rd

Prepared by: Bob Papadopoulos P.Eng., RHI *

Inspection Date: Sept 11 2024

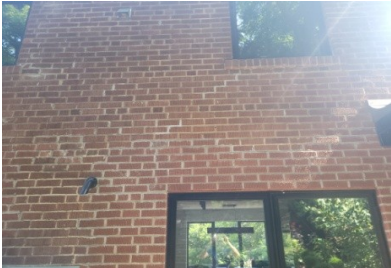
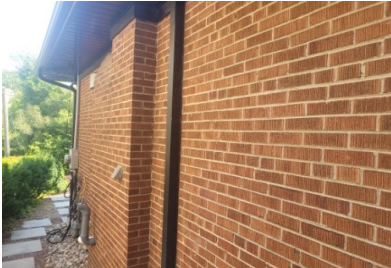
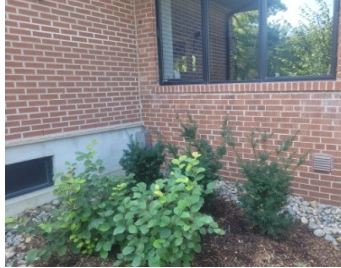
REFERENCE LINK		http://redbrickinspections.ca/docs/3_Exterior_Reference_Guide.pdf	
60 Ellis Park Rd		<div>EXTERIOR</div> <div>Sept 11 2024</div>	
Description			
Gutters & Downspouts: Aluminum:	Downspout(s) Discharge: Below/Above Grade	Lot Topography: Towards House Away From House House Below Ravine	Walls & Wall Structures: Brick Stone Retaining Wall Metal Retaining Wall
Limitations			
Exterior Inspection from Ground Level Storage in Garage			
Observations/Recommendations			
<p>WALL SURFACES: overall in good repair</p> <p>DOORS/WINDOWS: overall in good repair</p> <p>PORCH front/above garage overall good quality installations</p> <div>

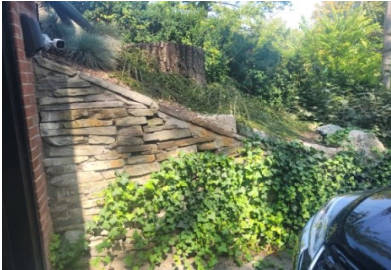
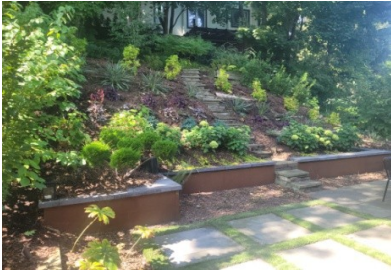
</div> <p>ATTACHED GARAGE: overall in good repair</p> <p>**Walk(s)/Driveway(s): overall in good repair</p> <p>**Landscaping: overall good quality installations rear slope: monitor and improve for erosion control as required</p> <p>RETAINING WALL(s): overall in good repair</p> <div>

<p>Note: Maintain Gutters & Downspouts annually. Extend Downspouts at least 6-feet away from the house</p> <p>** Any or all these items may contribute to Basement Leakage. Please see Interior Page</p>

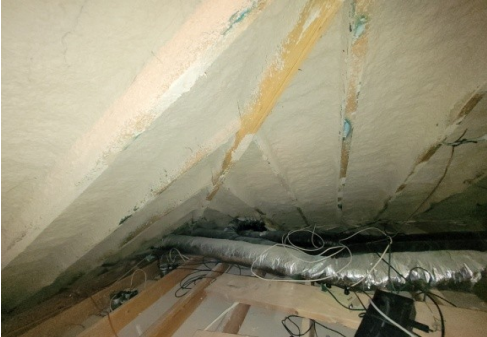
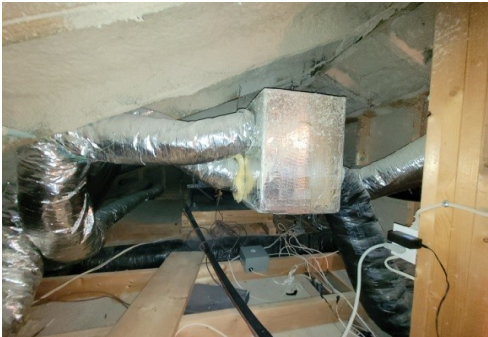
REFERENCE LINK		http://redbrickinspections.ca/docs/4_Structure_Reference_Guide.pdf		
60 Ellis Park Rd		STRUCTURE		Sept 11 2024
Description				
Configuration: Basement:	Foundations: Masonry Block	Floor : Wood Joists	Walls : Wood Frame(Brick Veneer)	Roof/Ceiling Framing: Wood Rafters/Joists
Limitations				
Restricted Access to: Wall Space	Foundation Wall Not Visible: <u>99</u> % Attic Entered but access was limited			
Observations/Recommendations				
<p>overall well built house (newer structure that was built on original structure)</p> <p>ROOF: overall in good repair</p> <div style="display: flex; justify-content: space-around;">

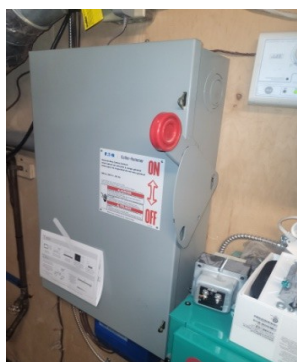
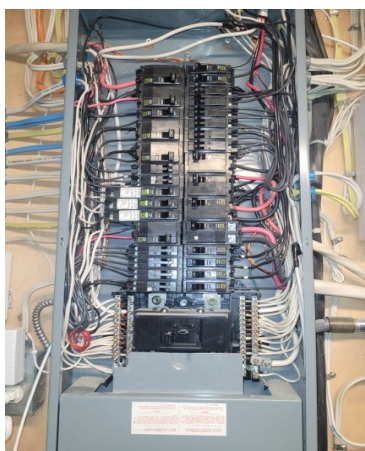
Limitations**Main Disconnect Cover Not Removed****Observations/Recommendations**SERVICE ENTRANCE: **overall in good repair**Main Disconnect: **overall in good repair**SERVICE PANEL: **overall in good repair**

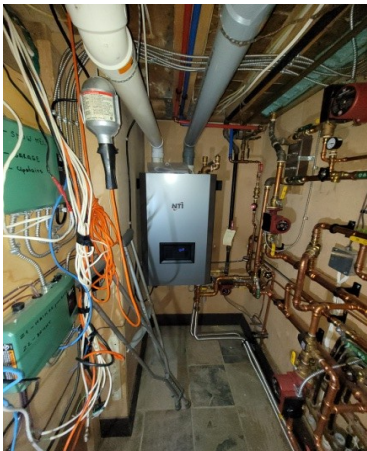
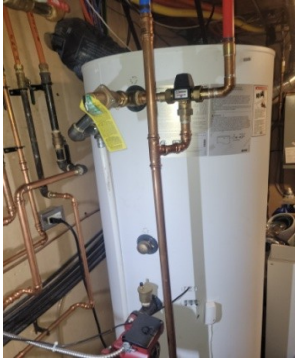
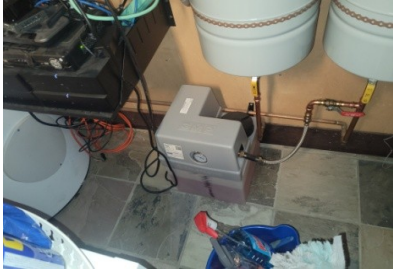
</div>							
<p>Piping: includes Kitec (brand name), this type of piping has history of defective/leaking connections - presently none observed, however may require further evaluation by specialist and/or replacement for insurance significant cost if replacement required - further evaluation</p> <p>Comments: we inspected house circa 2018 and no leaking observed</p>

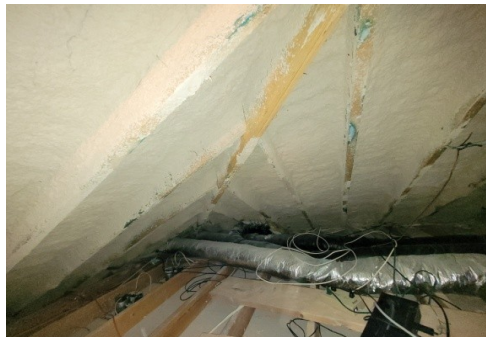
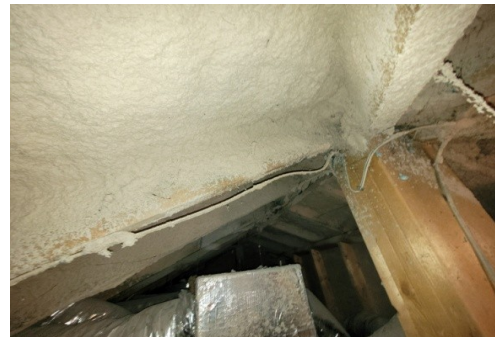
ROOF SPACE: insulation and ventilation is adequate

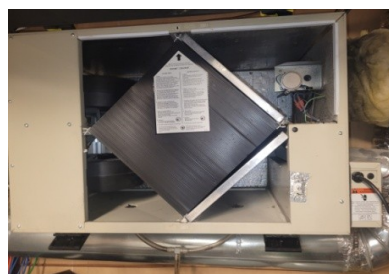
Heat Recover Ventilator: service annually
provides house with better air quality and efficiency
see owners manual for proper use and maintenance
