HOME INSPECTION REPORT

61 MacGregor Ave
Toronto

Inspection Date: Aug 13 2024

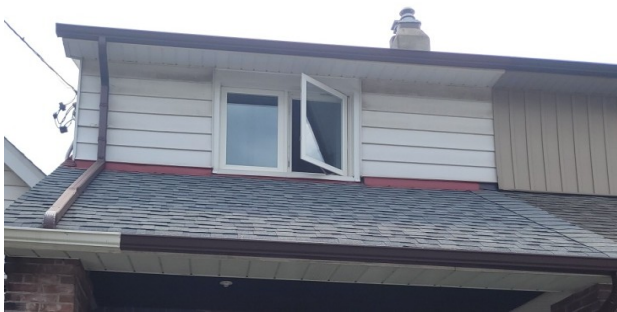
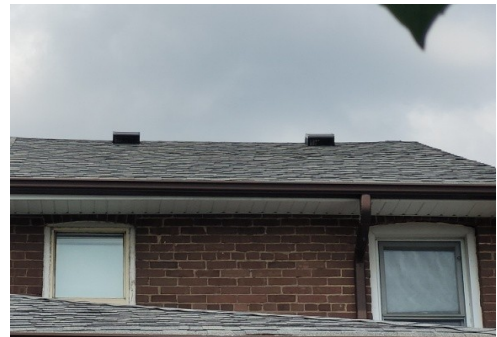
Sloped Surface: [overall surface in good repair](#)

Note: [Recommend Annual Maintenance Contract for Roof Surface, Flashing Details and Chimney\(s\)](#)

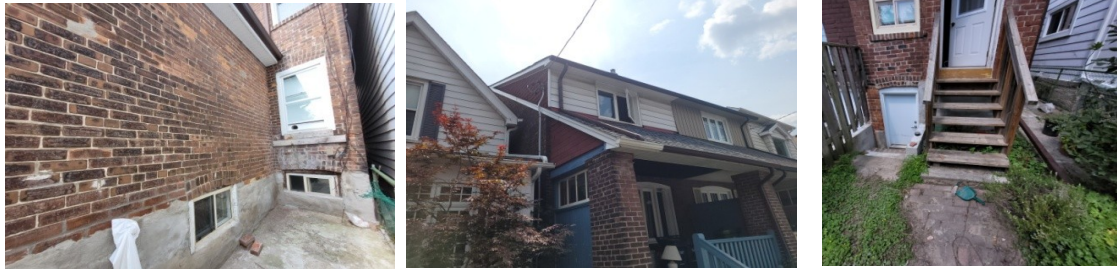
WALL SURFACES: overall in good repair

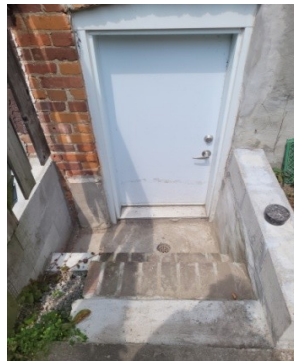
**BASEMENT WALKOUT: overall in good repair, provide hand rails for safety

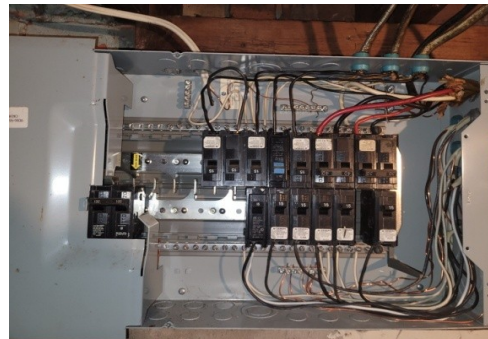
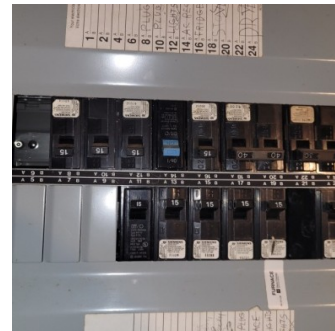
SERVICE ENTRANCE: **overall in good repair**
 SERVICE PANEL: **overall in good repair**
panel cover openings should be sealed

Note 1: All recommendations are safety issues - Treat them as high priority.

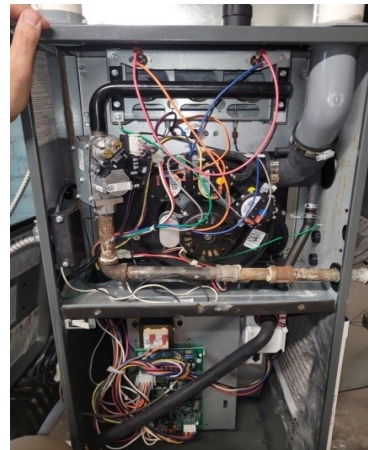
FORCED AIR FURNACE: [service annually](#)
Filter: [replace 1-per-3 months](#)
