HOME INSPECTION REPORT

68 Marion St
Toronto

Prepared by: Bob Papadopoulos P.Eng., RHI *

Inspection Date: [Aug 28 2024](#)

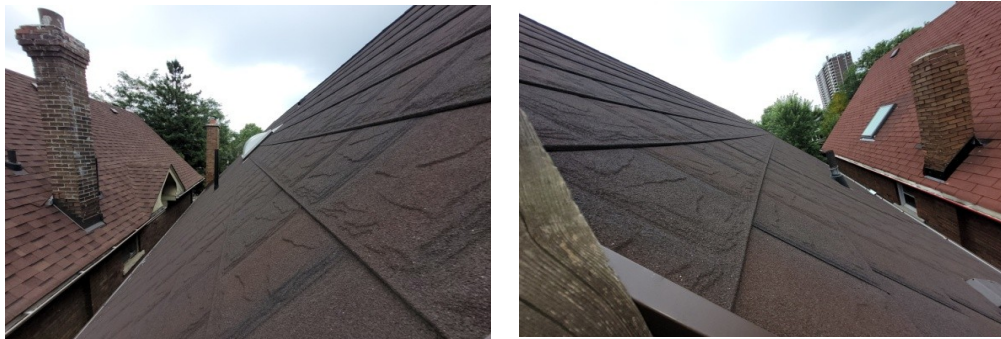
Sloped Surface: [overall surface in good repair](#)
 Chimney(s): [overall in good repair](#)

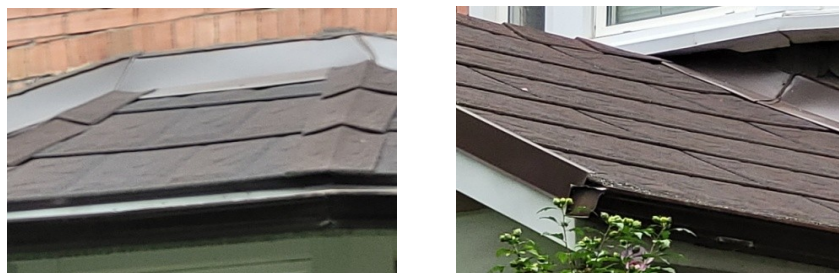
Porch(s): [overall in good repair](#)
 Bay(s): [overall in good repair](#)

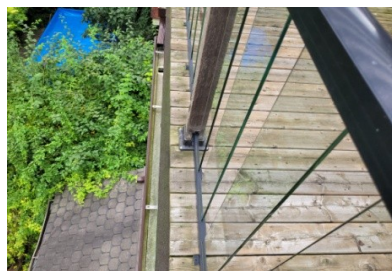
Flat Surface: [mostly not visible due to deck](#)

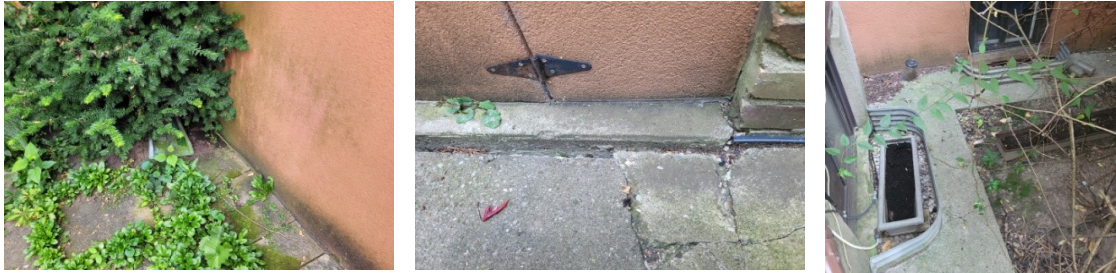
- **Gutters/Downspouts: requires maintenance/cleaning
- ** Downspouts: rear of house- extend 6-ft away from house
- **North Grading: rear of house- re-grade and slope away from house
- **Walk(s): seal gap along wall
- **Window wells: provide window well covers

Note: Maintain Gutters & Downspouts annually. Extend Downspouts at least 6-feet away from the house

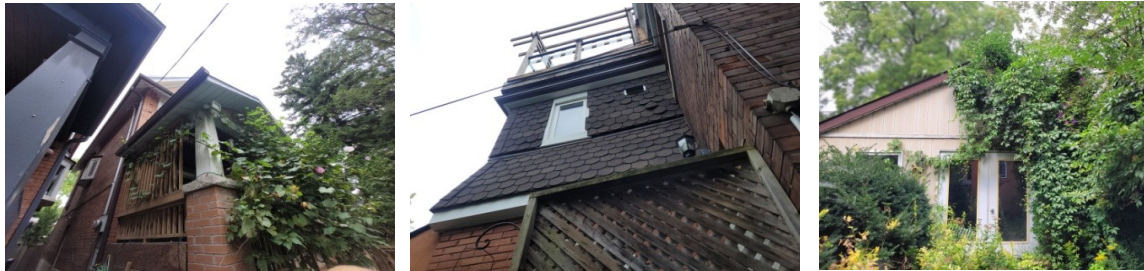
- Asphalt Shingles: overall in good repair
- Brick: overall in good repair
- Stucco: overall in good repair

DOORS/WINDOWS: overall in good repair, bay windows require general maintenance

PORCH: overall in good repair

DETACHED GARAGE: exterior requires general repairs and maintenance

DECK(s): overall in good repair

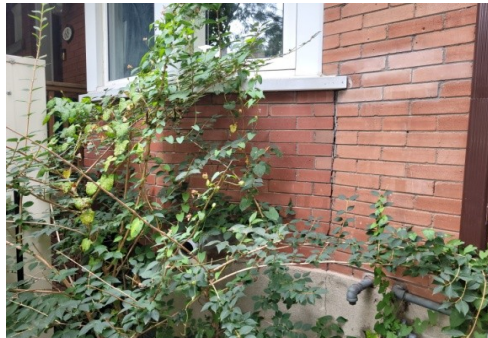
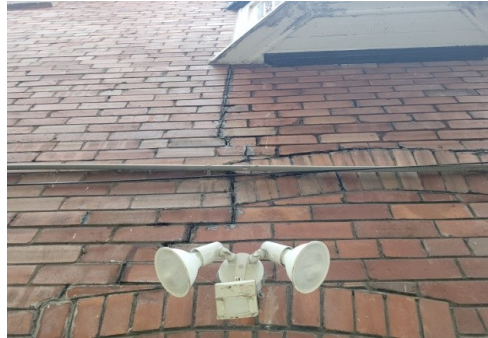
Masonry: minor mortar repairs in some areas - typical

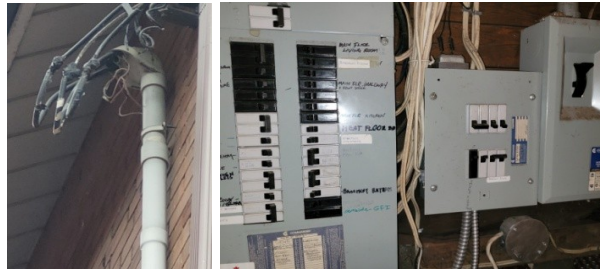
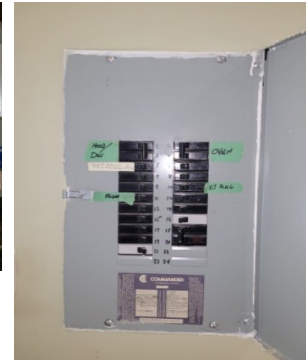
SERVICE ENTRANCE: **two meter base - in good repair**
 Mast: **overall in good repair, loose fastener at top - minor repair**
 SERVICE PANEL: **two units: in good repairs, covers not removed**

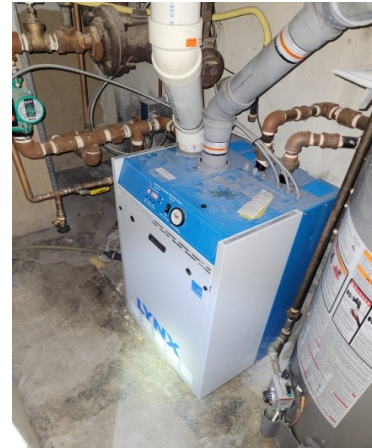
HOT WATER BOILER: [service annually](#)
Radiator(s): [monitor/repair valves as required](#)

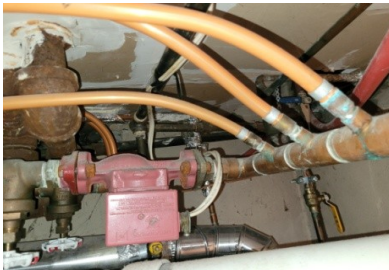
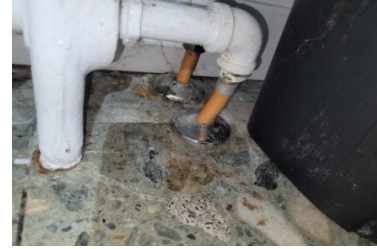
Piping: [Kitec \(brand name\) was identified which has history of leaking presently no signs of leaking or corroded connections, overall risk of leaking is low though might require replacement for insurance, further evaluation](#)

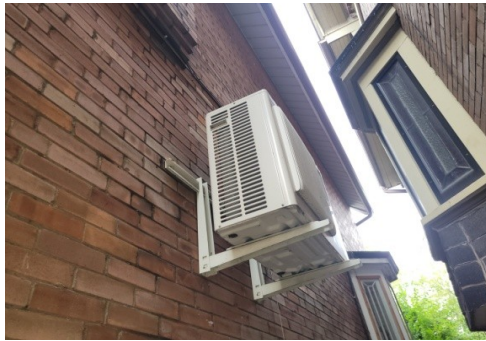
DUCTLESS A/C: multi split zoned for 2nd and 3rd level ductless wall mounted units
units require cleaning/clean filters

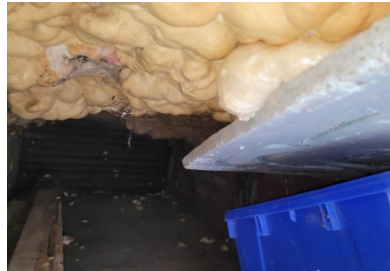
Crawlspace Floor: insulated with spray foam which is above average
