# HOME INSPECTION REPORT

31 Keane Ave  
Toronto

Inspection Date: [Sept 29 2024](#)

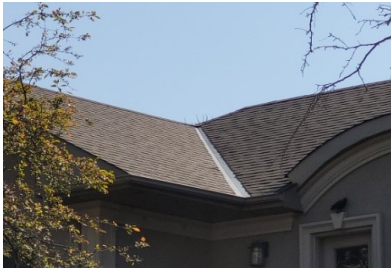
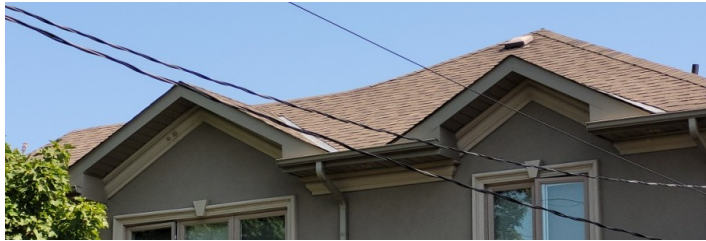
Sloped Surface: [overall surface in good repair](#)

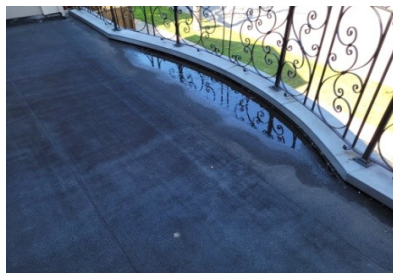
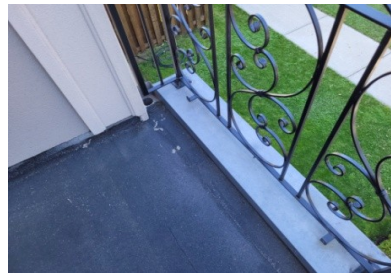
Porch(s): [overall surface in good repair, some ponding noted- monitor, service drain annually, install strainer to drain, should install decking over surface](#)

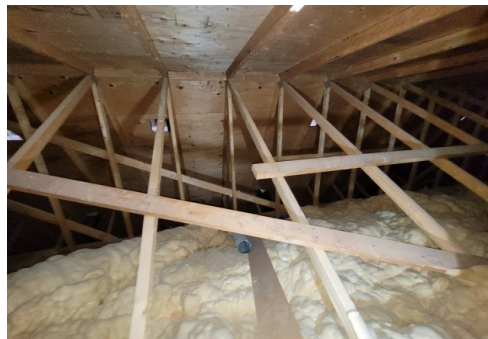
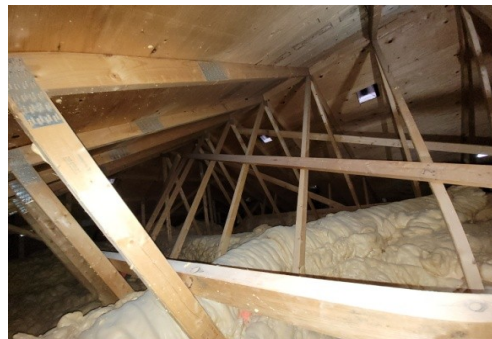
ROOF: overall in good repair

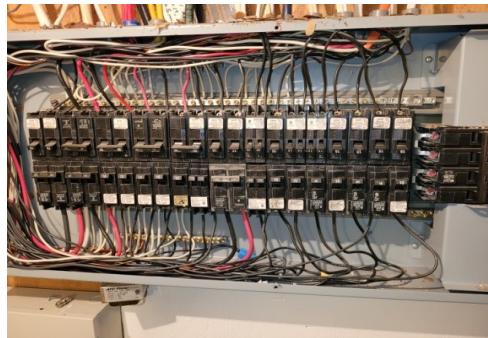
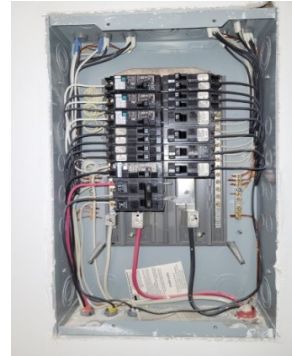
SERVICE ENTRANCE: overall in good repair  
 SERVICE PANEL: overall in good repair  
 Auxiliary Panel: overall in good repair

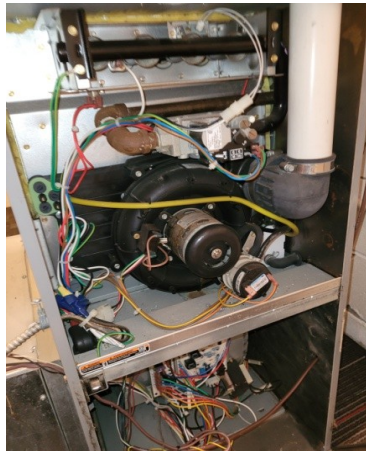
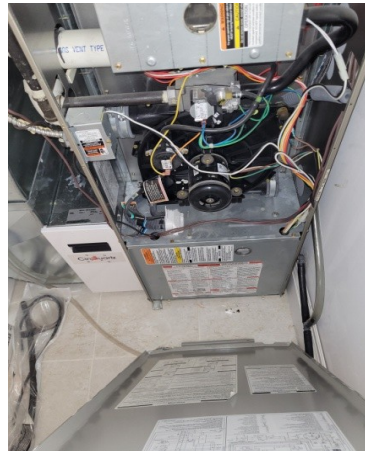
FORCED AIR FURNACE: [Two Units: service annually](#)  
[recommend obtaining replacement parts/servicing contract](#)  
Filter: [replace 1-per-3 months](#)

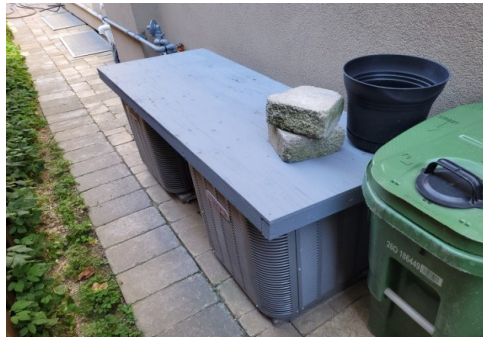
AIR CONDITIONER: [service annually](#)  
[units were covered outside- not tested](#)

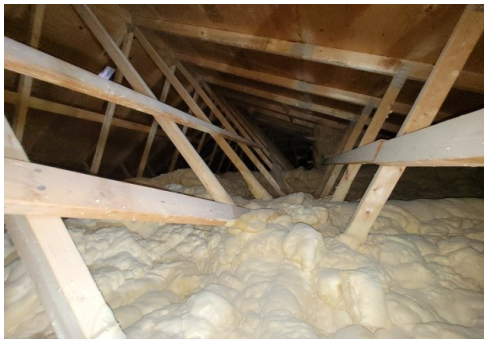
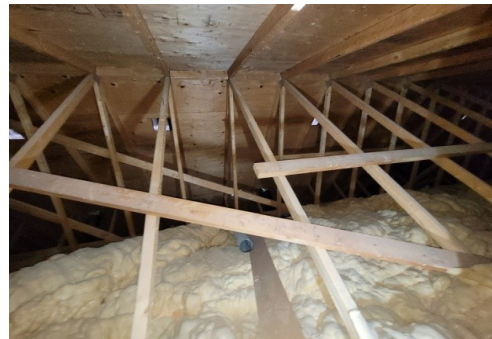
ROOF SPACE: insulation and ventilation is adequate  
spray foam insulation installed which is above average
