# HOME INSPECTION REPORT

3 Thornhill Ave  
Toronto

Prepared by: Bob Papadopoulos P.Eng., RHI \*

Inspection Date: [Oct 23 2024](#)

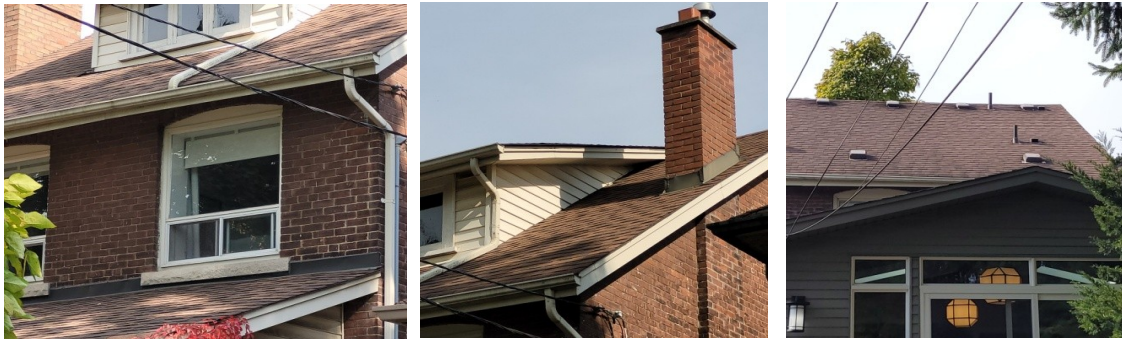
Sloped Surface: [overall surface in good repair](#)

Porch(s): [overall surface in good repair](#)

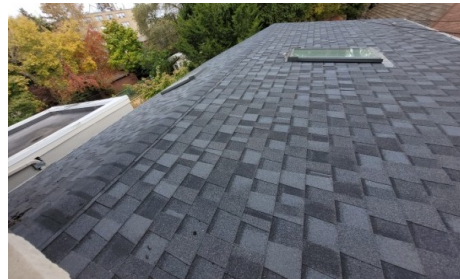
2nd Slope: [overall surface in good repair](#)  
[skylights in good repair](#)

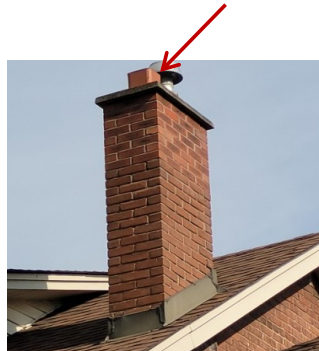
Chimney: [rebuilt and in good repair](#)  
[install rain/screen cap to clay liner](#)

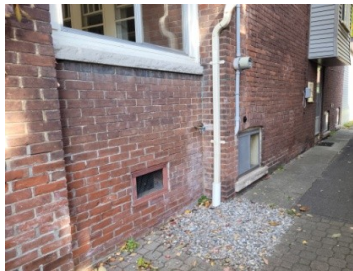
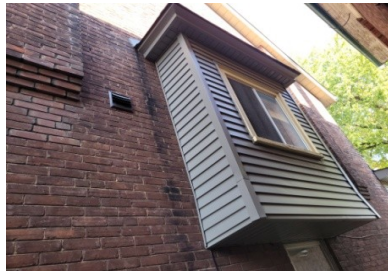
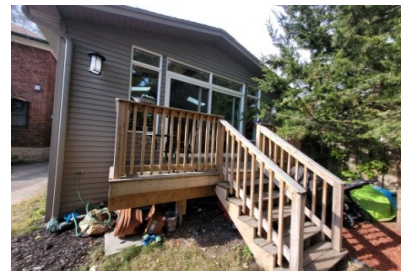
WALL SURFACES: overall in good repair  
DOORS/WINDOWS: overall in good repair  
DECK overall in good repair

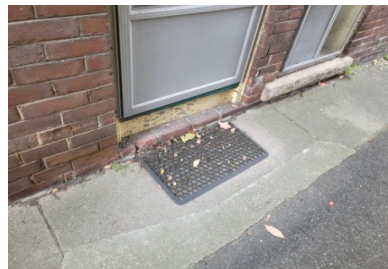
\*\*Walk(s): seal gaps/cracks

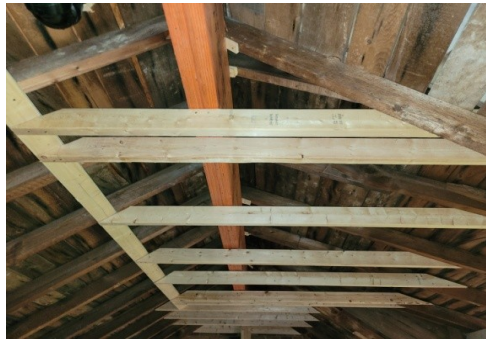
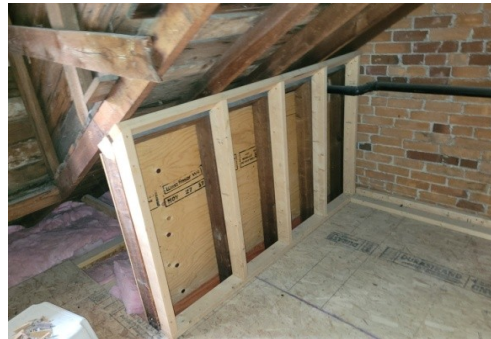
ROOF: overall in good repair  
roof has been reinforced for roughed in 3rd level

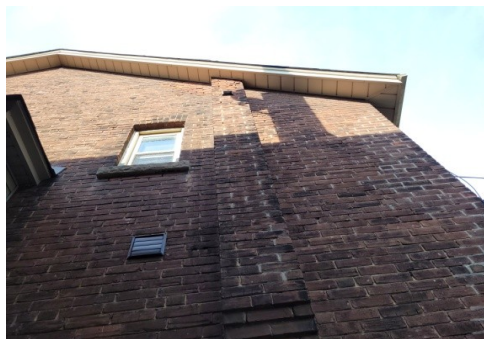
WALLS:  
Masonry: exterior south - minor/typical surface spalling

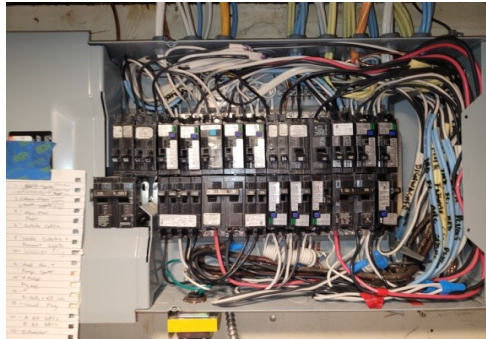
SERVICE ENTRANCE: overall in good repair  
 SERVICE PANEL: overall in good repair  
 remove abandoned wire in panel

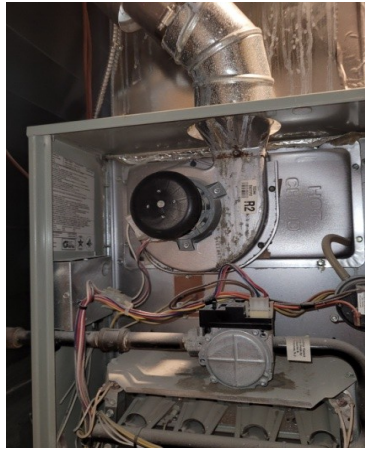
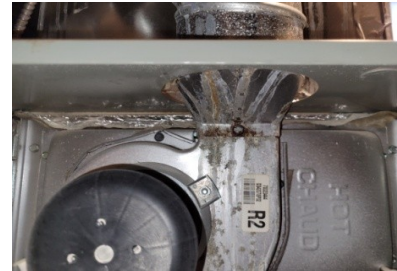
FORCED AIR FURNACE: [continue servicing until replacement becomes necessary](#)  
[recommend obtaining replacement parts/servicing contract](#)  
[some rusting on draft fan - service unit before use](#)  
Filter: [replace 1-per-3 months](#)

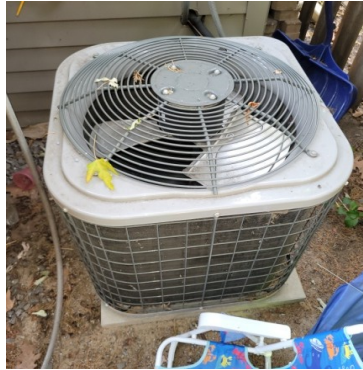
AIR CONDITIONER: [requires servicing](#)

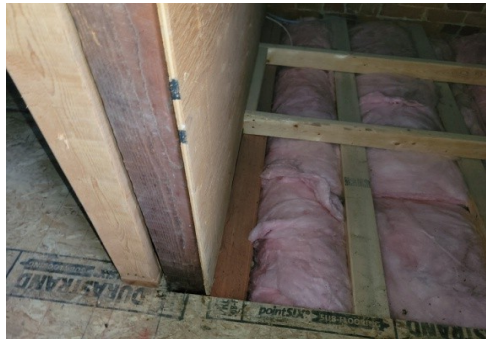
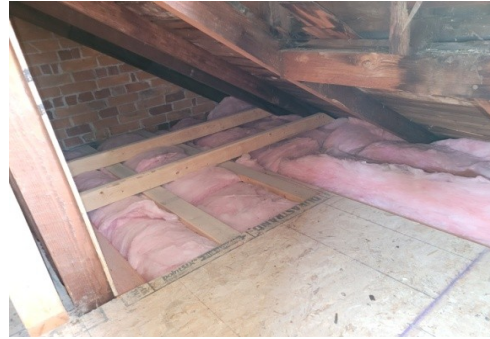
Comments: 2nd Level Ceiling insulated where observed form 3rd level attic
