HOME INSPECTION REPORT

19 Dacre Cr

Prepared by: Bob Papadopoulos P.Eng., RHI *

Inspection Date: [Feb 21 2025](#)

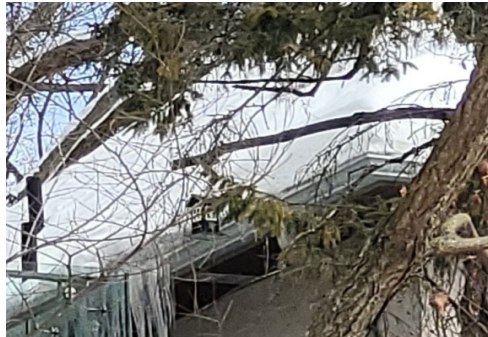
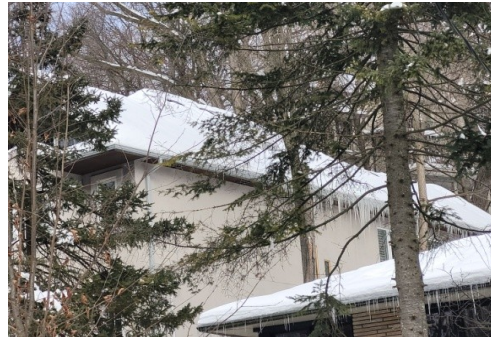
Tree Branches: [retain arbourist for annual monitoring/trimming](#)

Roofing: [not visible due to snow](#)

Ice Dams: [typical due to present weather - monitor](#)

[Note: Recommend Annual Maintenance Contract for Roof Surface, Flashing Details and Chimney\(s\)](#)

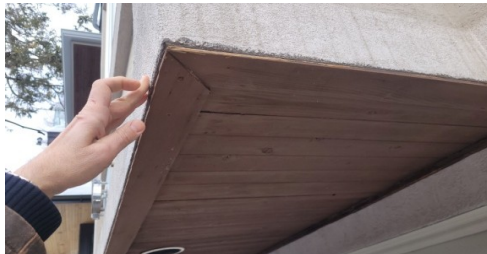
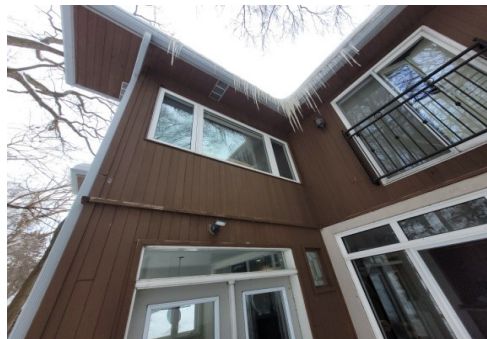
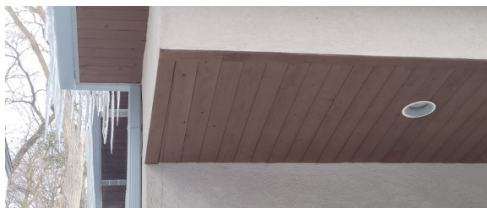
Synthetic Stucco: overall in good repair, front overhang - missing drip edge flashing- repair

Wood siding: requires general maintenance/painting

DOORS/WINDOWS: various calking repairs required

Note: Maintain Gutters & Downspouts annually. Extend Downspouts at least 6-feet away from the house

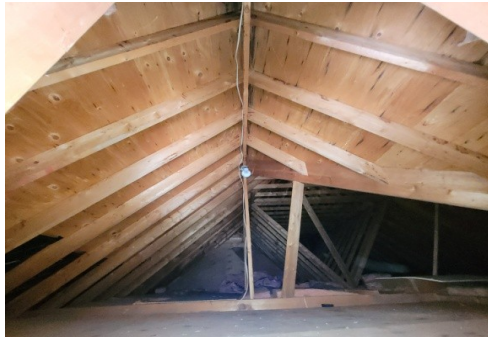
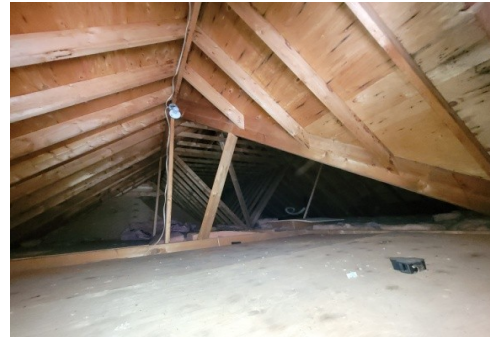
overall well built house

ROOF: overall in good repair

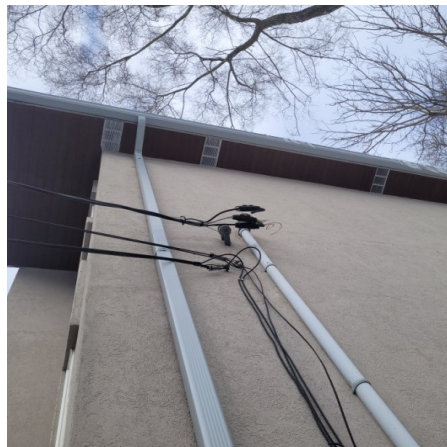
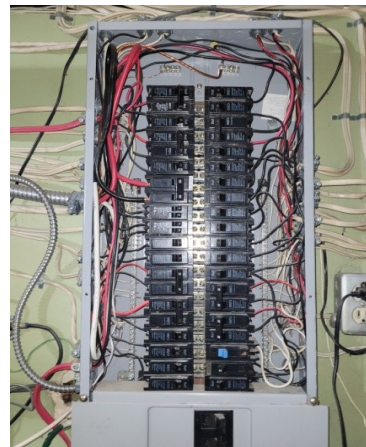
SERVICE ENTRANCE: **overall in good repair**

SERVICE PANEL: **overall in good repair**

GFCI: **provide to exterior outlet front**

Note 1: All recommendations are safety issues - Treat them as high priority.

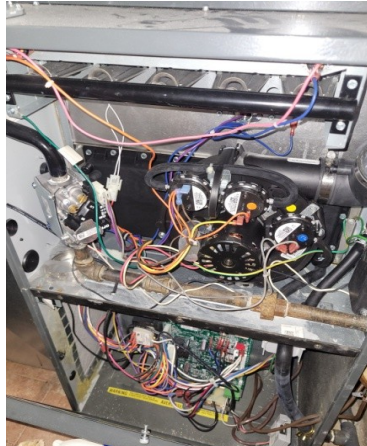
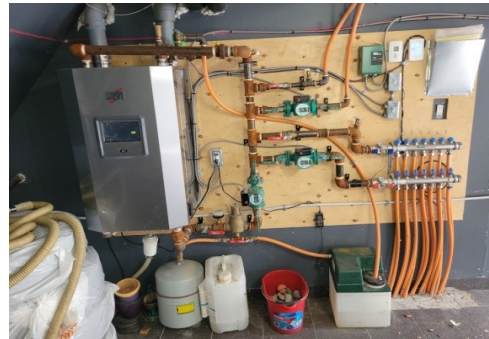
FORCED AIR FURNACE: [service annually](#)

HOT WATER BOILER: [service annually](#)

Hot Water Radiant Heat: [boiler provides basement/garage floor and driveway heating](#)

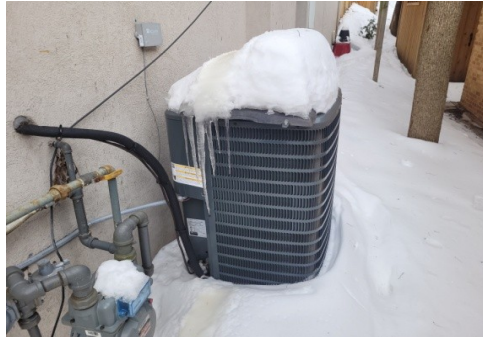
AIR CONDITIONER: not tested: should be serviced before using

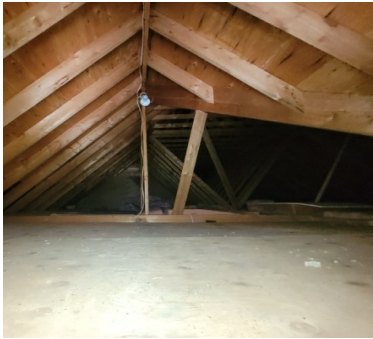
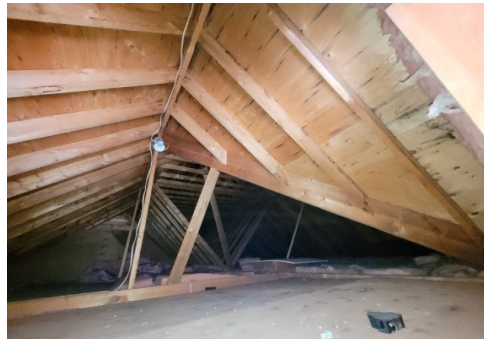
ROOF SPACE: insulation and ventilation is adequate
majority of roof used for storage space

Roof Access Hatch: insulate and weather-strip access hatch to roof space
