HOME INSPECTION REPORT

131 Colbeck St
Toronto

Inspection Date: [Feb 28 2025](#)

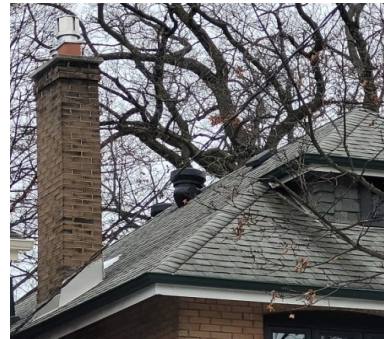
Chimney: [overall in good repair](#)

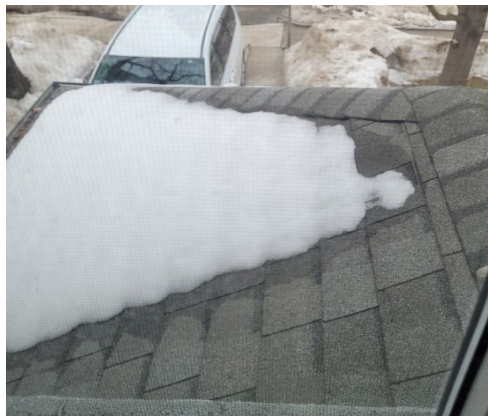
Porch(s): [mostly not visible due to snow](#)
[overall surface in good repair](#)

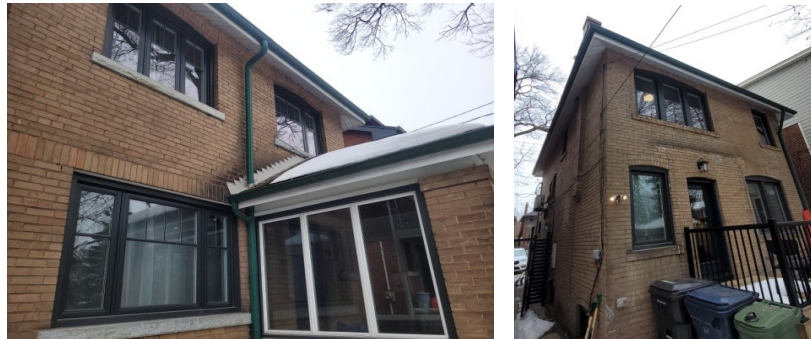
WALL SURFACES: [overall in good repair](#)
 DOORS/WINDOWS: [overall in good repair](#)

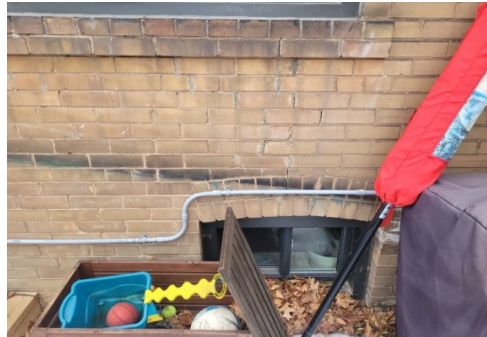
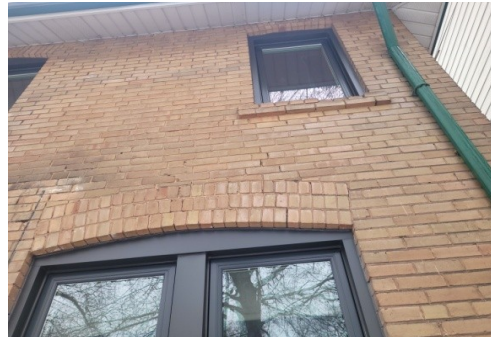
Masonry Arches: rear: typical settlement cracks
monitor-cracks above arch typical, repair mortar as required

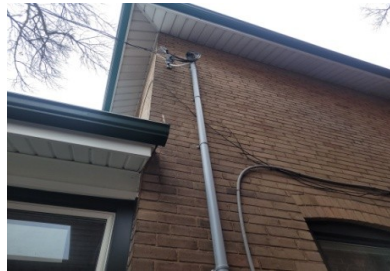
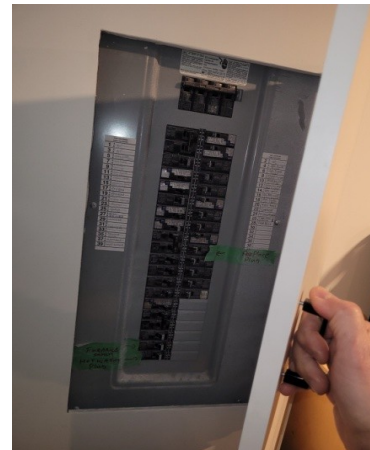
SERVICE ENTRANCE: overall in good repair
 SERVICE PANEL: overall in good repair
 panel obstructed by cabinet - cover not removed

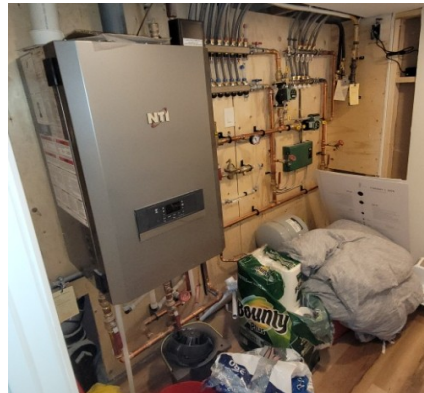
COMBINATION SYSTEM: [provides house heating \(radiators\) and domestic hot water](#)

HOT WATER BOILER: [service annually](#)

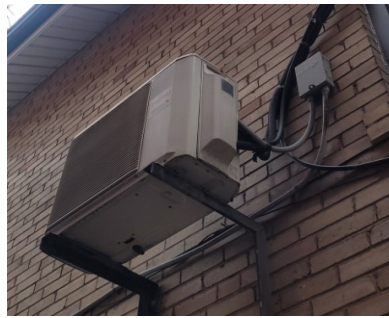
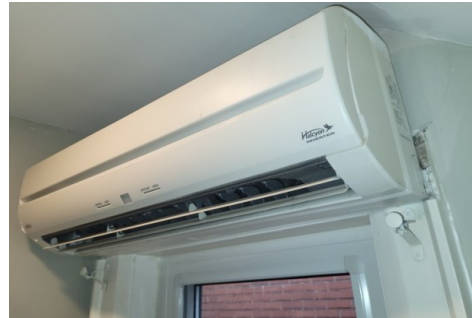
DUCTLESS A/C: not tested: should be serviced before using
aging unit, continue servicing until replacement becomes necessary
