HOME INSPECTION REPORT

228 Dewhurst Blvd N

Prepared by: **Bob Papadopoulos P.Eng., RHI** *

Inspection Date: **March 5 2025**

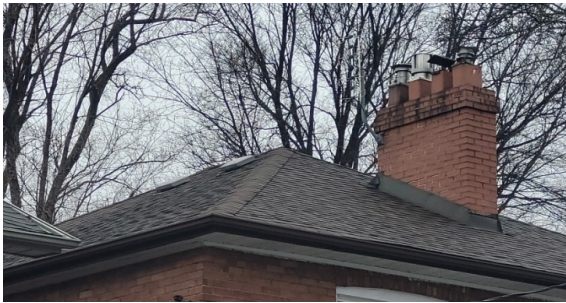
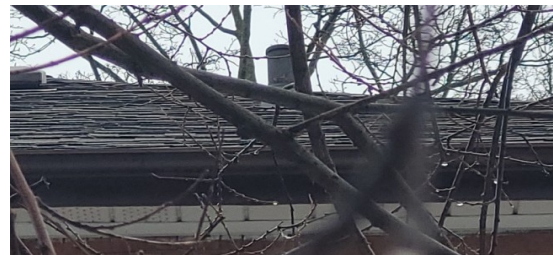
Chimney(s): [overall in good repair](#)

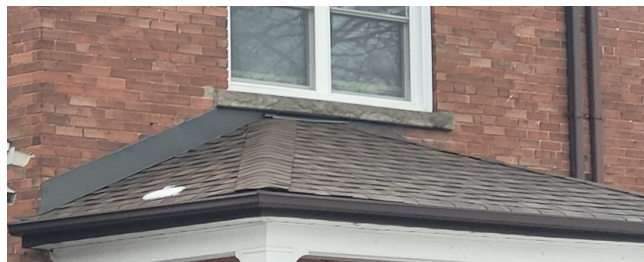
Porch(s): [overall surface in good repair](#)

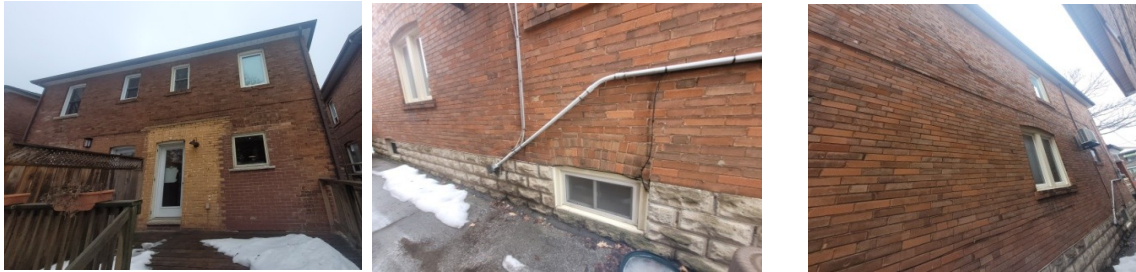
WALL SURFACES: overall in good repair

DOORS/WINDOWS: overall in good repair

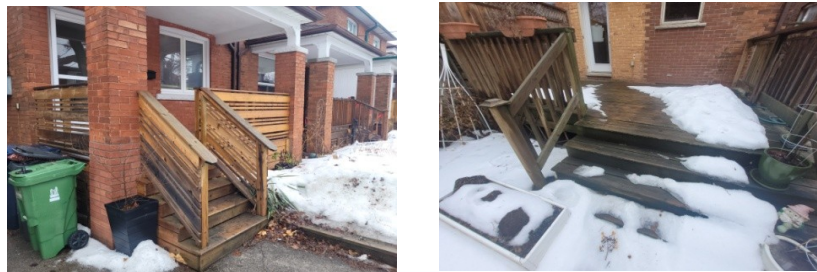
PORCH overall in good repair

DECK older, service/repair as required

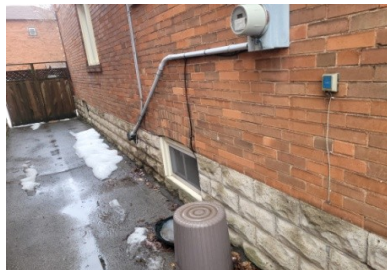
**Walk(s)/Driveway(s): continue to seal gaps along foundation wall, low area/pooling at rear corner-re-grade/repair to slope away from house

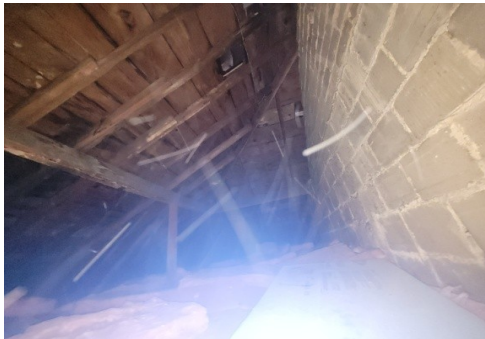
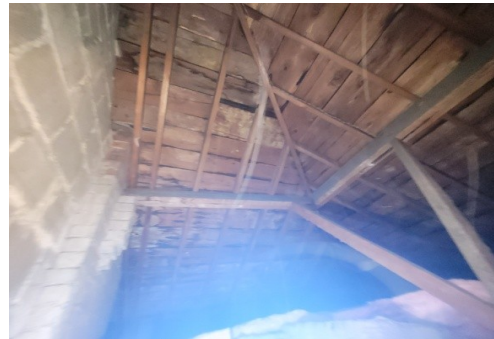
ROOF: overall in good repair
underside stains typical for age of house

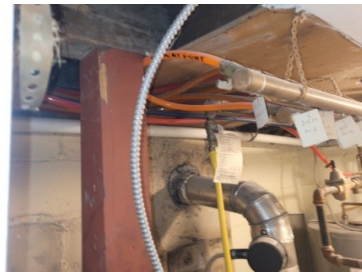
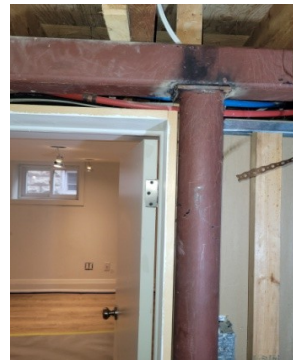
FLOORS: basement: main level floor has been shored up- likely during prior renovations

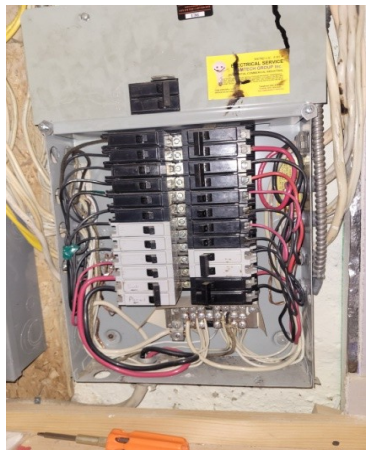
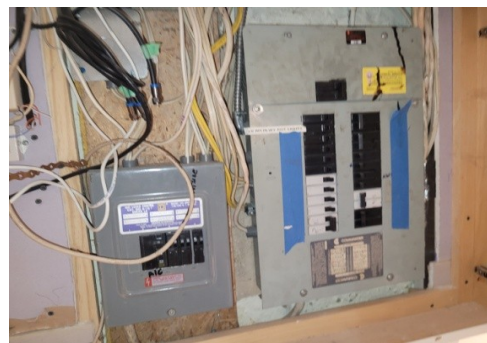
SERVICE ENTRANCE: **overall in good repair**
 SERVICE PANEL: **overall in good repair**
 Auxiliary Panel: **overall in good repair**

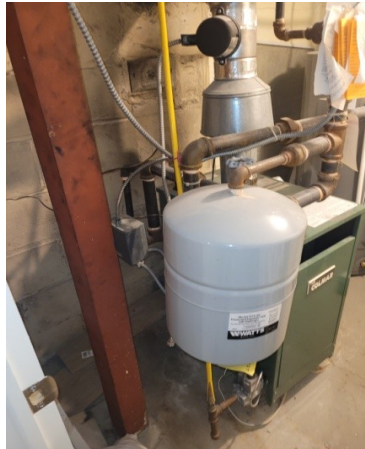
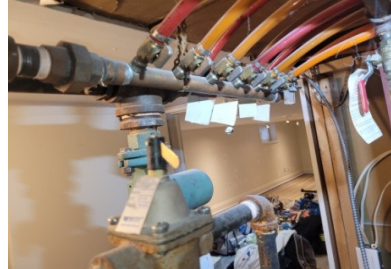
HOT WATER BOILER: [continue servicing until replacement becomes necessary](#)
[annual CO test mandatory for this type of unit](#)
[recommend obtaining replacement parts/servicing contract](#)

Piping: [all piping examined was in good repair](#)

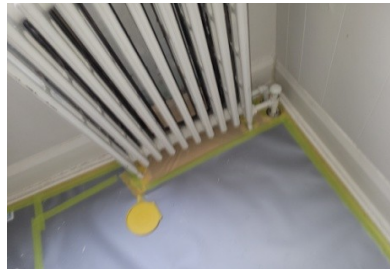
Radiator(s): [older units: monitor/repair valves as required](#)

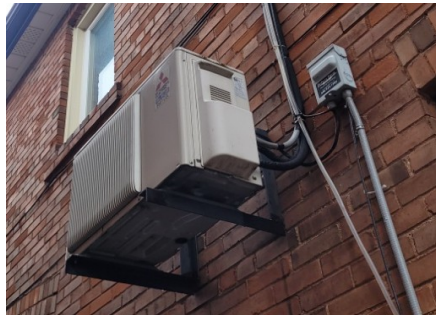
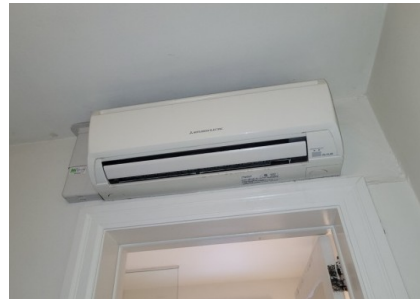
DUCTLESS A/C: not tested: should be serviced before using
aging unit, continue servicing until replacement becomes necessary

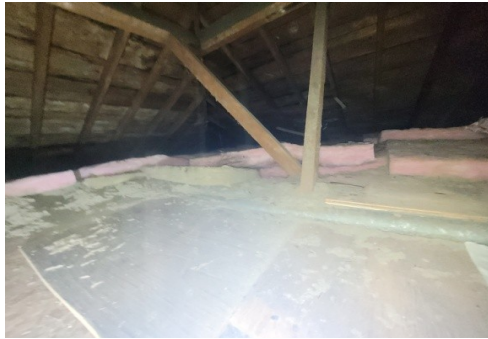
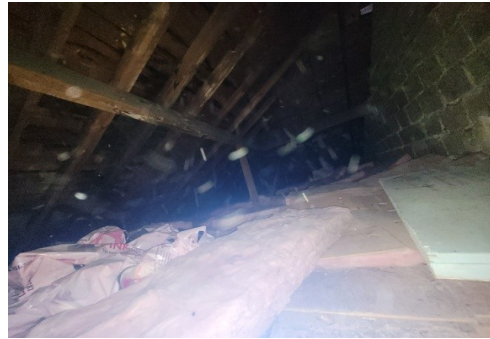
ROOF SPACE: uneven distribution of insulation - improve/add insulation
 portion appears used for storage
 recommend improving ventilation with soffit vents

Roof Access Hatch: insulate and weather-strip access hatch to roof space

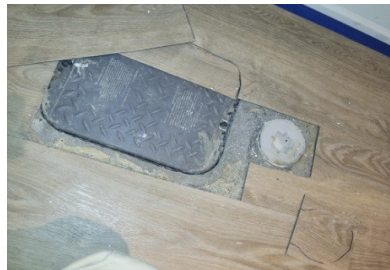
WASTE PIPING: [all piping examined was in good repair](#)
[a back flow valve has been installed to the main waste drain](#)
