HOME INSPECTION REPORT

16 Halford Ave
Toronto

Inspection Date: March 28 2025

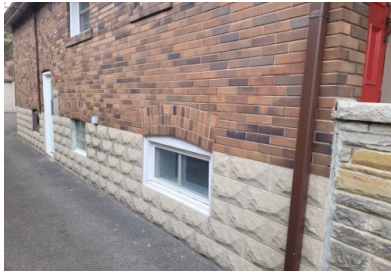
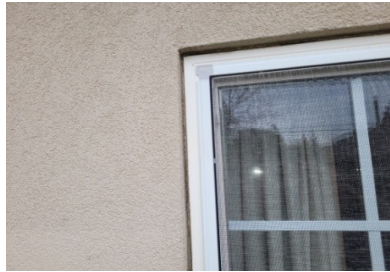
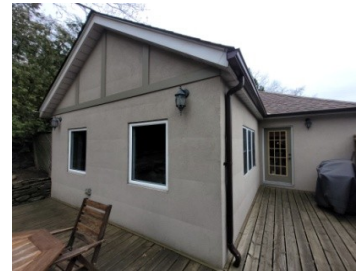
****Gutters/Downspouts:** requires general repairs and maintenance

WALL SURFACES: overall in good repair

DOORS/WINDOWS: overall in good repair, recommend caulking for some units

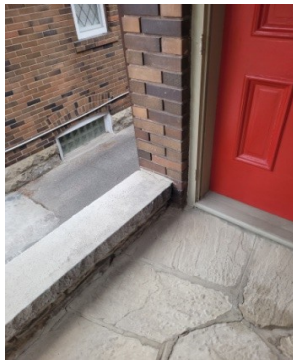
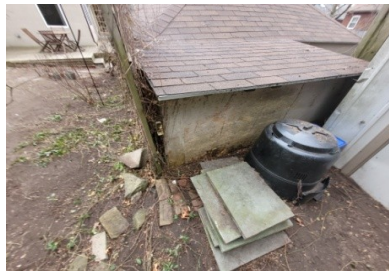
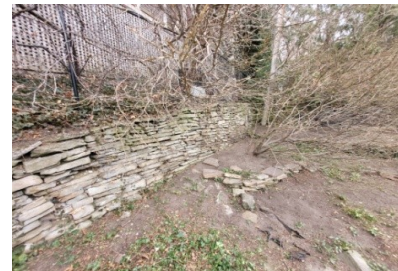
DECK overall in good repair

PORCH provide railings for safety

DETACHED GARAGE: older, typically ongoing repairs, rear portion prone to moisture damage

RETAINING WALL(s): overall in good repair, monitor

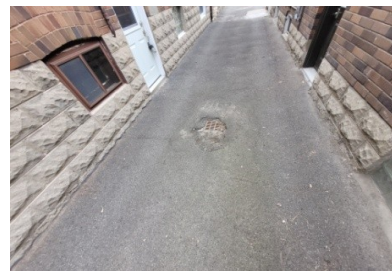
****Driveway(s):** service drain annually

Note: Maintain Gutters & Downspouts annually. Extend Downspouts at least 6-feet away from the house

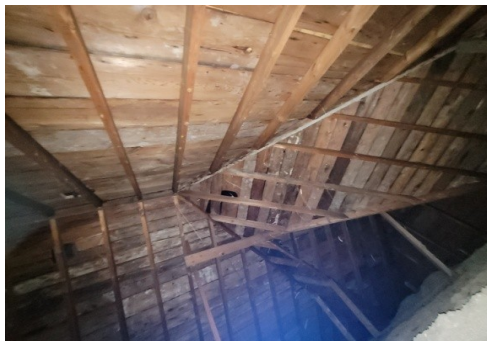
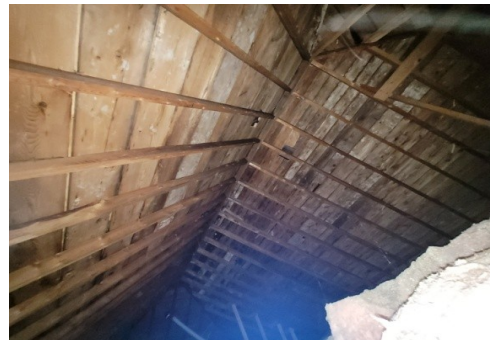
ROOF: overall in good repair

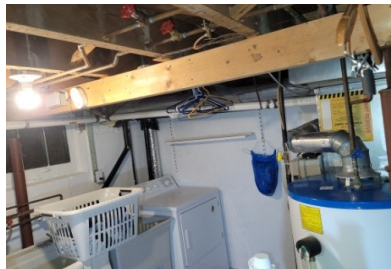
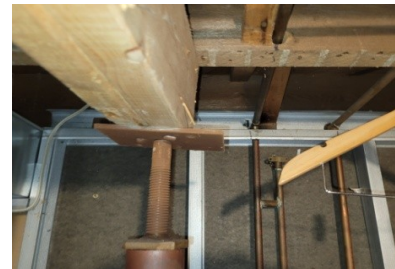
FLOORS: basement: rear main floor shored up with post and beam, ideally top and bottom post plates should be fastened, overall performance appears adequate, monitor

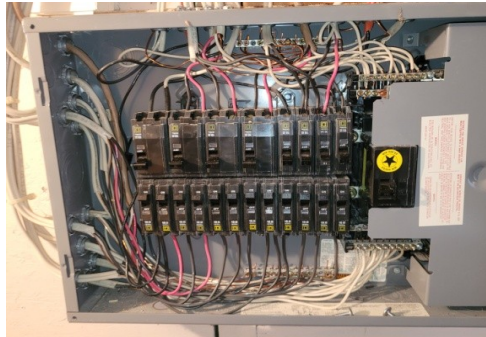
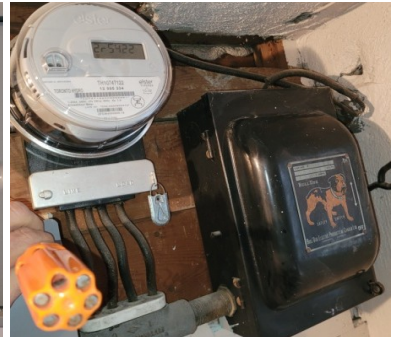
Clearance: **service drop wires low - adjust when upgrading service size, relocate meter to exterior, contact utility**

Main Disconnect: **older, overall in good repair, can be removed, see above**

SERVICE PANEL: **overall in good repair**

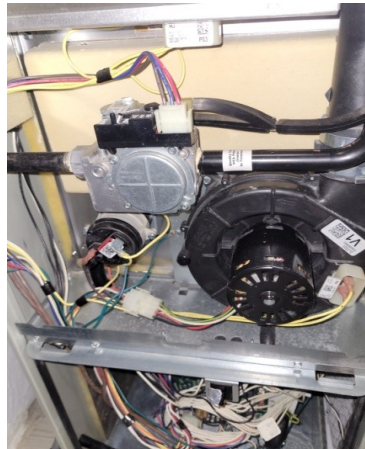
FORCED AIR FURNACE: [service annually](#)
[recommend obtaining replacement parts/servicing contract](#)

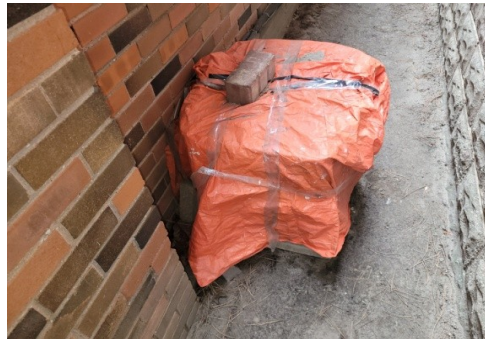
AIR CONDITIONER: not tested: should be serviced before using old unit, continue servicing until replacement becomes necessary consider replacing with new unit for improved efficiency

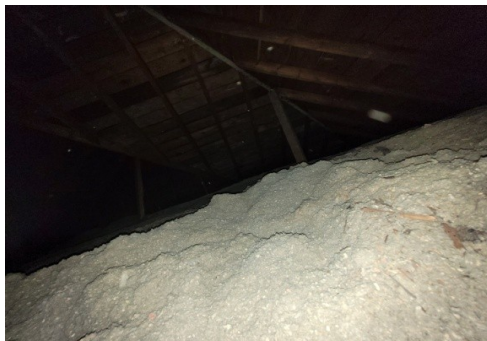
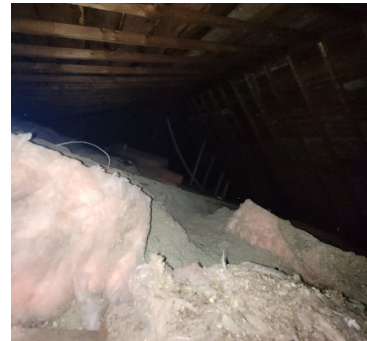
ROOF SPACE: uneven distribution of insulation - improve/add insulation
insulate and weather-strip access hatch to roof space

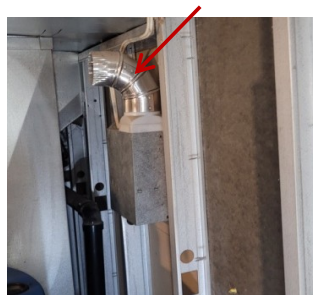
Exhaust Fan Vents: basement washroom: should vent to exterior
