HOME INSPECTION REPORT

37 Boustead Ave

Toronto

Inspection Date: [April 2 2025](#)

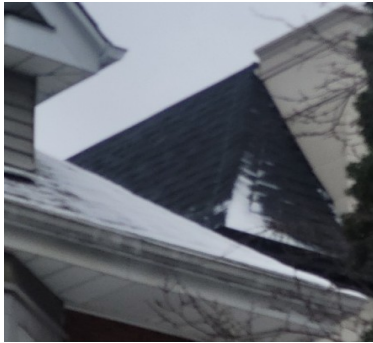
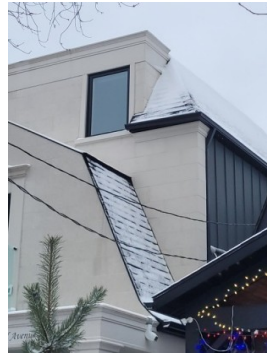
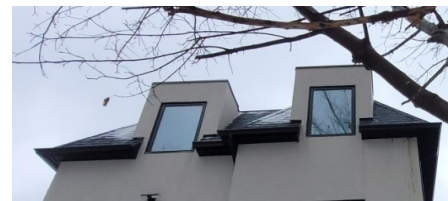
Sloped Surface: [new surface in good repair](#)

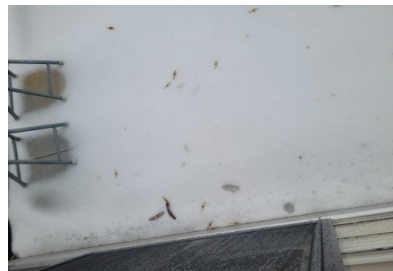
Porch(s): [not visible due to snow](#)
[Apt 2 porch not accessible](#)

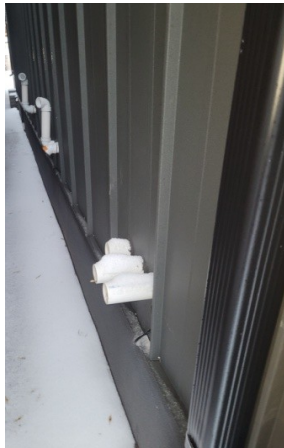
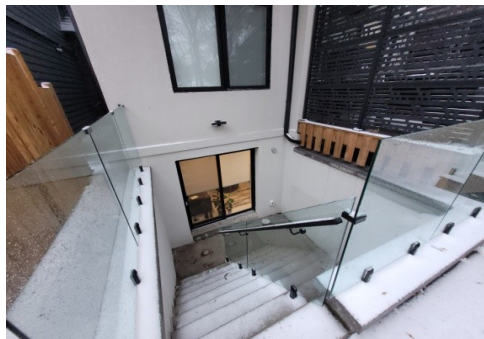
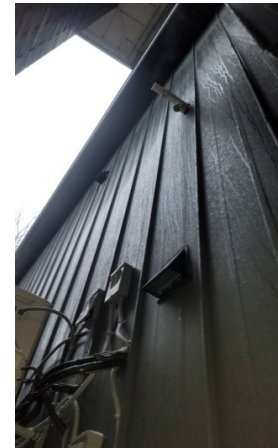
**BASEMENT WALKOUT: overall well built

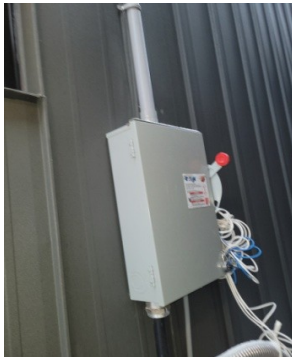
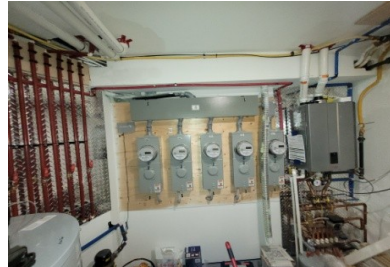
Main Disconnect: located on exterior - unusual - typically located interior
splitter box cover sealed - typical

Comments: reported service roughed in for 400 amps

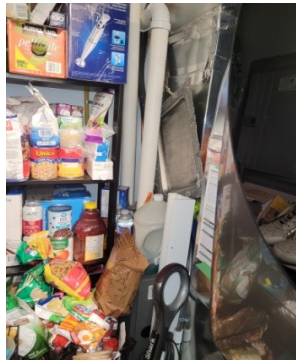
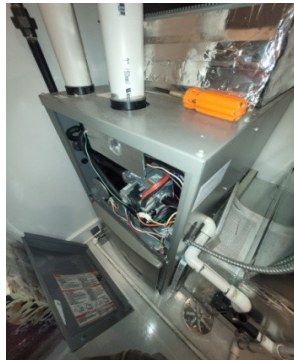
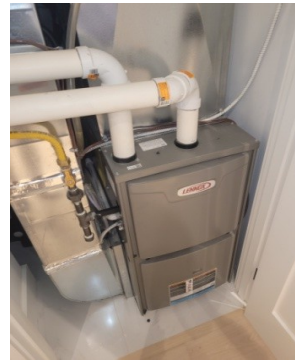
FORCED AIR FURNACE: [four units: service annually](#)
[main level unit - storage limited access, Apt 2 not accessible](#)
 Filter: [replace 1-per-3 months](#)

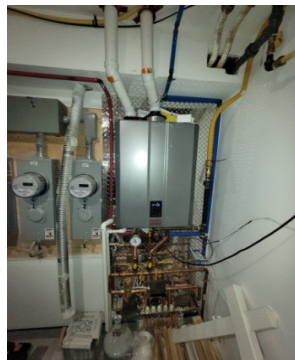
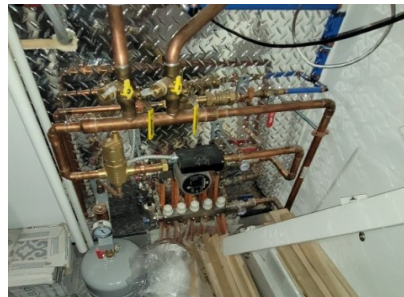
HOT WATER BOILER:
COMBINATION SYSTEM: [provides basement floor heating and domestic hot water to basement Apt 1](#)

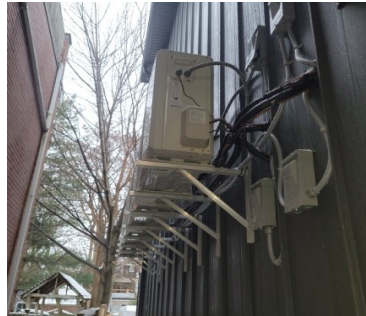
AIR CONDITIONER: four units: service annually
not tested: should be serviced before using

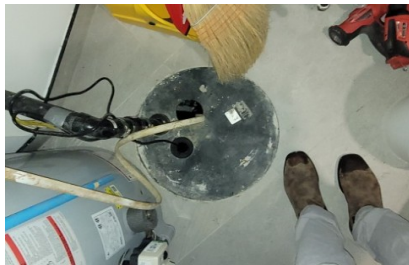
****Basement Leakage:** presently no leaking detected with moisture meter random sampling
 the foundation has been damp-proofed to minimize leaking risk
 service sump pump annually
 recommend back up battery for sump pump
