# HOME INSPECTION REPORT

62 Burr Ave  
Toronto

Inspection Date: March 27 2025

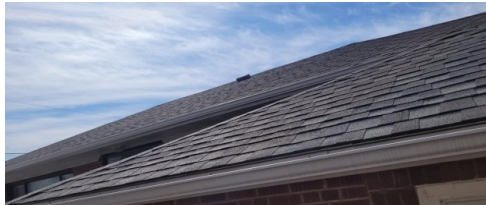
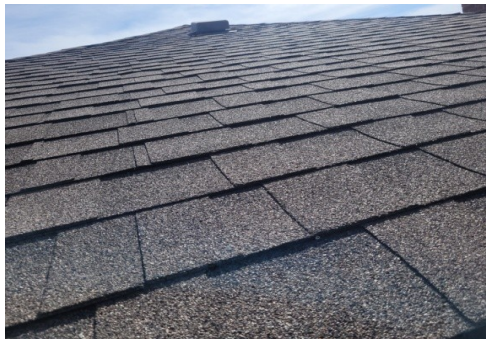
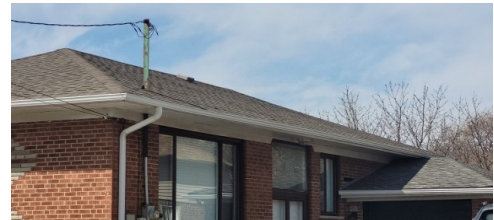
Sloped Surface: [overall surface in good repair](#)

Chimney: [overall in good repair](#)

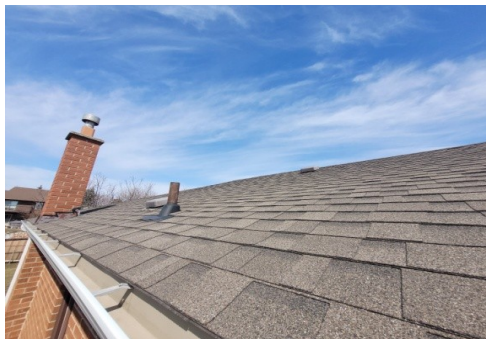
Roof/Wall: [ideally should install counter flashing](#)

[Note: Recommend Annual Maintenance Contract for Roof Surface, Flashing Details and Chimney\(s\)](#)

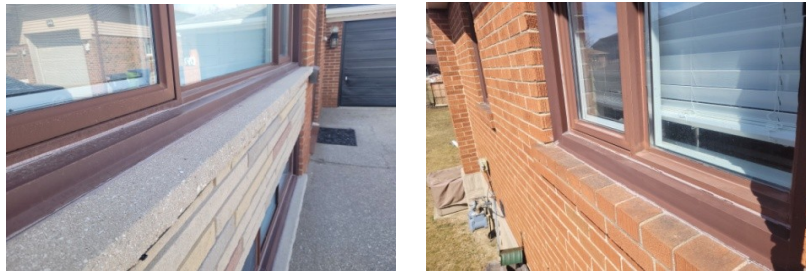
WALL SURFACES: overall in good repair  
DOORS/WINDOWS: overall in good repair  
some caulking repairs required

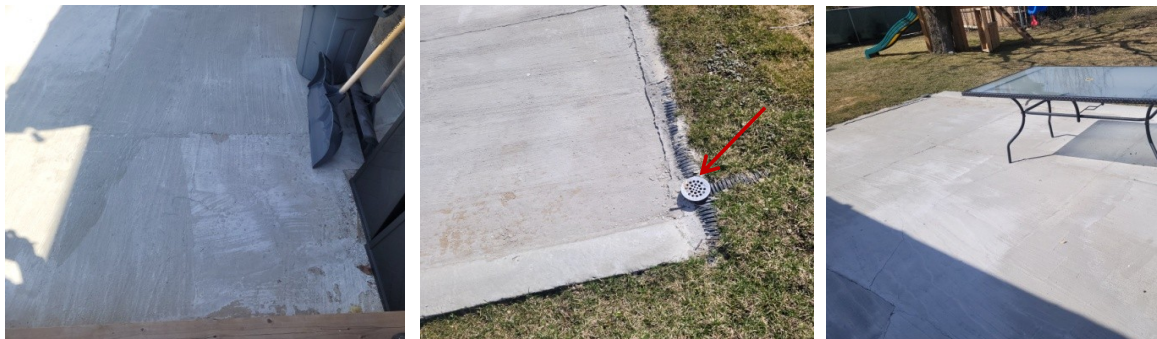
\*\*Grading: rear yard tends to slope towards foundation, concrete surface installed and drain with weeping bed tile, appears installed to minimize ground/surface water migrating towards house, monitor performance- see Interior Basement

Note: Maintain Gutters & Downspouts annually. Extend Downspouts at least 6-feet away from the house

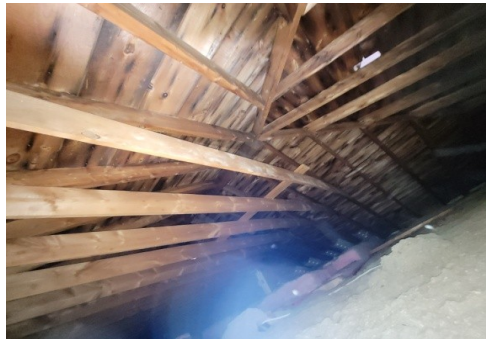
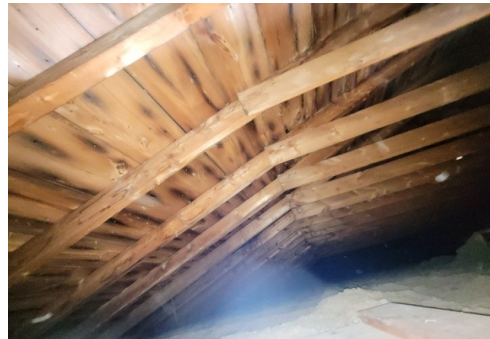
ROOF: overall in good repair

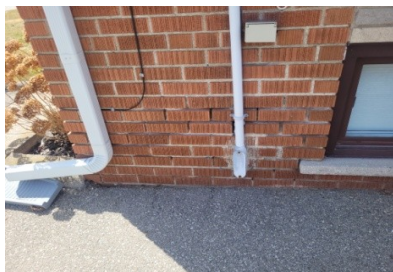
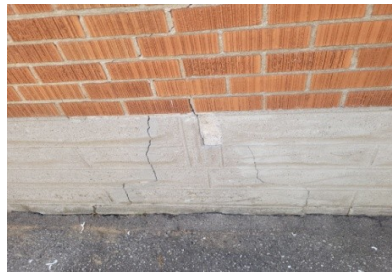
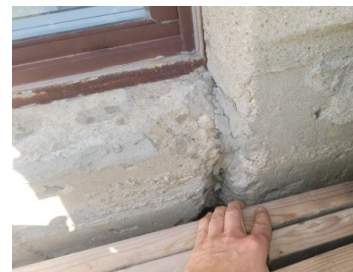
Masonry: front corner: requires mortar repairs

FOUNDATIONS: typical settlement cracks, repair and monitor

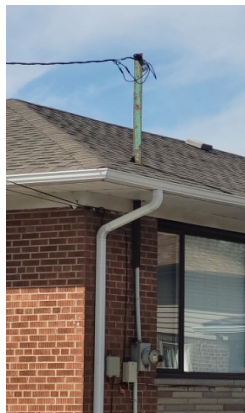
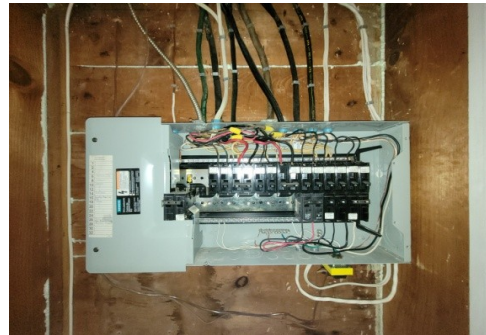
SERVICE ENTRANCE: **overall in good repair**  
 SERVICE PANEL: **overall in good repair**

Ungrounded Outlet(s): **provide GFCI's (ground fault circuit interrupters)**

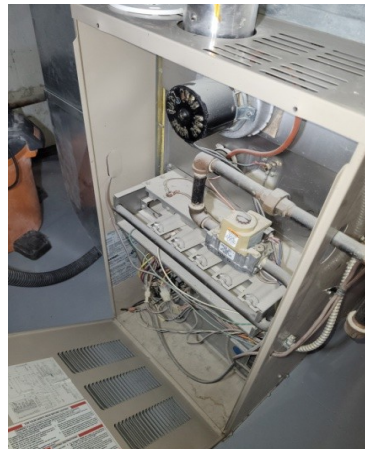
FORCED AIR FURNACE: [continue servicing until replacement becomes necessary](#)  
[recommend upgrading to high efficiency unit](#)

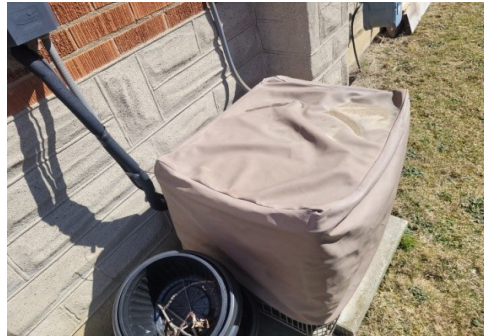
AIR CONDITIONER: old unit, continue servicing until replacement becomes necessary  
consider replacing with new unit for improved efficiency

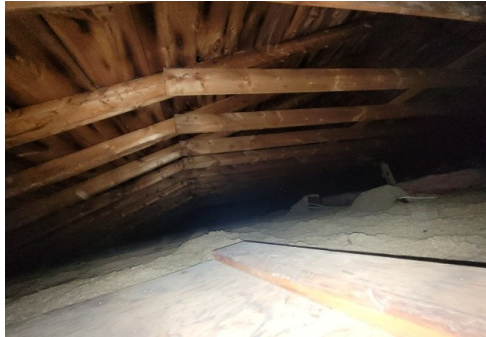
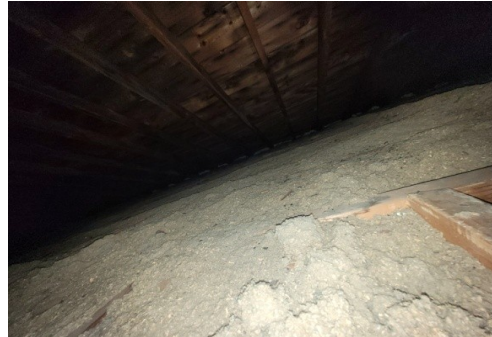
ROOF SPACE: recommend upgrading insulation to improve comfort and efficiency  
insulate and weather-strip access hatch to roof space

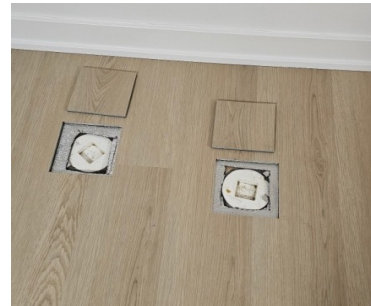
Basement Floor Drain: recommend installing backflow valve to main waste drain  
new plastic cleanout pipe(s)in basement floor indicates drain upgrades

Washroom(s): overall in good repair

Kitchen(s) overall in good repair
