# HOME INSPECTION REPORT

73 Riverview Gardens

Inspection Date: [March 24 2025](#)

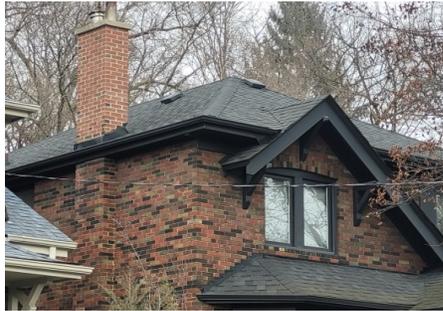
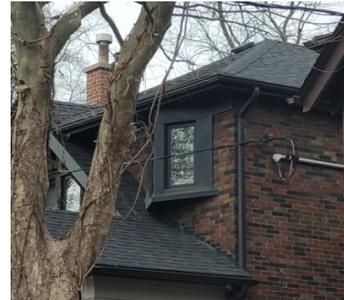
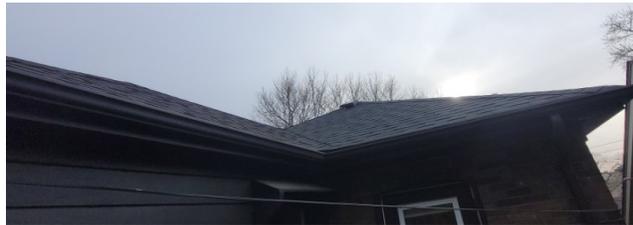
Sloped Surface: [overall surface in good repair](#)

Chimney: [rebuilt and in good repair](#)

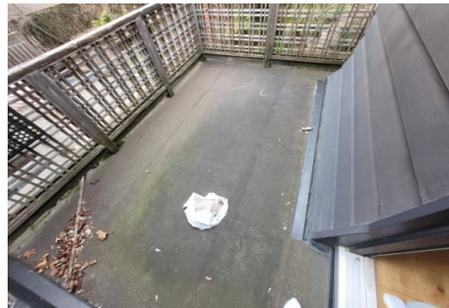
Flat Surface: [overall surface in good repair](#)

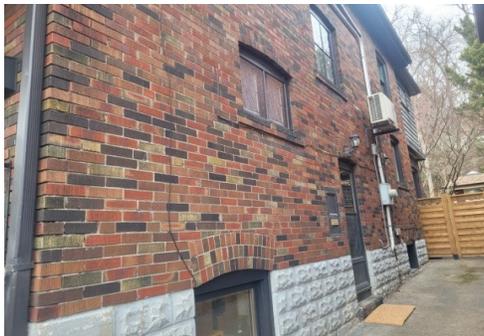
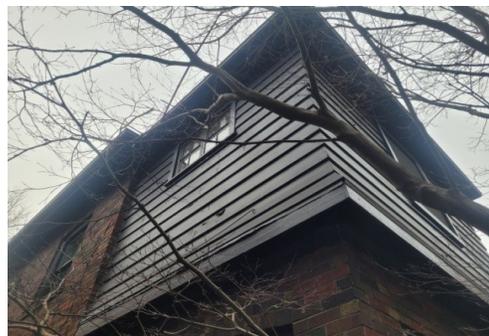
Brick: [overall in good repair](#)

Wood siding: [overall in good repair, ongoing monitoring/maintenance](#)

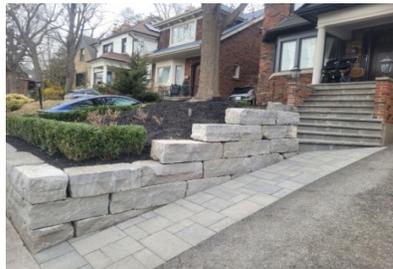
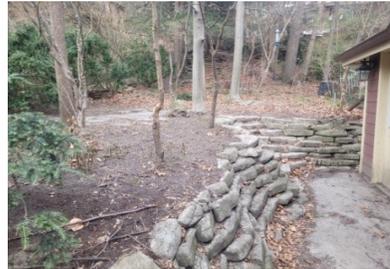
\*\*Landscaping: [ravine: monitor/minimize risk for erosion control](#)

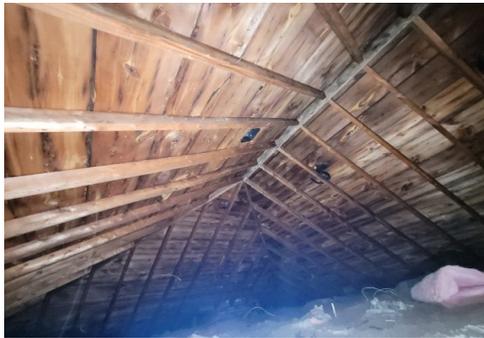
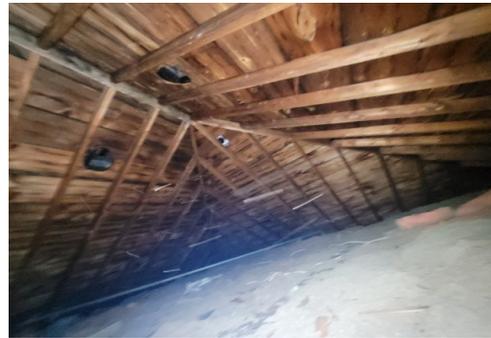
ROOF: overall in good repair

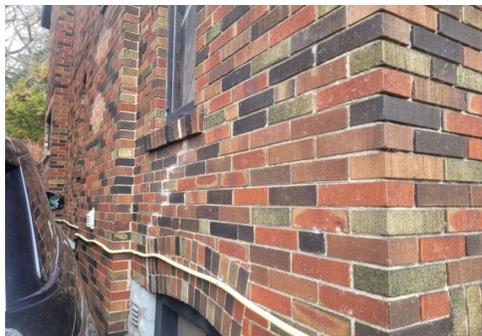
Masonry: typical settlement crack has been repaired - monitor

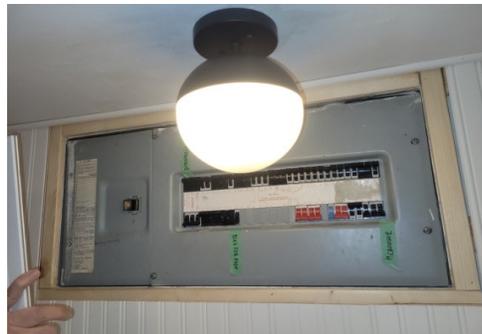
SERVICE ENTRANCE: overall in good repair  
 SERVICE PANEL: overall in good repair  
 cover not removed due to obstruction

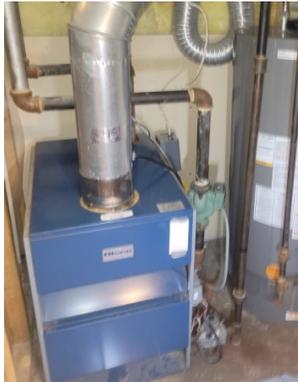
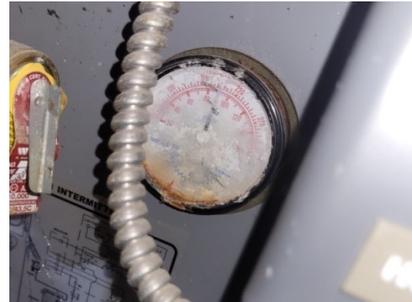
HOT WATER BOILER: [service annually](#)  
[primary temp/pressure valve damaged - replace](#)

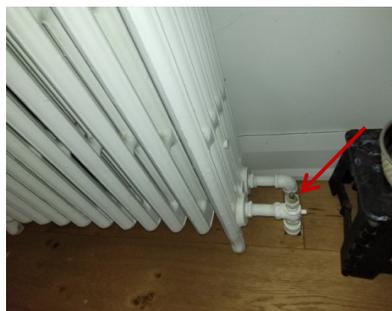
Radiator(s): [monitor/repair valves as required](#)

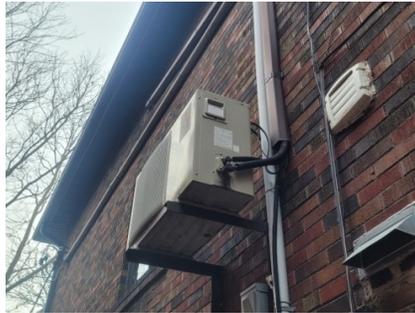
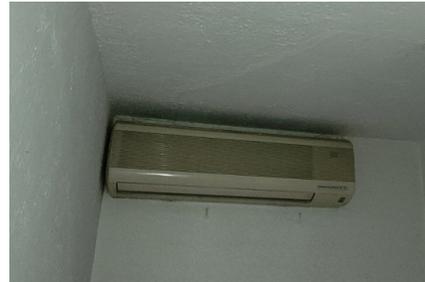
DUCTLESS A/C: not tested: should be serviced before using  
aging unit, continue servicing until replacement becomes necessary

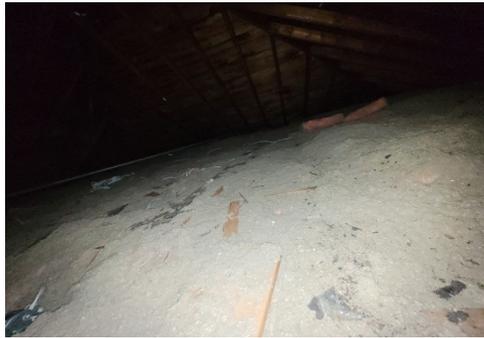
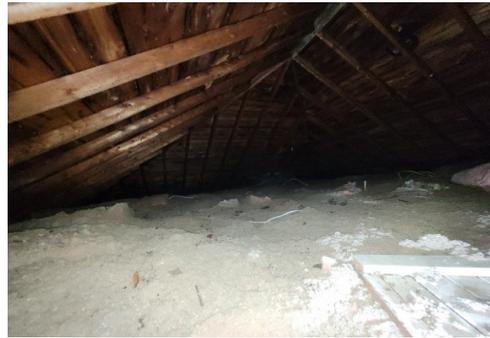
ROOF SPACE: uneven distribution of insulation - improve/add insulation  
recommend improving ventilation with soffit vents

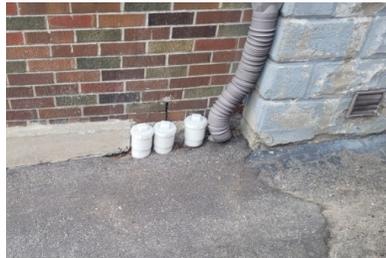
WASTE PIPING: [all piping examined was in good repair](#)  
[new plastic cleanout pipe\(s\) at front yard indicates drain upgrades](#)  
[recommend installing backflow valve to main waste drain](#)
