HOME INSPECTION REPORT

17 High Park Blvd
Toronto

Prepared for: [Squire Apartments Inc](#)

Inspection Date: [Jan 7 2025](#)

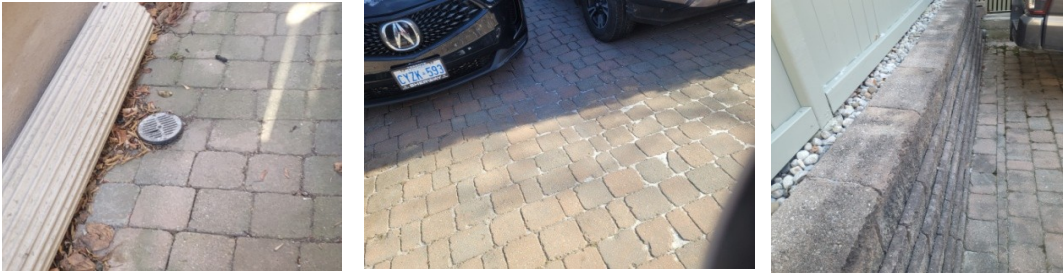
<p>**Walk(s): east: drain ideally should be flush with surface</p> <p>**Driveway(s): overall in good repair, minor settlement of pavers - typical/monitor</p> <p>RETAINING WALL: overall in good repair, minor movement- typical/monitor</p>

<p>Note: Maintain Gutters & Downspouts annually. Extend Downspouts at least 6-feet away from the house</p> <p>** Any or all these items may contribute to Basement Leakage. Please see Interior Page</p>

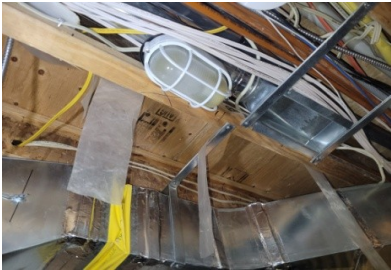
REFERENCE LINK		http://redbrickinspections.ca/docs/4_Structure_Reference_Guide.pdf		
17 High Park Blvd		STRUCTURE		Jan 7 2025
Description				
Configuration: Basement:	Foundations: Stone	Floor : Wood Joists	Walls : Masonry (Double-Brick) Wood Frame (Siding)	Roof/Ceiling Framing: Wood Rafters/Joists
Limitations				
Restricted Access to: Wall Space	Foundation Wall Not Visible: <u>90</u> % Roof Space Inspected From Access Hatch			
Observations/Recommendations				
<p>overall well built house</p> <p>FLOORS: rebuilt/reinforced as observed from basement</p> <div>

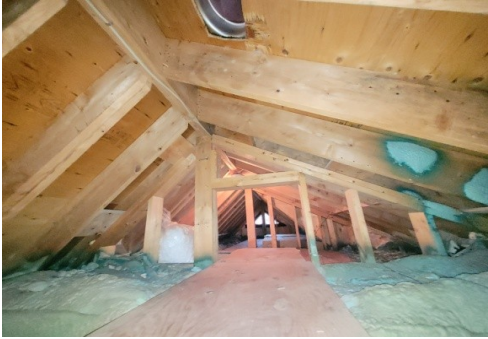
</div> <p>ROOF: rebuilt structure and reported hurricane resistant</p> <div><div> </div><div>

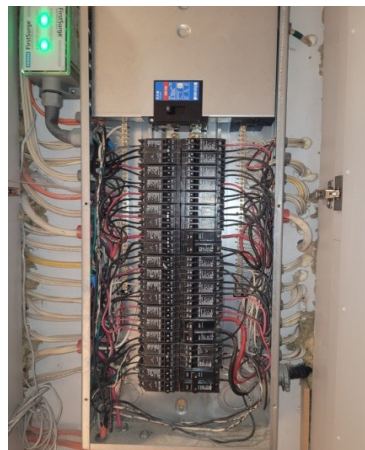
SERVICE PANEL: overall in good repair, crowded, double taps (two wires connect to one breaker) though typical and not critical

Auxiliary Panel: overall in good repair

Note 2: Please ensure accurate labelling on panels.

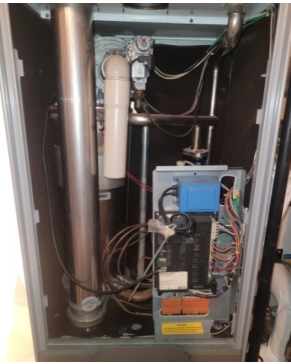
REFERENCE LINK		http://redbrickinspections.ca/docs/6_Heating_Reference_Guide.pdf			
17 High Park Blvd		HEATING		Jan 7 2025	
Description					
Description:	Efficiency:	Rated Input:	Approx. Age:	Life Expectancy:	Fuel Type: Shut Off at:
Hot Water Boiler:	High	? x1000BTU/hr	9 yrs.	20 yrs.	Gas Meter-Exterior
Hot Water Radiant Heat:					
Combination System:					
Two Air Handlers					
Exhaust Vent Arrangement:					
Limitations				Air Handlers	
Heat Loss Calculations Not Done				Supply Temp F: 70	
Data Plate Not Found				Return Temp F: 120	
Observations/Recommendations					
				Boiler Performance	
				Pressure lbs/in2: 10	
<p>THERMOSTAT: multi thermostats for zone control provides better comfort/efficiency</p> <p>COMBINATION SYSTEM: boiler provides house heating and domestic hot water (tank)</p> <p>HOT WATER BOILER: service annually</p> <p>recommend obtaining replacement parts/servicing contract</p>

<p>Filter: basement and 3rd level air-handler -replace 1-per-6 to 12 months</p> <p>Humidifier: high quality unit: presently not in use - service before use</p>

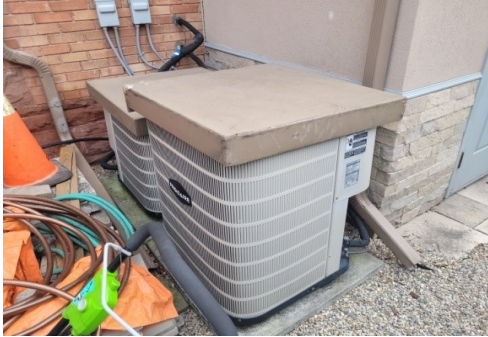
REFERENCE LINK		http://redbrickinspections.ca/docs/7_AC_Heat_Pump_Reference_Guide.pdf	
17 High Park Blvd		COOLING/Heat Pumps	
		Jan 7 2025	
Description			
Description:	Cooling Capacity:	Approx. Age:	Typical Life Expectancy:
Air Conditioner (air-cooled):	36 x1,000 BTU/hr	9 yrs. old	15 to 20 yrs.
Air Conditioner (air-cooled):	30 x1,000 BTU/hr	9 yrs. old	
Limitations			Cooling Performance
Cannot Test With Low Outdoor Temp			Supply Temp F:
Outdoor Coil Covered			Return Temp F:
Observations/Recommendations			
<p>AIR CONDITIONER: two units: not tested: should be serviced before using connected to basement and 3rd level air handlers</p>

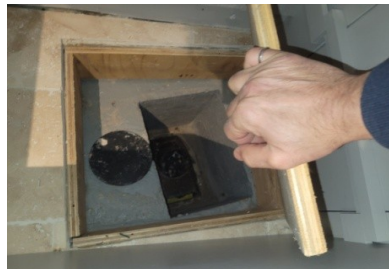
WASTE PIPING: [all piping examined was in good repair](#)
[a back flow valve has been installed to the main waste drain](#)
