HOME INSPECTION REPORT

166 Quebec Ave
Toronto

Prepared by: Bob Papadopoulos P.Eng., RHI *

Inspection Date: [May 30 2025](#)

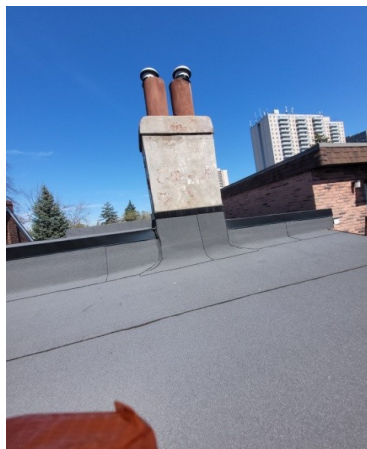
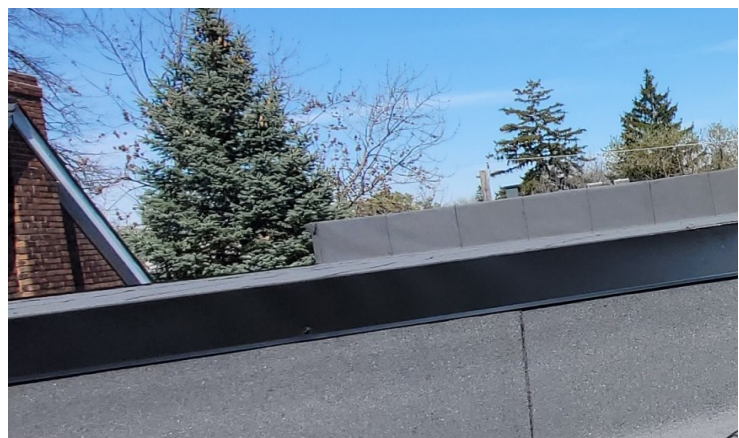
Flat Surface: overall surface in good repair where visible,
 reported to be newer installations, less than 5-yrs old, 20 plus yr life expectancy
 Chimney: overall in good repair

Note: Recommend Annual Maintenance Contract for Roof Surface, Flashing Details and Chimney(s)

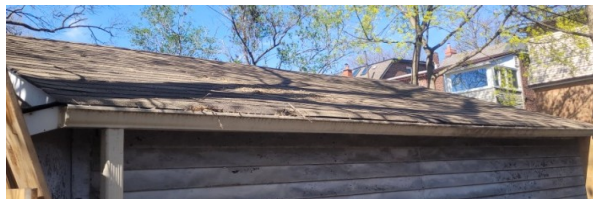
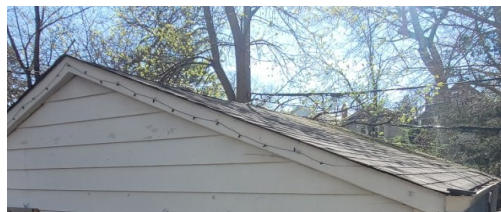
Garage: overall surface in good repair
 requires cleaning

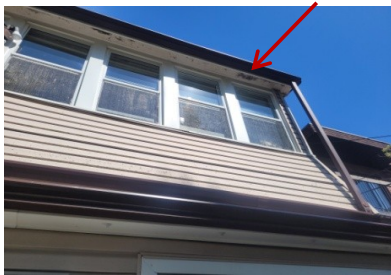
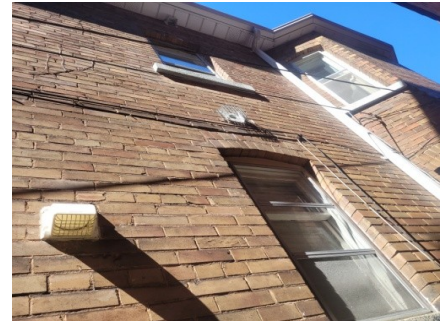
Soffit & Facia: requires general repairs and maintenance

Vinyl Siding: requires general repairs and maintenance

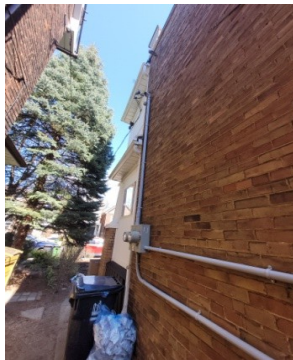
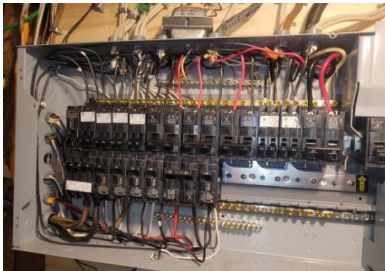
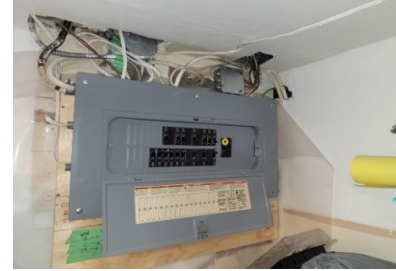
SERVICE ENTRANCE: overall in good repair
two-meter base - one for each Apt.

SERVICE PANEL: overall in good repair
Auxiliary Panel: overall in good repair

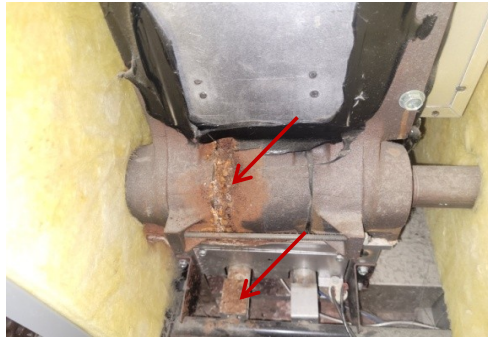
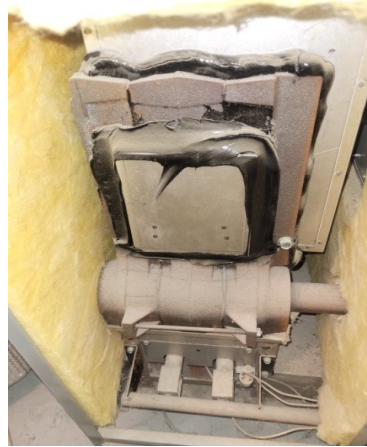
HOT WATER BOILER: Apt. 166:
 heat exchanger corrosion - suspect prior leaking- further evaluation,
 leak caused burner corrosion, draft fan noisy- further evaluation
 and repairs/replacement if required
 Apt. 168: service annually
 recommend obtaining replacement parts/servicing contract

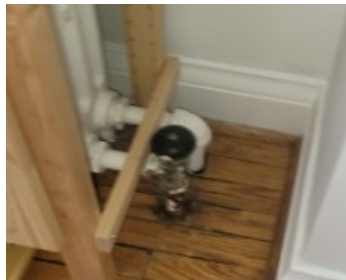
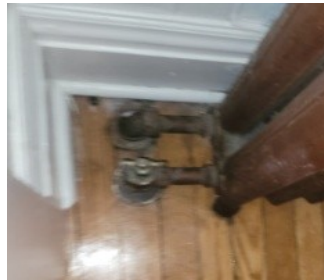
Radiator(s): monitor/repair valves as required
