HOME INSPECTION REPORT

6 Nagel Rd
Toronto

Prepared by: Bob Papadopoulos P.Eng., RHI *

Inspection Date: April 17 2025

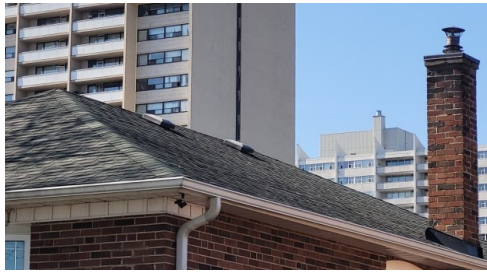
Chimney: [overall in good repair](#)

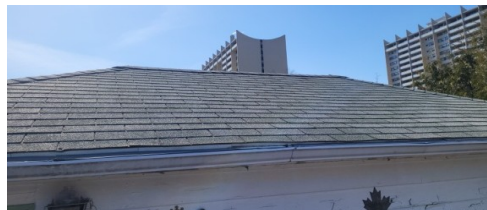
Garage: [overall surface in good repair](#)

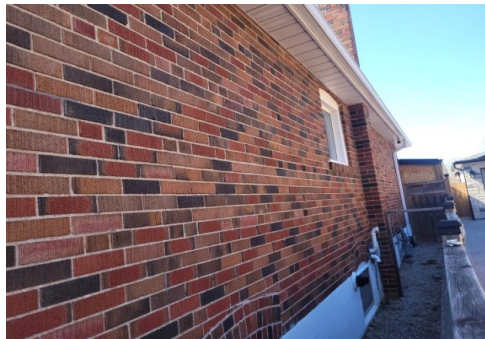
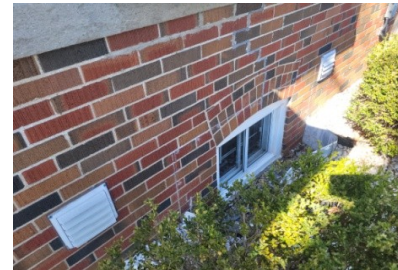
WALL SURFACES: overall in good repair
DOORS/WINDOWS: overall in good repair
**Window Well: provide window well covers

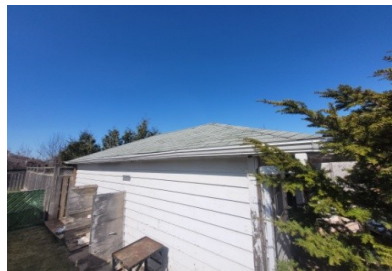
DETACHED GARAGE: older, typically ongoing repairs
bottom perimeter prone to rot - repair as required, budget to repair perimeter

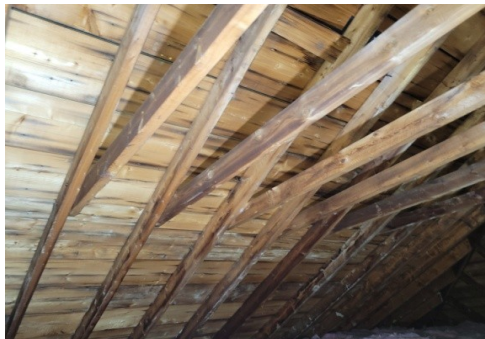
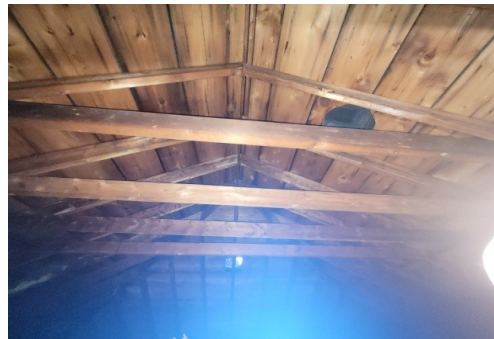
ROOF: overall in good repair

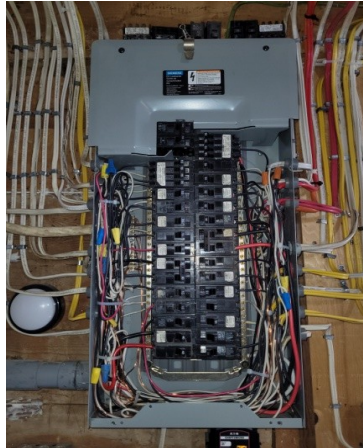
SERVICE ENTRANCE: **overall in good repair**
 SERVICE PANEL: **overall in good repair**
 Auxiliary Panel: **overall in good repair**

Comments: **gas powered auxiliary generator - refer to owners manual for servicing**

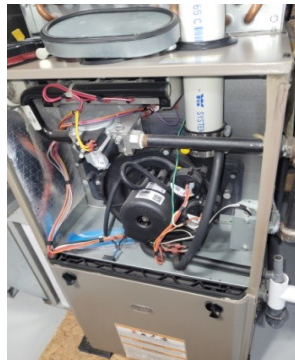
Filter: [high quality HEPA unit - refer to owners manual for servicing includes UV filter](#)

Filter: [replace 1-per-6 to 12 months](#)

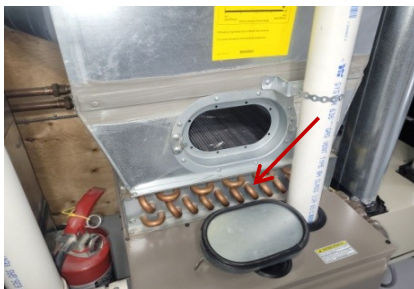
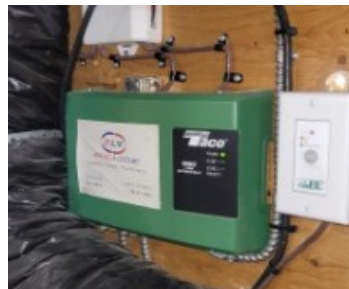
Comments: [temp. gauge leaking - replace](#)

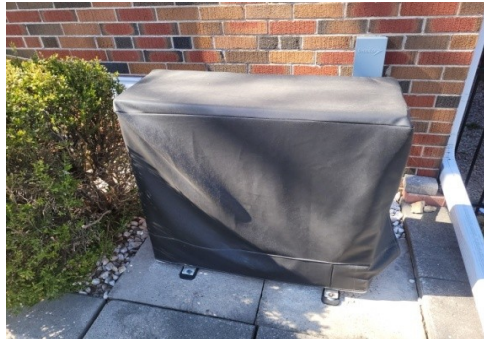
AIR CONDITIONER: not tested: should be serviced before using
age of unit was reported by home owner

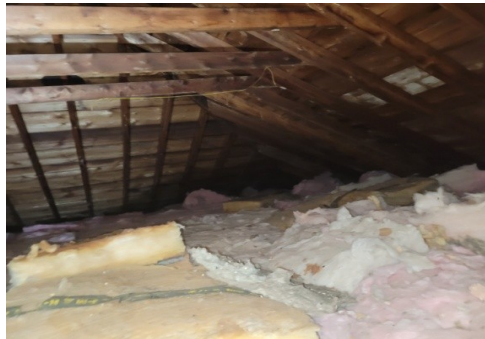
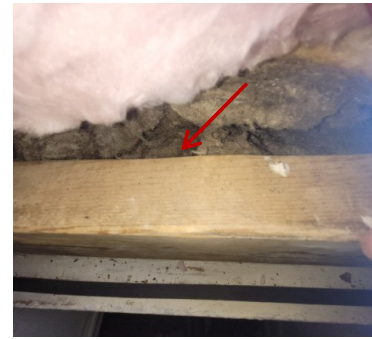
ROOF SPACE: insulation and ventilation is adequate
uneven distribution of insulation - improve/add insulation

Vermiculite Insulation: located under older insulation
insulation may contain asbestos, requires lab test to confirm
