HOME INSPECTION REPORT

62 Humber Trail

Prepared by: Bob Papadopoulos P.Eng., RHI *

Inspection Date: April 8 2025

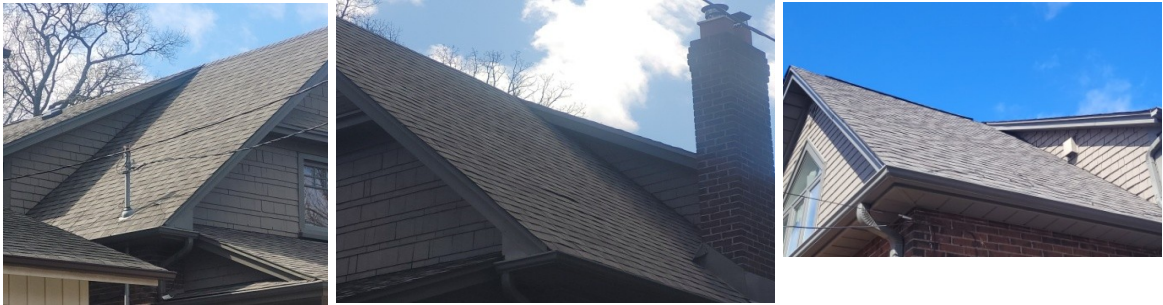
REFERENCE LINK		http://redbrickinspections.ca/docs/2_Roofing_Reference_Guide.pdf		
62 Humber Trail		ROOFING/Chimneys		April 8 2025
Description				
Roofing Material:	Location:	Leakage Probability:	Chimney(s) Type:	Location:
Asphalt Shingles:	Slope:	Low	Brick:	South
Asphalt Shingles:	Garage:	Low		
Limitations				
Roof Inspected By:	Access Limited By:	Chimney Access Limited By:		
From Grade	Height	Height		
Observations/Recommendations				
<p>Sloped Surface: overall surface in good repair</p> <p>Chimney(s): rebuilt and in good repair</p>

<p>Note: Recommend Annual Maintenance Contract for Roof Surface, Flashing Details and Chimney(s)</p>

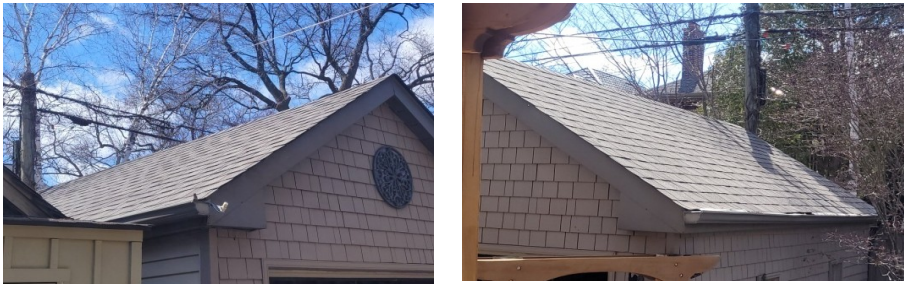
<p>Garage: overall surface in good repair</p>

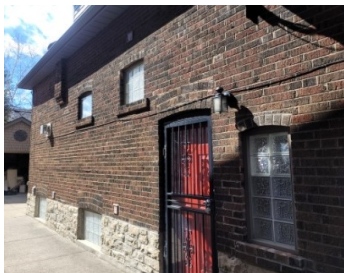
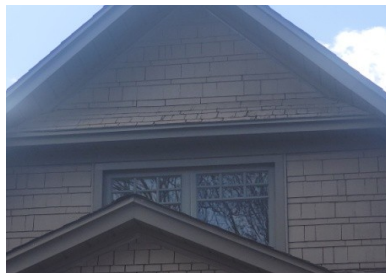
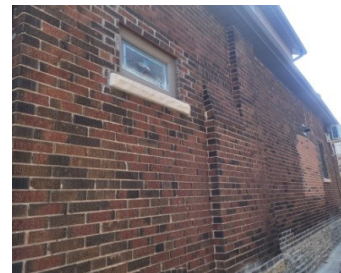
Wood Shingles: overall in good repair, some worn at front gable - replace as required

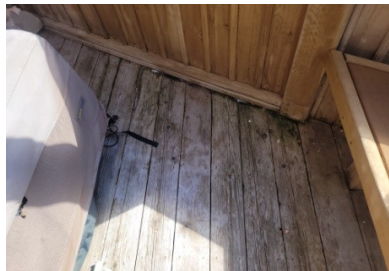
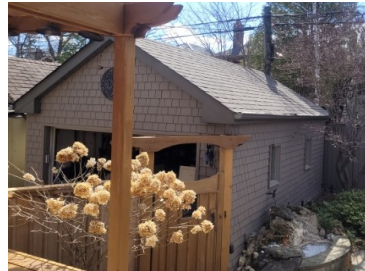
DETACHED GARAGE: overall well built

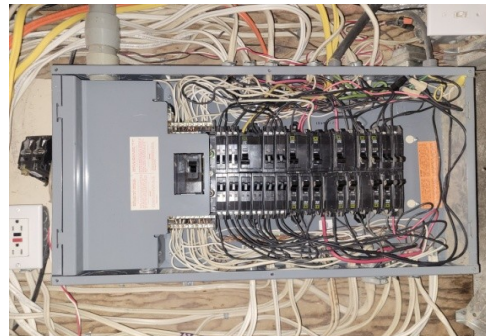
SERVICE PANEL: **overall in good repair**

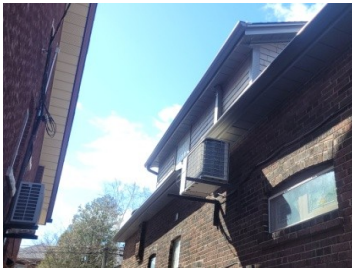
REFERENCE LINK		http://redbrickinspections.ca/docs/7_AC_Heat_Pump_Reference_Guide.pdf	
62 Humber Trail		COOLING/Heat Pumps	
April 8 2025			
Description			
Description:	Cooling Capacity:	Approx. Age:	Typical Life Expectancy:
Ductless (air-cooled)	12 x1,000 BTU/hr	approx. 1 yrs. old	15 to 20 yrs.
Air Conditioner (air-cooled):	? x1,000 BTU/hr	approx. 10 yrs. old	
Limitations			Cooling Performance
Data Plate Not Found	Cannot Test With Low Outdoor Temp		Supply Temp F:
Restricted Access			Return Temp F:
Observations/Recommendations			
<p>AIR CONDITIONER: not tested: should be serviced before using access hatch was fastened - did not access air handler</p>

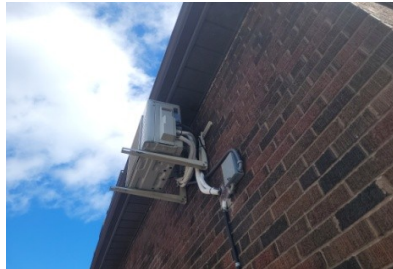
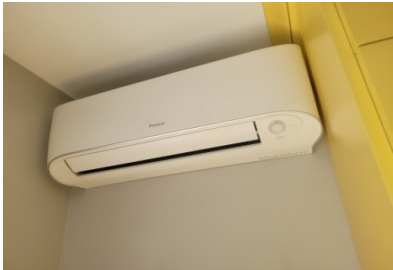
<p>DUCTLESS A/C: not tested: should be serviced before using</p> <div>
