# HOME INSPECTION REPORT

1372 Islington Ave  
Toronto

Prepared by: Bob Papadopoulos P.Eng., RHI \*

Inspection Date: April 30 2025

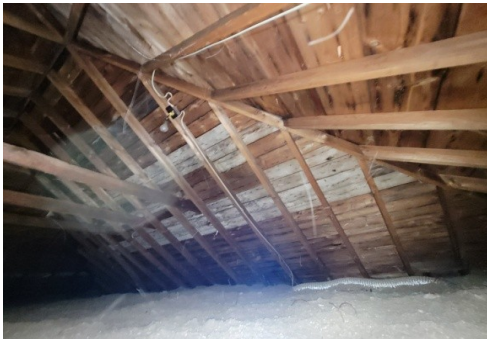
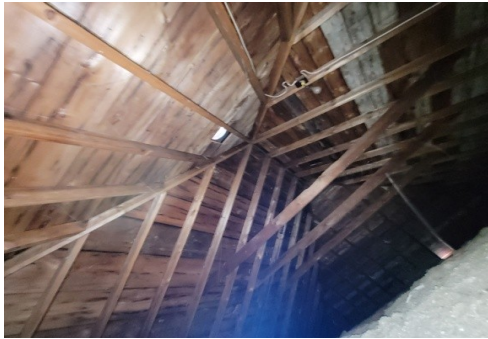
REFERENCE LINK		<a href="http://redbrickinspections.ca/docs/4_Structure_Reference_Guide.pdf">http://redbrickinspections.ca/docs/4_Structure_Reference_Guide.pdf</a>		
1372 Islington Ave		<b>STRUCTURE</b>		April 30 2025
<b>Description</b>				
Configuration: Basement:	Foundations: Brick	Floor : Wood Joists	Walls : Masonry (Double-Brick) Wood Frame (Siding)	Roof/Ceiling Framing: Wood Rafters/Joists
<b>Limitations</b>				
Restricted Access to: Wall Space	Foundation Wall Not Visible: <u>90</u> % Roof Space Inspected From Access Hatch			
<b>Observations/Recommendations</b>				
<p>overall well built house</p> <p>ROOF: overall in good repair</p> <div style="display: flex; justify-content: space-around;">

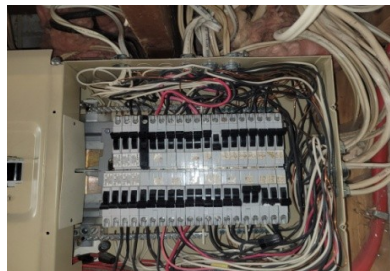
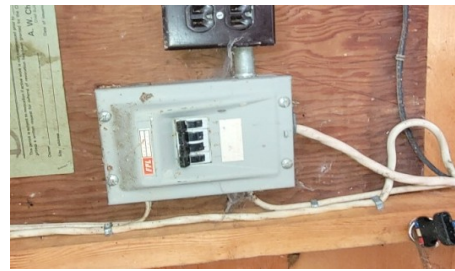
SERVICE ENTRANCE: overall in good repair

SERVICE PANEL: overall in good repair, might require larger/sub panel if renovating

Auxiliary Panel: overall in good repair

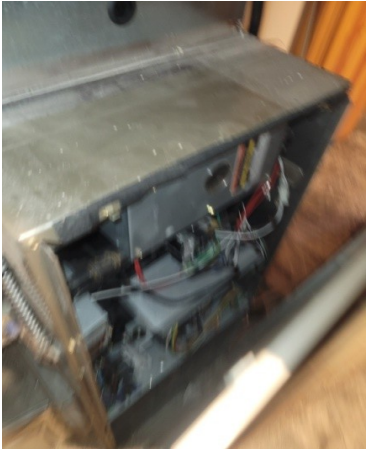
<p>Ducts: <a href="#">older arrangement (shared registers between rooms) typical for age of house</a>  <a href="#">improve/upgrade if renovating</a></p> <p><a href="#">presently recommend duct cleaning</a></p> <p>ELECTRIC HEATERS(s): <a href="#">not tested: breaker turned off</a></p>

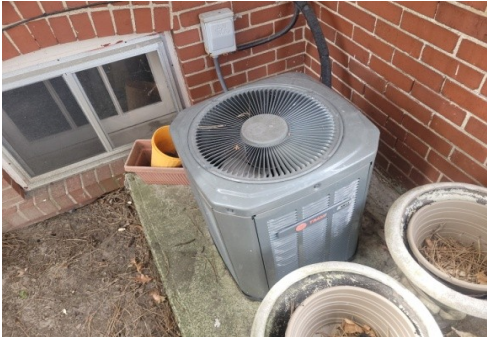
REFERENCE LINK	<a href="http://redbrickinspections.ca/docs/7_AC_Heat_Pump_Reference_Guide.pdf">http://redbrickinspections.ca/docs/7_AC_Heat_Pump_Reference_Guide.pdf</a>		
1372 Islington Ave	COOLING/Heat Pumps		April 30 2025
Description			
Description:	Cooling Capacity:	Approx. Age:	Typical Life Expectancy:
Air Conditioner (air-cooled):	24 x1,000 BTU/hr	20 yrs. old	15 to 20 yrs.
Limitations			Cooling Performance
			Supply Temp F:
			Return Temp F:
Observations/Recommendations			
<p>AIR CONDITIONER: not tested: should be serviced before using old unit, continue servicing until replacement becomes necessary consider replacing with new unit for improved efficiency</p>

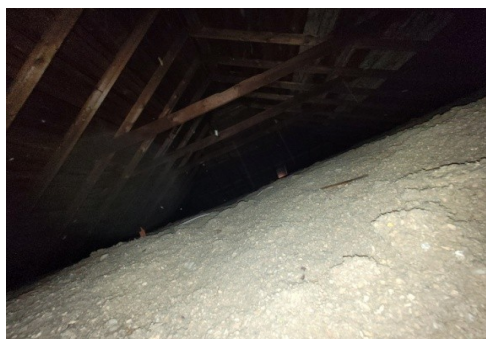
ROOF SPACE: recommend upgrading insulation to improve comfort and efficiency  
 recommend improving ventilation with soffit vents

Roof Access Hatch: insulate and weather-strip access hatch to roof space
