HOME INSPECTION REPORT

27 Hook Ave

Toronto

Inspection Date: **June 18 2025**

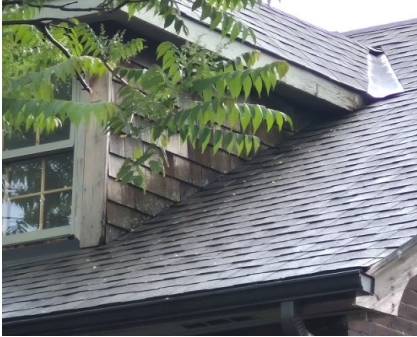
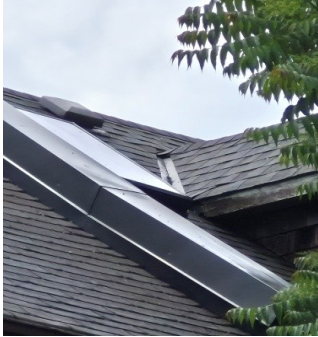
REFERENCE LINK		http://redbrickinspections.ca/docs/2_Roofing_Reference_Guide.pdf		
27 Hook Ave		ROOFING/Chimneys		June 18 2025
Description				
Roofing Material:	Location:	Leakage Probability:	Chimney(s) Type:	Location:
Asphalt Shingles:	Slope:	Low	Brick Shared:	Northeast
Modified Bitumen:	Flat:	Medium deck		
Modified Bitumen:	2nd Flat:	Low upper		
Limitations				
Roof Inspected By:	Access Limited By:		Chimney Access Limited By:	
From Grade Walking On	Height Deck			
From Edge	Tree			
Observations/Recommendations				
<p>Tree Branches: retain arbourist for annual monitoring/trimming</p> <p>Sloped Surface: overall surface in good repair</p> <div>

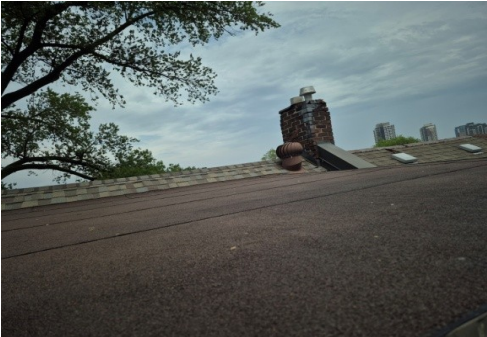
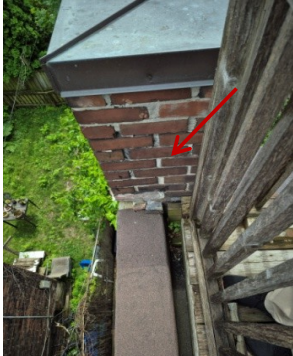
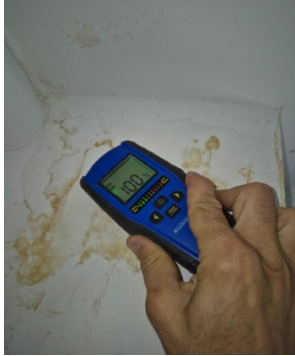
</div> <p>2nd Flat: overall surface in good repair</p> <p>Flat Surface: mostly not visible, parapet at southeast leaking (stain in ceiling)- requires maintenance/ flashing - minor repair overall</p> <div>

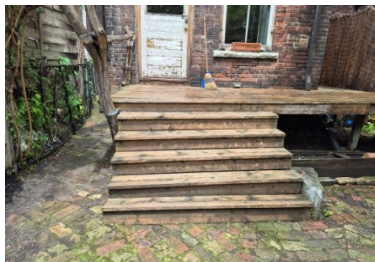
PORCH columns leaning, older condition though continue to monitor and budget to repair/replace, porch has settled away from house - old condition though recommend installing anchors/fasteners to secure to house- contact specialist for best approach

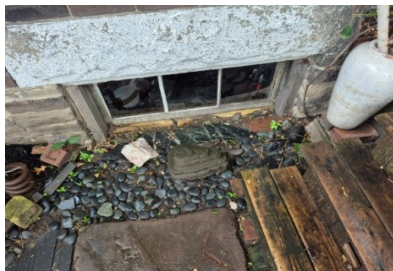
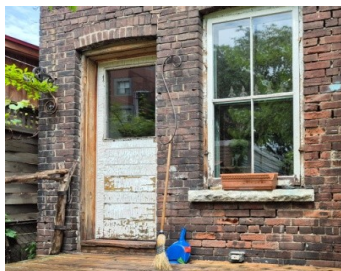
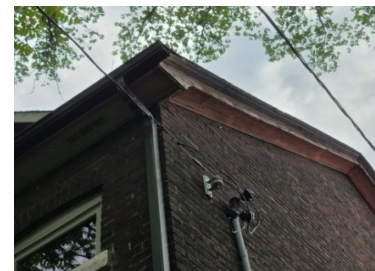
****Window Well:** budget to install/if renovating basement/damp proofing**DOORS/WINDOWS:** requires general repairs and maintenance, or replace if more cost effective

Soffit & Facia: budget for painting/maintenance or cap with metal

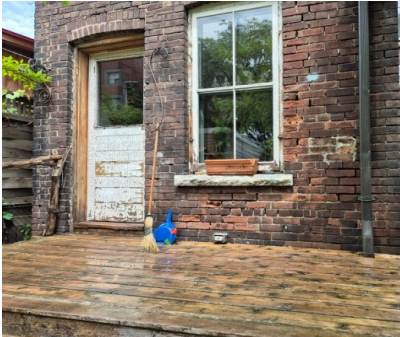
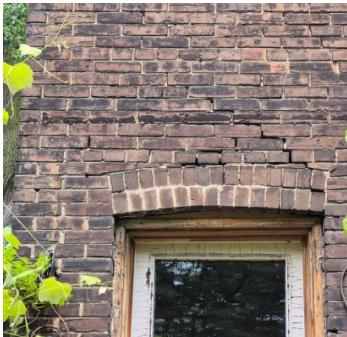
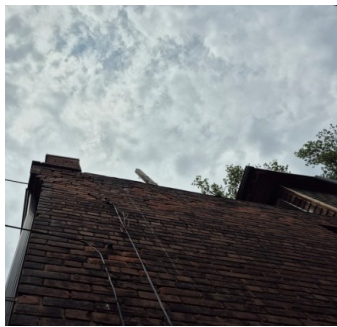
REFERENCE LINK		http://redbrickinspections.ca/docs/4_Structure_Reference_Guide.pdf		
27 Hook Ave		STRUCTURE		June 18 2025
Description				
Configuration: Basement:	Foundations: Stone	Floor : Wood Joists	Walls : Masonry (Double-Brick) Wood Frame (Siding)	Roof/Ceiling Framing: No Access
Limitations				
Restricted Access to: Wall Space Roof Space Flat Roof Space		Foundation Wall Not Visible: <u>50</u> %		
Observations/Recommendations				
<p>overall well built house</p> <p>FLOORS: minor sagging around stair areas though typical for older house</p> <p>WALLS: Masonry: overall general mortar repairs/brick replacement as required Masonry Arch: as above</p> <div>

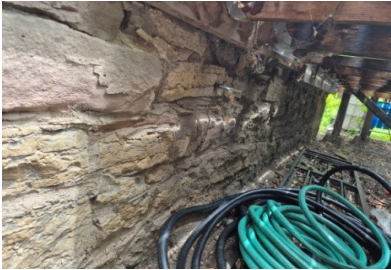
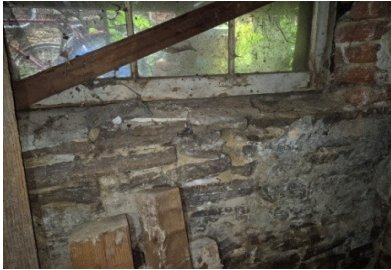
</div> <p>FOUNDATIONS: general mortar maintenance as required and/or renovating basement</p> <div>

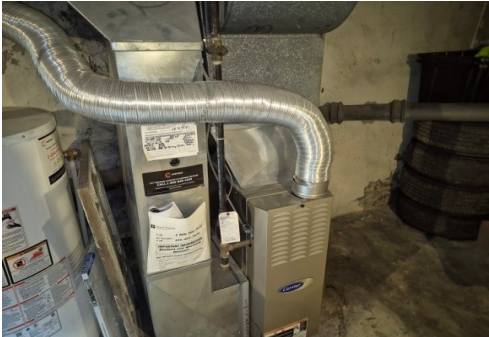
REFERENCE LINK	http://redbrickinspections.ca/docs/6_Heating_Reference_Guide.pdf						
27 Hook Ave		HEATING				June 18 2025	
Description							
Description:	Efficiency:	Rated Input:	Approx. Age:	Life Expectancy:	Fuel Type:	Shut Off at:	
Forced Air Furnace:	Mid	70 x1000BTU/hr	20 yrs.	20+ yrs.	Gas	Meter-Exterior	
Exhaust Vent Arrangement: Metal Through Masonry Chimney							
Limitations					Furnace Performance		
Heat Loss Calculations Not Done					Summer Test Procedure		
Heat Exchanger- Inaccessible					Supply Temp F:		
					Return Temp F:		
Observations/Recommendations							
<p>FORCED AIR FURNACE: continue servicing until replacement becomes necessary recommend obtaining replacement parts/servicing contract</p> <p>Filter: replace 1-per-3 months</p> <div>

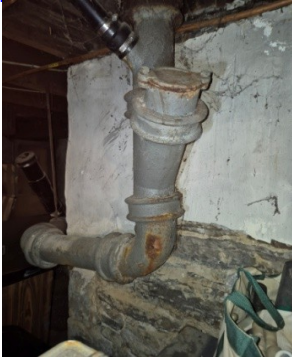
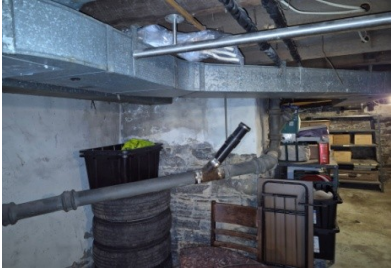
REFERENCE LINK		http://redbrickinspections.ca/docs/9_Plumbing_Reference_Guide.pdf
27 Hook Ave		<div>PLUMBING</div> <div>June 18 2025</div>
Description		
Service Piping into House:	Main Shut Off Valve at:	Water Flow (Pressure):
Not Visible	Basement-Front	Below Average
Supply Piping & Pump(s):	Waste Piping & Pump(s):	Water Heater
Copper	Plastic	Type: Conventional
	Cast Iron	Fuel Type: Gas
		Capacity: 50 Gal
		Age Yrs.: 4
		Life Expectancy: 15
Limitations		
Isolating/Relief Valves & Main Shut Off Valves Not Tested		Concealed Plumbing not Inspected
Kitchen and Laundry Appliances Were Not Inspected		Tub/Sink Overflows Not Tested
Observations/Recommendations		
<p>WATERMAIN: not determined - possibly older lead or galvanized steel pipe- recommend upgrade to copper contact city to arrange replacement lead testing kits available from city centers</p> <p>SUPPLY PIPING: all piping examined was in good repair</p> <p>WASTE PIPING: basement: rusting components, monitor, budget to replace, replace if renovating basement,</p> <p>Basement Floor Drain: none found - suspect none - further evaluation - install if required/if renovating suspect older main drain to city, recommend video-scan, risk of tree roots recommend installing backflow valve to main waste drain if/when installing floor drain</p> <div>

</div> <p>Washroom(s): old, anticipate renovations Kitchen(s) old, anticipate renovations</p>
