HOME INSPECTION REPORT

64 Mooreshead Dr
Toronto

Prepared by: Bob Papadopoulos P.Eng., RHI *

Inspection Date: [June 6 2025](#)

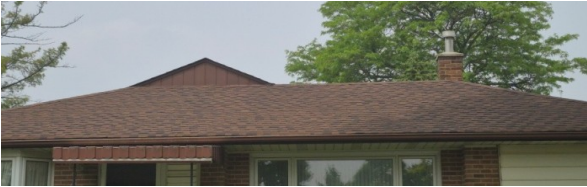
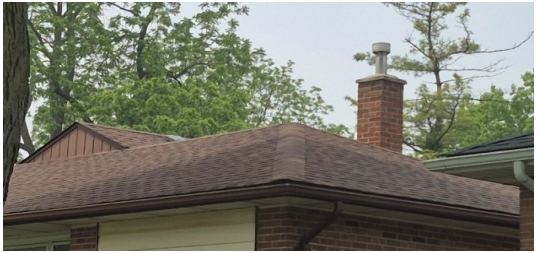
REFERENCE LINK		http://redbrickinspections.ca/docs/2_Roofing_Reference_Guide.pdf	
64 Mooreshead Dr		ROOFING/Chimneys June 6 2025	
Description			
Roofing Material: Asphalt Shingles:	Location: Slope:	Leakage Probability: Low	Chimney(s) Type: Brick: Location: Central
Limitations			
Roof Inspected By: From Grade	Access Limited By:	Chimney Access Limited By:	
Observations/Recommendations			
<p>Sloped Surface: overall surface in good repair</p> <div style="display: flex; justify-content: space-around; align-items: flex-start;">

</div> <p>Chimney: overall in good repair</p>			
<p>Note: Recommend Annual Maintenance Contract for Roof Surface, Flashing Details and Chimney(s)</p>

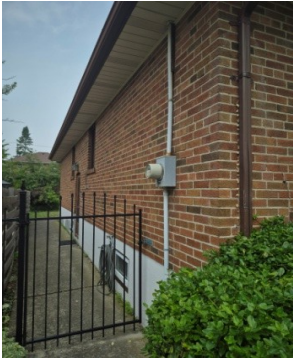
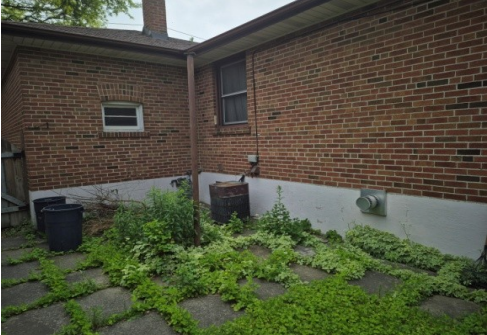
REFERENCE LINK		http://redbrickinspections.ca/docs/3_Exterior_Reference_Guide.pdf	
64 Mooreshead Dr		<div>EXTERIOR</div> <div>June 6 2025</div>	
Description			
Gutters & Downspouts: Aluminum:	Downspout(s) Discharge: Various Above Grade	Lot Topography: Flat	Walls & Wall Structures: Brick
Limitations			
Exterior Inspection from Ground Level			
Observations/Recommendations			
<p>WALL SURFACES: overall in good repair DOORS/WINDOWS: overall in good repair</p> <div>

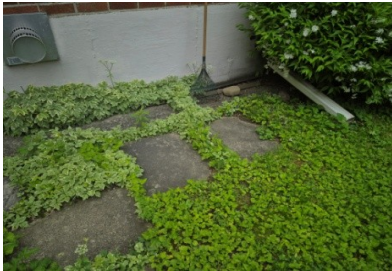
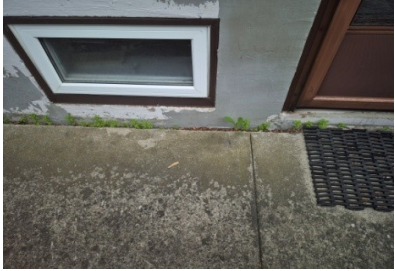
</div> <p>**Lot Grading: low areas around foundation: re-grade away from house **Walk(s): seal gaps along foundation wall</p> <div>

</div> <p>**Driveway(s): budget to re-surface driveway ATTACHED GARAGE: concrete floor slab settlement - budget to repair/replace</p> <p>Note: Maintain Gutters & Downspouts annually. Extend Downspouts at least 6-feet away from the house ** Any or all these items may contribute to Basement Leakage. Please see Interior Page</p>

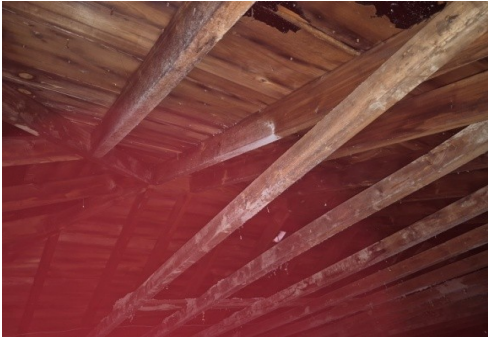
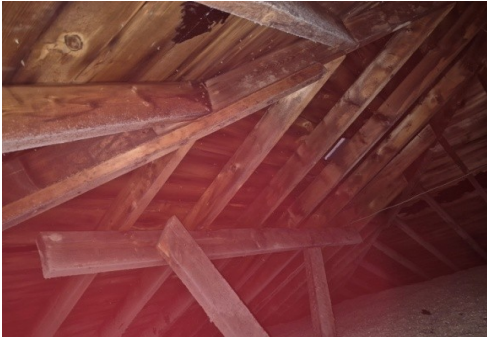
REFERENCE LINK		http://redbrickinspections.ca/docs/4_Structure_Reference_Guide.pdf		
64 Mooreshead Dr		STRUCTURE		June 6 2025
Description				
Configuration: Basement:	Foundations: Poured Concrete	Floor : Wood Joists	Walls : Masonry (Double-Brick)	Roof/Ceiling Framing: Wood Rafters/Joists
Limitations				
Restricted Access to: Wall Space	Foundation Wall Not Visible: <u>80</u> % Roof Space Inspected From Access Hatch			
Observations/Recommendations				
<p>overall well built house</p> <p>ROOF: overall in good repair</p> <div style="display: flex; justify-content: space-around;">

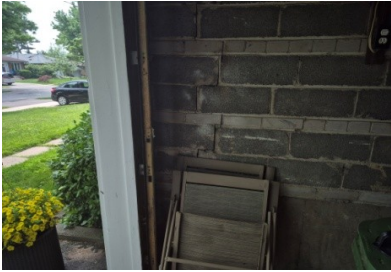
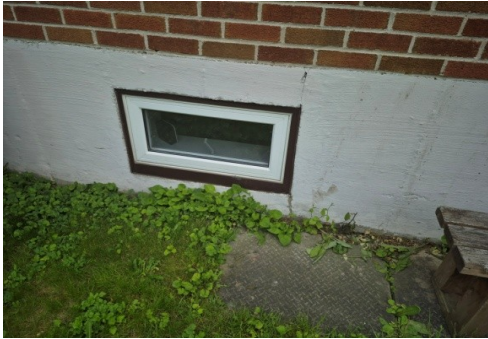
</div> <p>WALLS: garage: typical settlement cracks</p> <p>FOUNDATIONS: typical settlement cracks</p> <div style="display: flex; justify-content: space-around;">

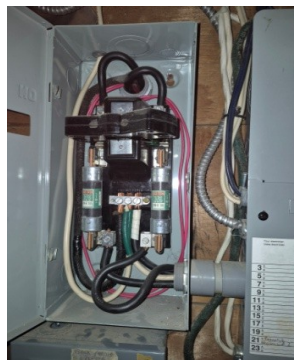
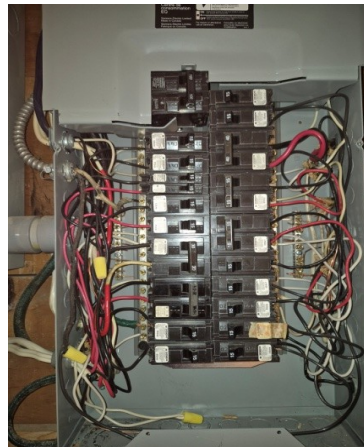
Main Disconnect: **overall in good repair**
SERVICE PANEL: **overall in good repair**

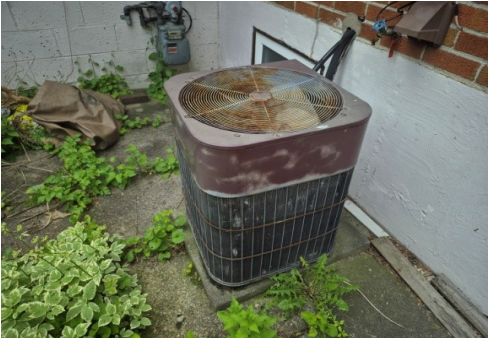
REFERENCE LINK		http://redbrickinspections.ca/docs/7_AC_Heat_Pump_Reference_Guide.pdf	
64 Mooreshead Dr		COOLING/Heat Pumps	June 6 2025
Description			
Description:	Cooling Capacity:	Approx. Age:	Typical Life Expectancy:
Air Conditioner (air-cooled):	x1,000 BTU/hr	42 yrs. old	20 yrs.
Limitations			Cooling Performance
			Supply Temp F:
			Return Temp F:
Observations/Recommendations			
<p>AIR CONDITIONER: not tested: should be serviced before using old unit, continue servicing until replacement becomes necessary consider replacing with new unit for improved efficiency</p>

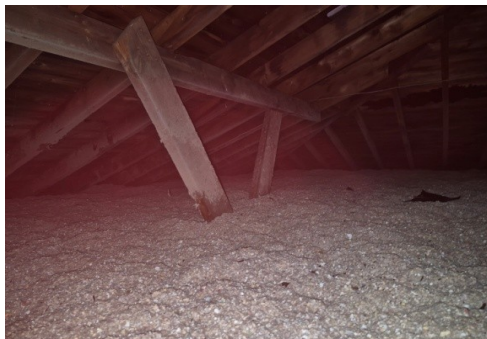
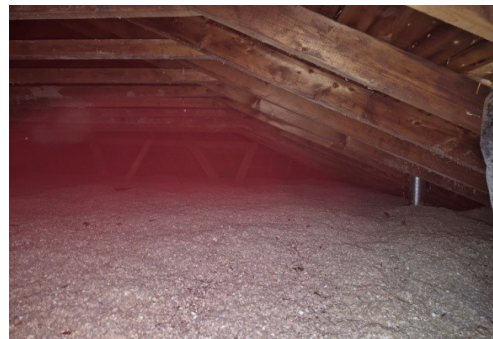
ROOF SPACE: insulation and ventilation is adequate
insulation has been upgraded which will improve comfort and efficiency
