85 Harshaw Avenue, Toronto, Ontario

## SUMMARY INSPECTION REPORT

## INSPECTION REPORT

PROPERTY: 85 Harshaw Avenue, Toronto, Ontario

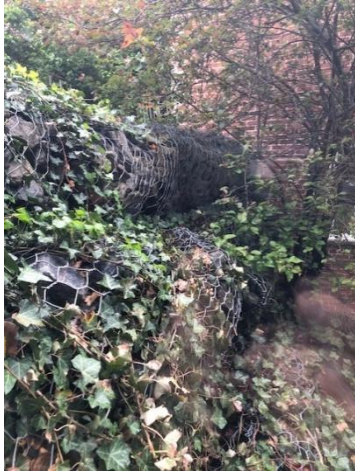
#### 2.12 Retaining walls:

*M: the gabion (stone and wire mesh) retaining wall at the south end of the property bows outward in areas. Due to a lack of access, the stability of this retaining wall system could not be determined. Monitor for further movement. It may be necessary in future to reinforce or reconstruct sections of this wall.*

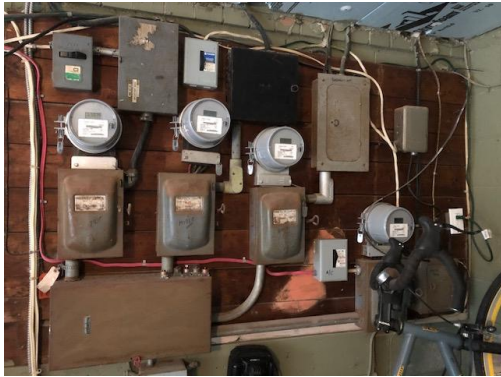
3.01 Electrical service & panel: This building is equipped with a 120/240-volt, 200-amp service. The service is split into four 60-amp mains for the three apartments, plus a house panel. Updated circuit breaker panels are located in each of the apartments. The size of the service is considered sufficient for the electrical requirements of the house. The incoming service wires run through a vertical conduit mounted on the outside wall. The pipe is intact and is secure to the wall. A drip loop is present at the top of the mast. The electrical service appears to be grounded to the supply plumbing.

*G: eventual upgrade of the fuse panels/main disconnects in the garage is recommended. You may want to eliminate a couple of the meters at that time.  
(budget \$5,000)*
