HOME INSPECTION REPORT

90 Humberview Rd
Toronto

Inspection Date: [June 11 2025](#)

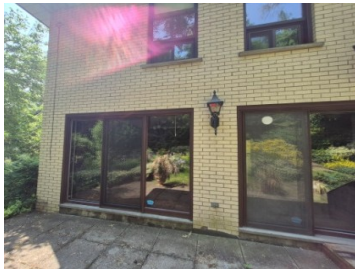
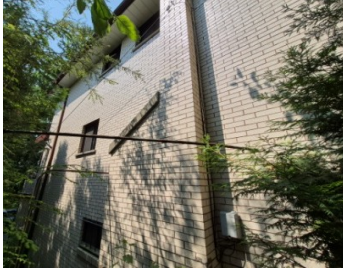
REFERENCE LINK		http://redbrickinspections.ca/docs/3_Exterior_Reference_Guide.pdf	
90 Humberview Rd		EXTERIOR	
		June 11 2025	
Description			
Gutters & Downspouts: Aluminum:	Downspout(s) Discharge: Below Grade	Lot Topography: Towards House House Below Ravine Away From House	Walls & Wall Structures: Brick Concrete Retaining Wall Stone Retaining Wall Metal Siding
Limitations			
Exterior Inspection from Ground Level Flora Against Building Restricted Inspection			
Observations/Recommendations			
<p>**Gutters/Downspouts: requires maintenance/cleaning</p> <p>WALL SURFACES: overall in good repair DOORS/WINDOWS: overall in good repair</p> <div>

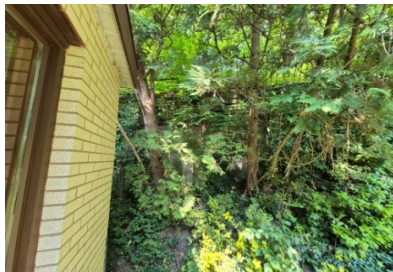
</div> <p>RETAINING WALL(s): recommend damp-proofing if renovating basement</p> <div>

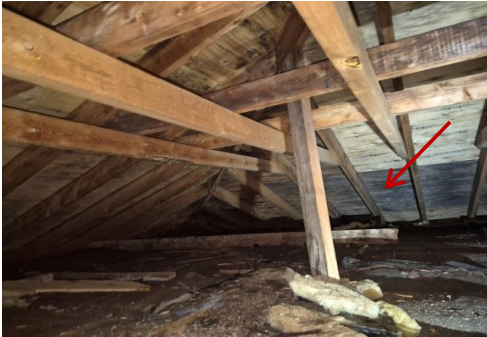
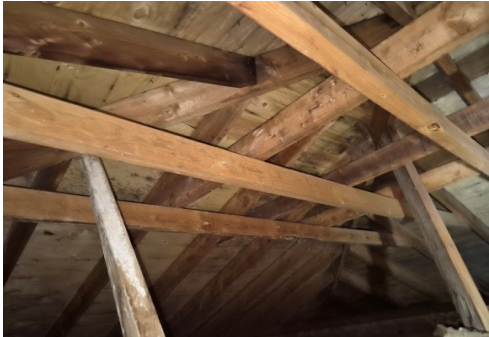
REFERENCE LINK		http://redbrickinspections.ca/docs/4_Structure_Reference_Guide.pdf		
90 Humberview Rd		STRUCTURE		June 11 2025
Description				
Configuration: Basement:	Foundations: Masonry Block Poured Concrete	Floor : Wood Joists	Walls : Wood Frame(Brick Veneer)	Roof/Ceiling Framing: Wood Rafters/Joists
Limitations				
Restricted Access to: Wall Space	Foundation Wall Not Visible: <u>95</u> % Roof Space Inspected From Access Hatch			
Observations/Recommendations				
<p>overall well built house</p> <p>ROOF: overall in good repair</p> <p>Roof Sheathing: some areas: underside shows signs of mould though no damage observed recommend further evaluation by specialist and remediation/mould treatment if required</p>				
<div>

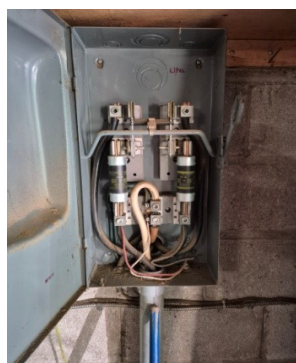
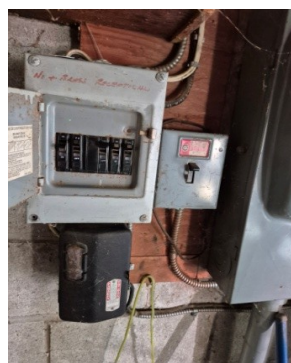
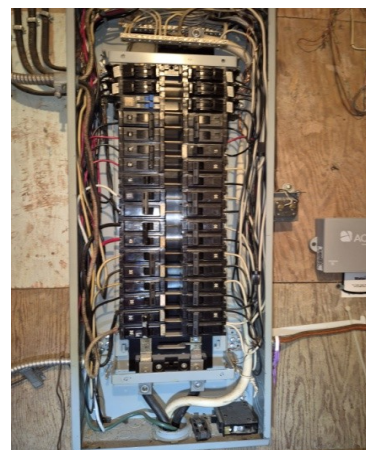
SERVICE PANEL: **overall in good repair**

anticipate replacing when renovating

GFCI: **provide to exterior outlet**
provide to washroom outlet

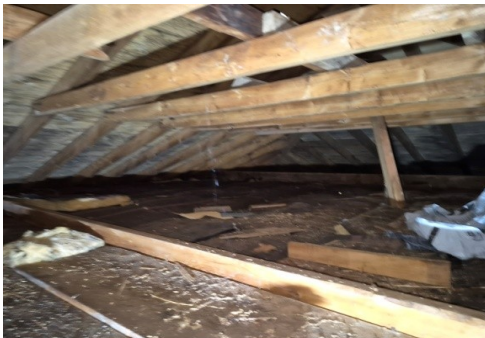
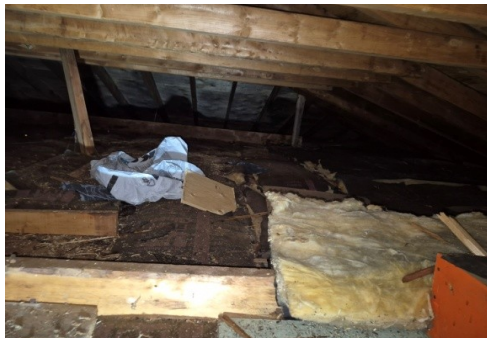
REFERENCE LINK		http://redbrickinspections.ca/docs/8_Insulation_Ventilation_Reference_Guide.pdf		
90 Humberview Rd		INSULATION/VENTILATION		June 11 2025
Description				
Material:	Location	R-Value	Air/Vapour Barrier:	Venting:
Fiberglass:	Main Roof:	24	Kraft Paper	Roof
Limitations				
Roof Space Inspected from Access Hatch		Access Not Gained To Flat Roof		
Access Not Gained To Wall Space				
Observations/Recommendations				
ROOF SPACE: recommend upgrading insulation to improve comfort and efficiency
