HOME INSPECTION REPORT

16 Palisades

Toronto

Inspection Date: June 30 2025

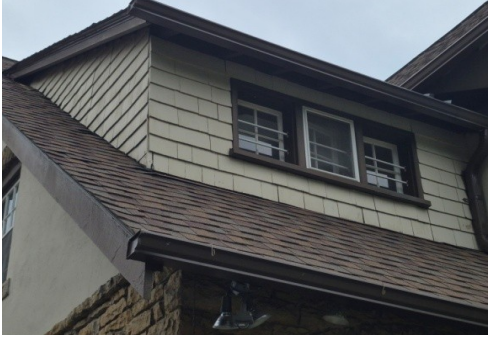
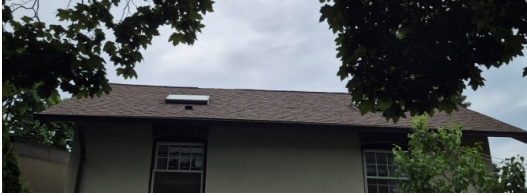
REFERENCE LINK		http://redbrickinspections.ca/docs/2_Roofing_Reference_Guide.pdf		
16 Palisades		ROOFING/Chimneys		June 30 2025
Description				
Roofing Material:	Location:	Leakage Probability:	Chimney(s) Type:	Location:
Asphalt Shingles:	Slope:	Low	Stone:	North
Asphalt Shingles:	Garage:	Low		
Limitations				
Roof Inspected By:	Access Limited By:	Chimney Access Limited By:		
From Grade	Height	Height		
Observations/Recommendations				
<p>Sloped Surface: overall surface in good repair</p> <div style="display: flex; justify-content: space-around;">

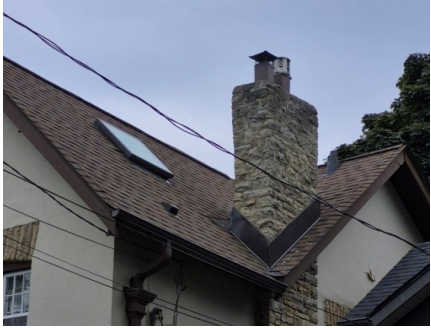
</div> <p>Vulnerable Areas: north side where chimney intersects with chimney - monitor chimney in good repair</p> <div style="text-align: center;">

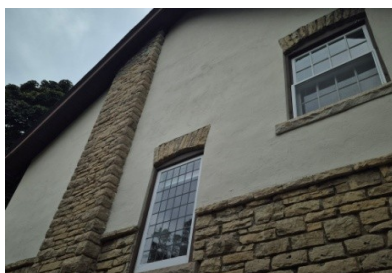
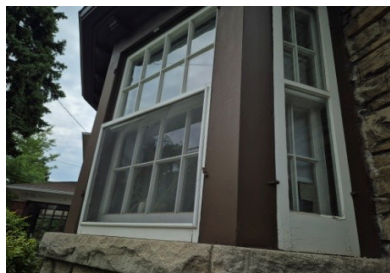
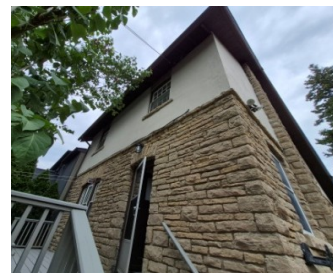
DOORS/WINDOWS: overall in good repair, monitor/paint wood components as required

Soffit & Facia: monitor/paint wood components as required

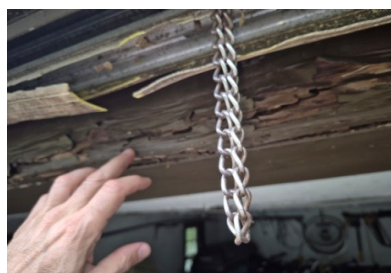
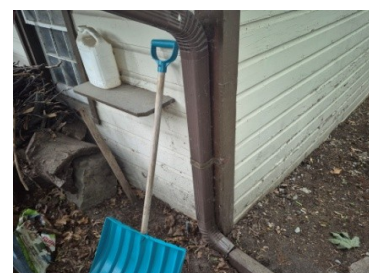
DETACHED GARAGE: older, typically ongoing repairs

bottom perimeter prone to rot - repair as required, budget to repair perimeter

presently car door wood support requires repairs/replacement

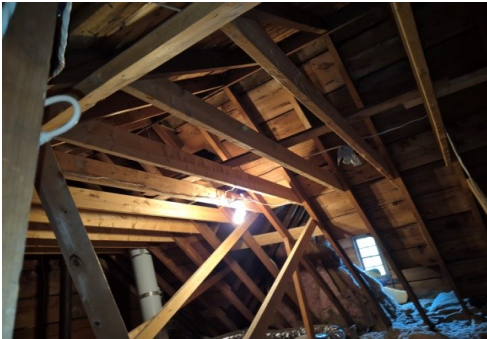
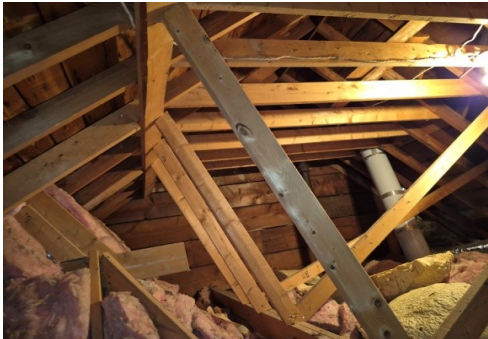
REFERENCE LINK		http://redbrickinspections.ca/docs/4_Structure_Reference_Guide.pdf		
16 Palisades		STRUCTURE		June 30 2025
Description				
Configuration: Basement:	Foundations: Stone	Floor : Wood Joists	Walls : Masonry (Stucco Finish) Stone	Roof/Ceiling Framing: Wood Rafters/Joists
Limitations				
Restricted Access to: Wall Space	Foundation Wall Not Visible: _____ % Roof Space Inspected From Access Hatch			
Observations/Recommendations				
<p>overall well built house</p> <p>ROOF: overall in good repair structure reinforced when skylights were installed</p> <div style="display: flex; justify-content: space-around;">

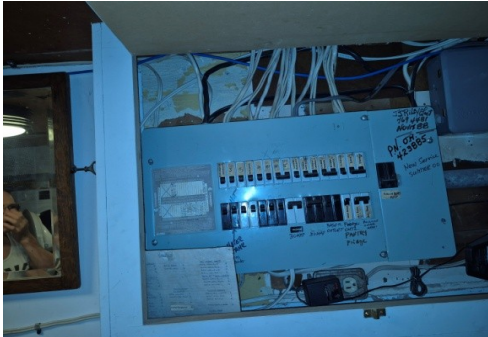
REFERENCE LINK	http://redbrickinspections.ca/docs/5_Electrical_Reference_Guide.pdf		
16 Palisades	ELECTRICAL		June 30 2025
Description			
Service Size: 100 AMP (240volts)	Service Entrance Cable:	Distribution Wire:	
Main Disconnect/Service Box	Location: Overhead	Copper	
Rating: 100 AMP	Type of material: Not Visible	Grounded	
Description: Breakers			
Location: Basement			
Distribution Panel	System Grounding:		
Rating: 100 AMP	Description: Copper		
Description: Breakers	Location: Water Pipe	Ground Fault Circuit Interrupter:	
Location: Basement		Location: Outside	
Auxiliary Panel(s):	Outlets	Bathroom(s)	
Rating: AMP	Description: Grounded		
Description:	Number of Outlets: Upgraded	Arc Fault Circuit Interrupter:	
Location:		Location:	
Limitations			
Main Disconnect Cover Not Removed			
Observations/Recommendations			
<p>SERVICE ENTRANCE: overall in good repair</p> <p>SERVICE PANEL: overall in good repair</p> <div>

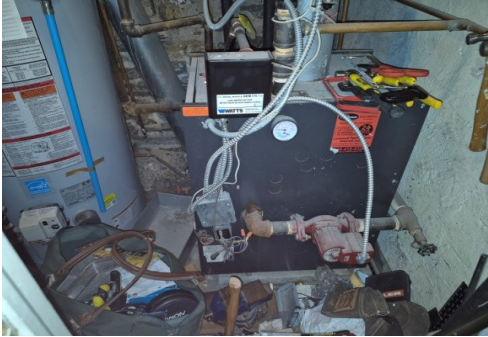
REFERENCE LINK		http://redbrickinspections.ca/docs/6_Heating_Reference_Guide.pdf			
16 Palisades		HEATING		June 30 2025	
Description					
Description:	Efficiency:	Rated Input:	Approx. Age:	Life Expectancy:	Fuel Type: Shut Off at:
Hot Water Boiler:	Low	? x1000BTU/hr	20 yrs.	20+ yrs.	Gas Meter-Exterior
Exhaust Vent Arrangement:					
Limitations				Boiler Performance	
Heat Loss Calculations Not Done				Summer Test Procedure	
Heat Exchanger- Inaccessible				Pressure lbs/in2: 8	
Observations/Recommendations					
<p>HOT WATER BOILER: service annually annual CO test mandatory for this type of unit recommend obtaining replacement parts/servicing contract</p>

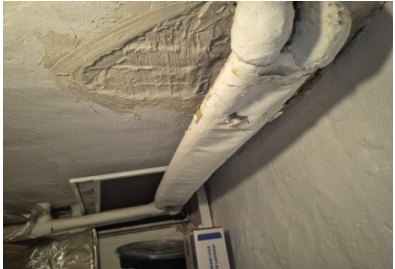
<p>Piping: basement rear storage: insulation on heating pipes may contain asbestos encapsulating the insulation is often the best approach Environmental Consultants can assist if this is a concern</p> <p>Radiator(s): monitor/repair valves as required</p>

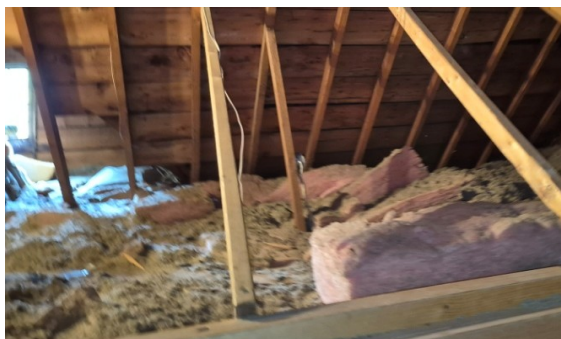
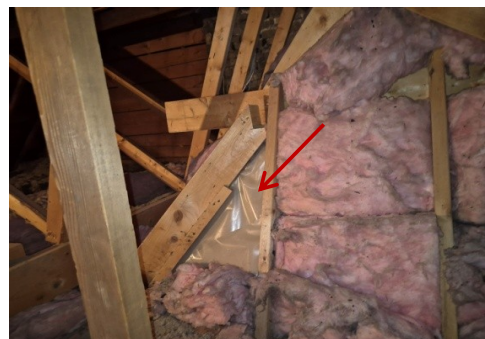
ROOF SPACE: uneven distribution of insulation - improve/add insulation

Roof Access Hatch: insulate and weather-strip access hatch to roof space

Skylight wells: some loose insulation - repair

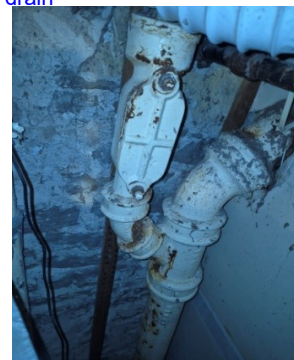
REFERENCE LINK		http://redbrickinspections.ca/docs/9_Plumbing_Reference_Guide.pdf	
16 Palisades		PLUMBING	
		June 30 2025	
Description			
Service Piping into House:	Main Shut Off Valve at:	Water Flow (Pressure):	
Copper	Basement	Good	
Supply Piping & Pump(s):	Waste Piping & Pump(s):	Water Heater	
Copper	Plastic		
	Cast Iron	Type: Induced Draft	
		Fuel Type: Gas	
		Capacity: 50 Gal	
		Age Yrs.: 8	
		Life Expectancy: 15	
Limitations			
Isolating/Relief Valves & Main Shut Off Valves Not Tested		Concealed Plumbing not Inspected	
Kitchen and Laundry Appliances Were Not Inspected		Tub/Sink Overflows Not Tested	
Observations/Recommendations			
<p>SUPPLY PIPING: all piping examined was in good repair</p> <p>WASTE PIPING: all piping examined was in good repair older piping: monitor/replace as required</p> <p>Basement Floor Drain: main drain to city sewer- recommend video-scan recommend installing backflow valve to main waste drain</p> <p>Washroom(s): overall in good repair</p> <p>Kitchen(s) overall in good repair</p>
