# HOME INSPECTION REPORT

625 Windermere Ave  
Toronto

Prepared for: [The Babiak Team](#)

Inspection Date: June 19 2025

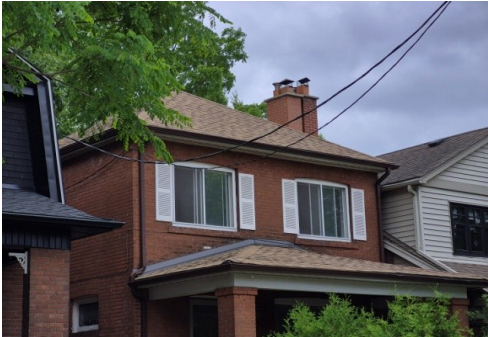
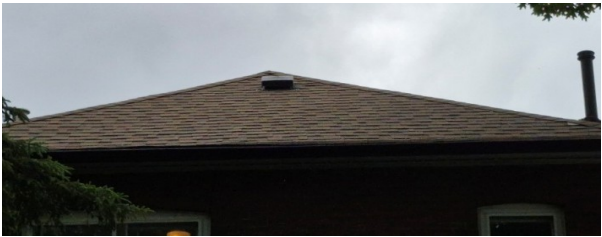
REFERENCE LINK		<a href="http://redbrickinspections.ca/docs/2_Roofing_Reference_Guide.pdf">http://redbrickinspections.ca/docs/2_Roofing_Reference_Guide.pdf</a>	
625 Windermere Ave		<b>ROOFING/Chimneys</b>	
		June 19 2025	
Description			
Roofing Material:	Location:	Leakage Probability:	Chimney(s) Type:
Asphalt Shingles:	Slope:	Low	Brick:
Asphalt Shingles:	Porch(s):		South
Limitations			
Roof Inspected By:	Access Limited By:	Chimney Access Limited By:	
From Grade	Height	Slope	
Observations/Recommendations			
<p>Tree Branches: <a href="#">retain arbourist for annual monitoring/trimming</a></p> <p>Sloped Surface: <a href="#">overall surface in good repair</a>  Porch(s): <a href="#">overall surface in good repair</a></p> <div style="display: flex; justify-content: space-around;">

</div> <p>Chimney: <a href="#">rebuilt and in good repair</a></p>			
<p><a href="#">Note: Recommend Annual Maintenance Contract for Roof Surface, Flashing Details and Chimney(s)</a></p>

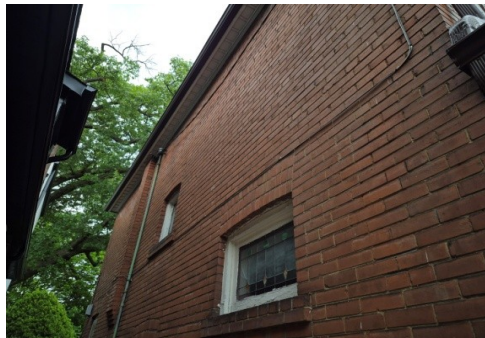
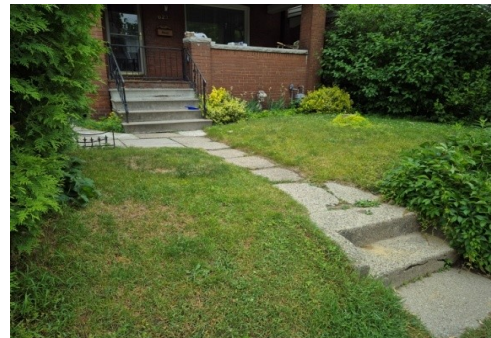
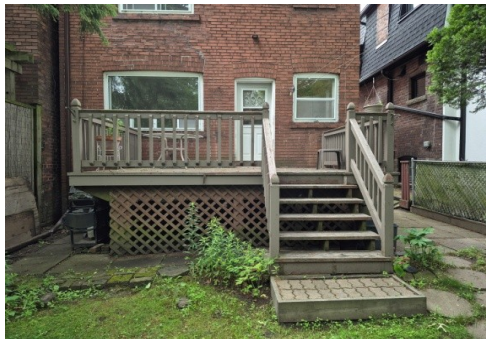
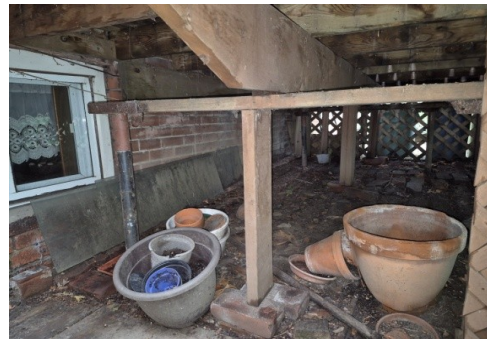
**\*\*Gutters/Downspouts:** requires maintenance/cleaning  
extend 6-ft away from house

DOORS/WINDOWS: older, maintain as required or replace as required

**\*\*Walk(s):** damaged/ settlement, budget to replace

Note: Maintain Gutters & Downspouts annually. Extend Downspouts at least 6-feet away from the house

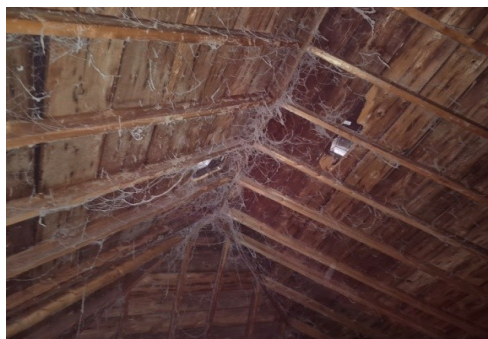
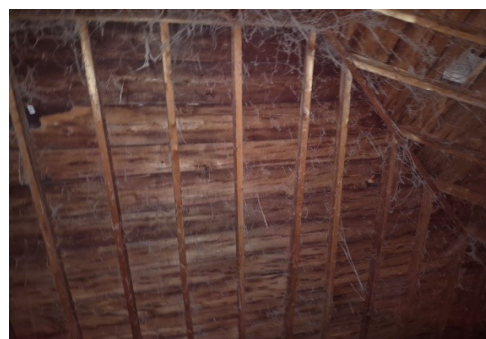
overall well built house

ROOF: overall in good repair

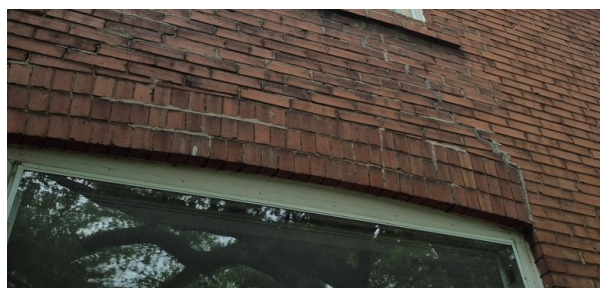
Masonry Arch: typical settlement cracks, prior repair- monitor

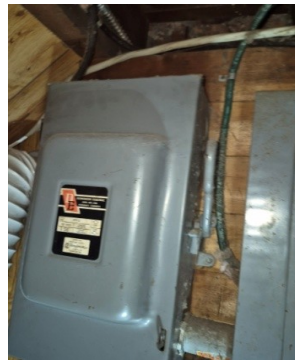
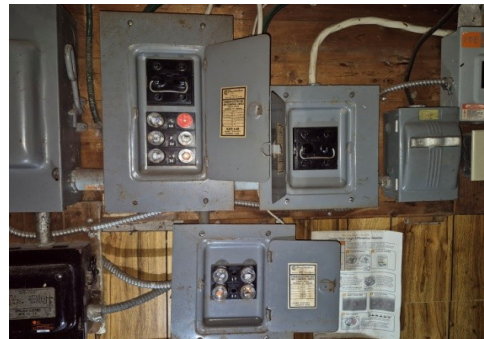
**Limitations****Main Disconnect Cover Not Removed****Observations/Recommendations**SERVICE ENTRANCE: **replace mast**Main Disconnect: **replace with combination panel**SERVICE PANEL: **upgrade when replacing wiring**Auxiliary Panel: **as above**

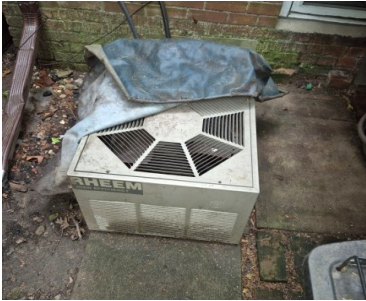
REFERENCE LINK	<a href="http://redbrickinspections.ca/docs/7_AC_Heat_Pump_Reference_Guide.pdf">http://redbrickinspections.ca/docs/7_AC_Heat_Pump_Reference_Guide.pdf</a>		
625 Windermere Ave	COOLING/Heat Pumps		June 19 2025
Description			
Description:	Cooling Capacity:	Approx. Age:	Typical Life Expectancy:
Air Conditioner (air-cooled):	24 x1,000 BTU/hr	25 yrs. old	20 yrs.
Limitations			Cooling Performance
			Supply Temp F:
			Return Temp F:
Observations/Recommendations			
<p>AIR CONDITIONER: not tested: should be serviced before using old unit, continue servicing until replacement becomes necessary consider replacing with new unit for improved efficiency</p>

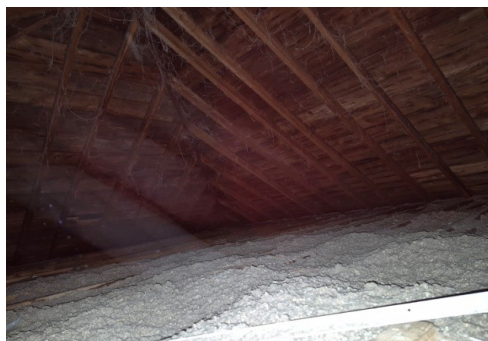
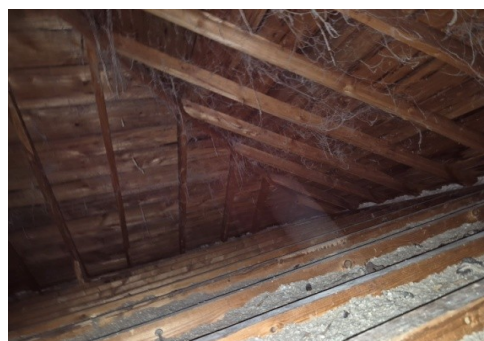
ROOF SPACE: odour- suspect prior animal activity -  
recommend removing/replacing insulation to improve comfort and efficiency  
ventilation with roof and soffit vents

Roof Access Hatch: insulate and weather-strip access hatch to roof space
