# HOME INSPECTION REPORT

90 Humberview Blvd

Prepared by: Bob Papadopoulos P.Eng., RHI \*

Inspection Date: [June 11 2025](#)

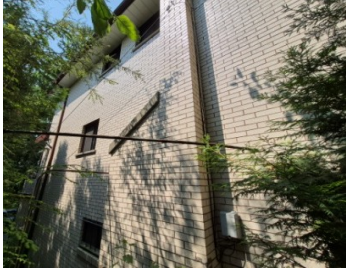
REFERENCE LINK		<a href="http://redbrickinspections.ca/docs/3_Exterior_Reference_Guide.pdf">http://redbrickinspections.ca/docs/3_Exterior_Reference_Guide.pdf</a>	
90 Humberview Blvd		EXTERIOR	
		June 11 2025	
Description			
Gutters & Downspouts: Aluminum:	Downspout(s) Discharge: Below Grade	Lot Topography: Towards House House Below Ravine Away From House	Walls & Wall Structures: Brick Concrete Retaining Wall Stone Retaining Wall Metal Siding
Limitations			
Exterior Inspection from Ground Level Flora Against Building Restricted Inspection			
Observations/Recommendations			
<p><b>**Gutters/Downspouts:</b> <a href="#">requires maintenance/cleaning</a></p> <p>WALL SURFACES: <a href="#">overall in good repair</a> DOORS/WINDOWS: <a href="#">overall in good repair</a></p> <div>

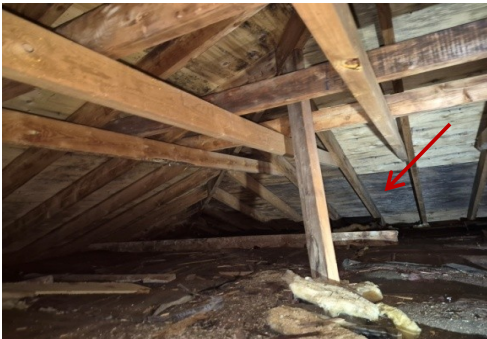
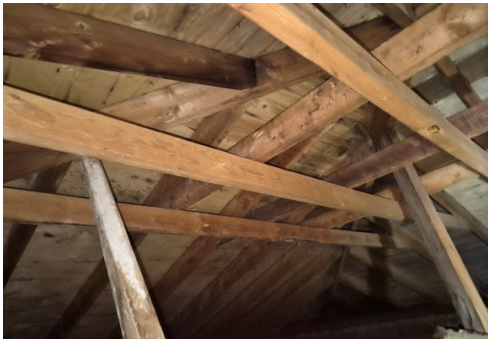
REFERENCE LINK		<a href="http://redbrickinspections.ca/docs/4_Structure_Reference_Guide.pdf">http://redbrickinspections.ca/docs/4_Structure_Reference_Guide.pdf</a>		
90 Humberview Blvd		<b>STRUCTURE</b>		June 11 2025
<b>Description</b>				
Configuration: Basement:	Foundations: Masonry Block Poured Concrete	Floor : Wood Joists	Walls : Wood Frame(Brick Veneer)	Roof/Ceiling Framing: Wood Rafters/Joists
<b>Limitations</b>				
Restricted Access to: Wall Space	Foundation Wall Not Visible: <u>95</u> % Roof Space Inspected From Access Hatch			
<b>Observations/Recommendations</b>				
<p>overall well built house</p> <p>ROOF: overall in good repair</p> <p>Roof Sheathing: some areas: underside shows signs of mould though no damage observed recommend further evaluation by specialist and remediation/mould treatment if required</p>				
<div>

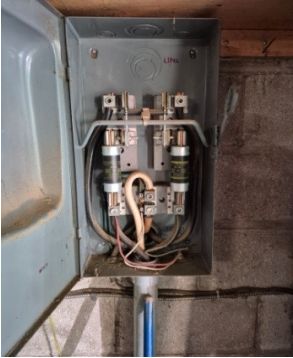
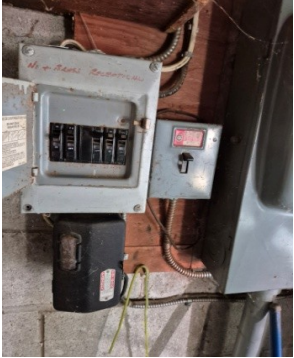
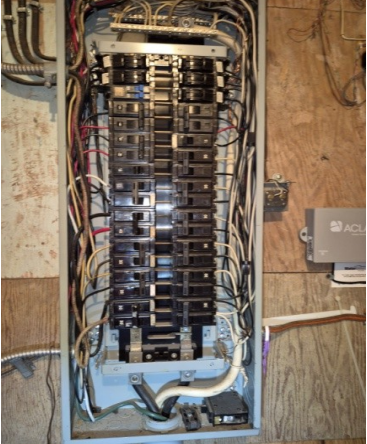
Location: <b>Garage</b>			Location:
<b>Limitations</b>			
<b>Main Disconnect Cover Not Removed</b>			
<b>Observations/Recommendations</b>			
<p>SERVICE ENTRANCE:</p> <p>Main Disconnect: <b>overall in good repair</b></p> <p>SERVICE PANEL: <b>overall in good repair</b>  <b>anticipate replacing when renovating</b></p>			
<div>

</div>			
<p>GFCI: <b>provide to exterior outlet</b>  <b>provide to washroom outlet</b></p>			
<p>Note 1: All recommendations are safety issues - Treat them as high priority.</p> <p>Note 2: Please ensure accurate labelling on panels.</p>

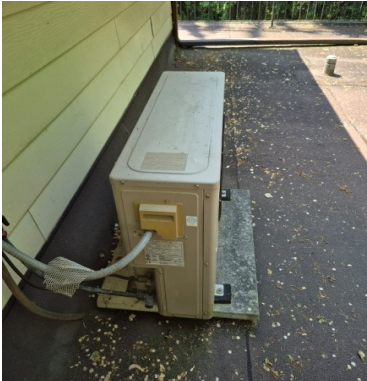
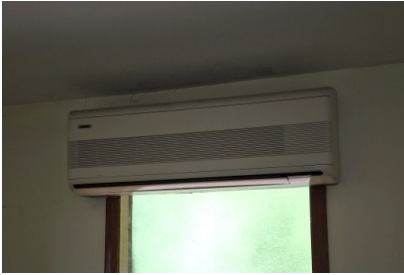
REFERENCE LINK		<a href="http://redbrickinspections.ca/docs/7_AC_Heat_Pump_Reference_Guide.pdf">http://redbrickinspections.ca/docs/7_AC_Heat_Pump_Reference_Guide.pdf</a>	
90 Humberview Blvd		<b>COOLING/Heat Pumps</b> <span style="float: right;">June 11 2025</span>	
<b>Description</b>			
Description:	Cooling Capacity:	Approx. Age:	Typical Life Expectancy:
Ductless (air-cooled)	18 x1,000 BTU/hr	25 yrs. old	15 to 20 yrs.
<b>Limitations</b>			<b>Cooling Performance</b>
			Supply Temp F:
			Return Temp F:
<b>Observations/Recommendations</b>			
<p>DUCTLESS A/C: older, tested functional, continue servicing until replacement becomes necessary</p> <div style="display: flex; justify-content: space-around; align-items: center;">

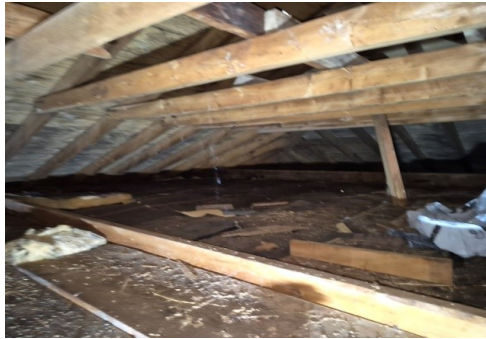
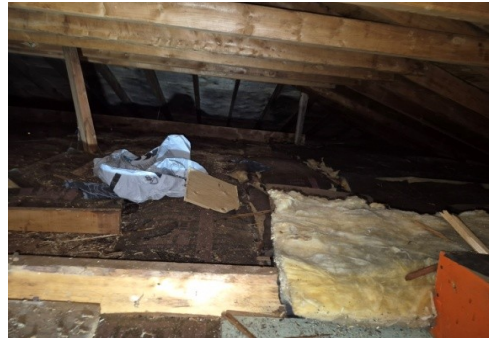
ROOF SPACE: recommend upgrading insulation to improve comfort and efficiency
