HOME INSPECTION REPORT

122 Colbeck St

Toronto

Inspection Date: Aug 7 2025

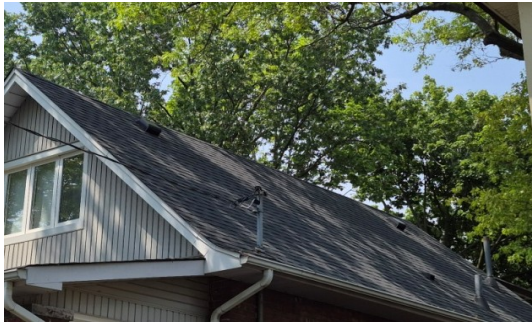
REFERENCE LINK		http://redbrickinspections.ca/docs/2_Roofing_Reference_Guide.pdf		
122 Colbeck St		ROOFING/Chimneys		Aug 7 2025
Description				
Roofing Material:	Location:	Leakage Probability:	Chimney(s) Type:	Location:
Asphalt Shingles:	Slope:	Low	Brick:	West
Asphalt Shingles:	Garage:	Low		
Asphalt Shingles:	2nd Slope:	Low		
Limitations				
Roof Inspected By:	Access Limited By:		Chimney Access Limited By:	
From Grade	Height Tree			
Observations/Recommendations				
<p>Tree Branches: retain arbourist for annual monitoring/trimming</p> <p>Sloped Surface: overall surface in good repair</p> <div style="display: flex; justify-content: space-around;">

</div> <p>Garage: overall surface in good repair</p>   <p>Chimney: overall in good repair</p> <p>2nd Slope: overall in good repair skylight in good repair</p>

<p>Note: Recommend Annual Maintenance Contract for Roof Surface, Flashing Details and Chimney(s)</p>

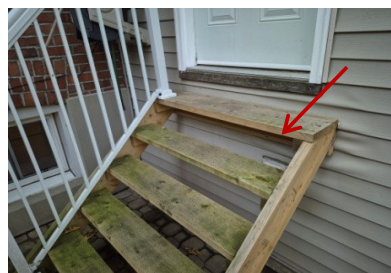
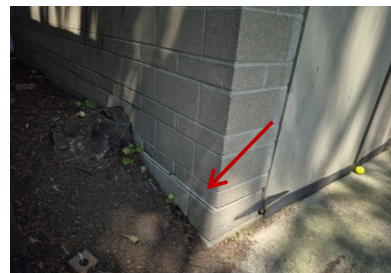
DETACHED GARAGE: prior settlement, likely polder condition: monitor

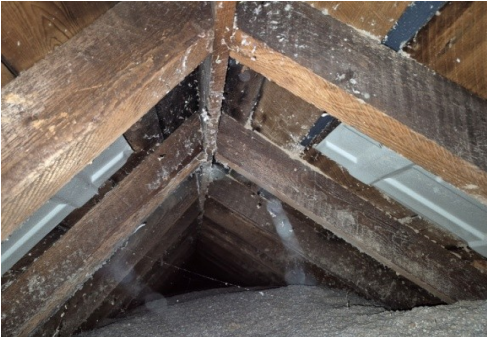
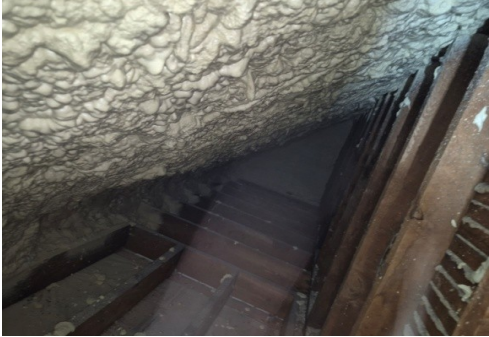
REFERENCE LINK		http://redbrickinspections.ca/docs/4_Structure_Reference_Guide.pdf		
122 Colbeck St		STRUCTURE		Aug 7 2025
Description				
Configuration: Basement:	Foundations: Poured Concrete	Floor : Wood Joists	Walls : Masonry (Double-Brick) Wood Frame (Siding)	Roof/Ceiling Framing: Wood Rafters/Joists
Limitations				
Restricted Access to: Wall Space	Foundation Wall Not Visible: <u>90</u> % Roof Space Inspected From Access Hatch Knee Wall Inspected From Access Hatch			
Observations/Recommendations				
<p>overall well built house</p> <p>ROOF: overall in good repair mostly not visible in knee walls due to spray foam</p> <div style="display: flex; justify-content: space-around;">

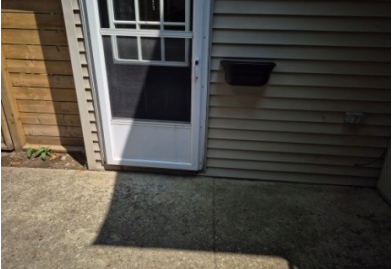
</div> <p>FLOORS/WALLS rear extension: low to grade- more prone to moisture damage, presently do not suspect and appears well sealed, monitor</p> <div style="text-align: center;">

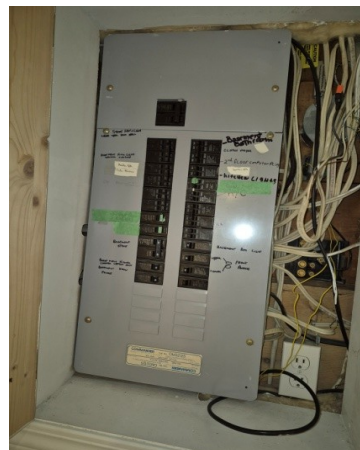
Limitations**Main Disconnect Cover Not Removed****Observations/Recommendations**SERVICE ENTRANCE: **overall in good repair**SERVICE PANEL: **overall in good repair**

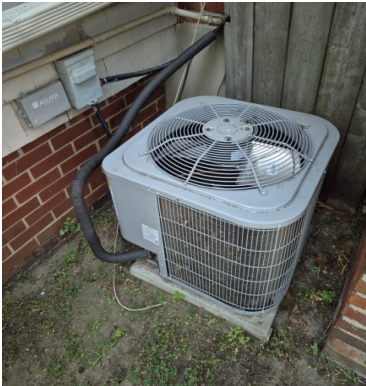
REFERENCE LINK	http://redbrickinspections.ca/docs/7_AC_Heat_Pump_Reference_Guide.pdf		
122 Colbeck St	COOLING/Heat Pumps		Aug 7 2025
Description			
Description:	Cooling Capacity:	Approx. Age:	Typical Life Expectancy:
Air Conditioner (air-cooled):	24 x1,000 BTU/hr	new yrs. old	10 to 15 yrs.
Limitations			Cooling Performance
			Supply Temp F: 50
			Return Temp F: 70
Observations/Recommendations			
<p>AIR CONDITIONER: service annually</p> <div>

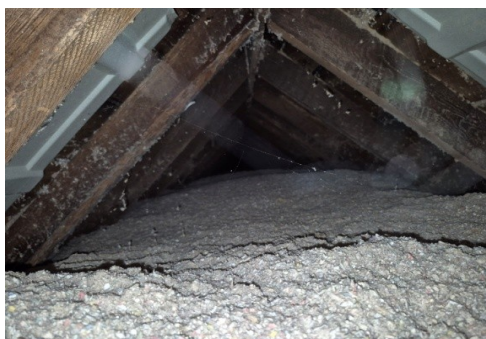
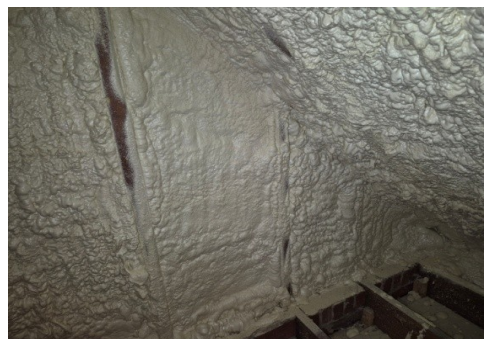
ROOF SPACE: insulation has been upgraded which will improve comfort and efficiency

Knee Walls: insulation has been upgraded which will improve comfort and efficiency
