HOME INSPECTION REPORT

117 South Kingsway
Toronto

Prepared by: Bob Papadopoulos P.Eng., RHI *

Inspection Date: [June 27 2025](#)

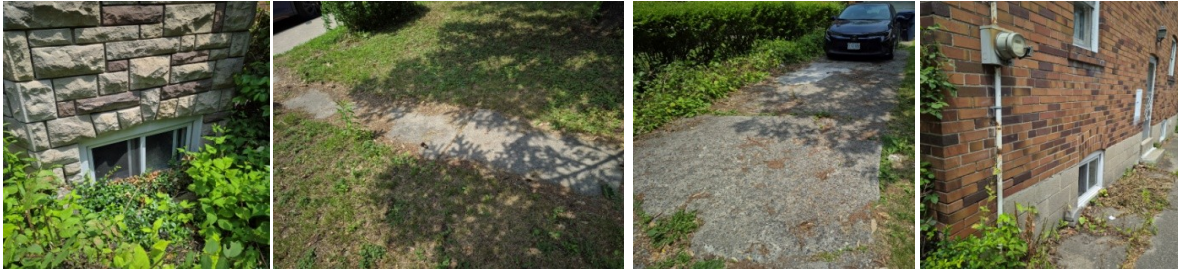
REFERENCE LINK		http://redbrickinspections.ca/docs/3_Exterior_Reference_Guide.pdf	
117 South Kingsway		<div>EXTERIOR</div> <div>June 27 2025</div>	
Description			
Gutters & Downspouts: Aluminum:	Downspout(s) Discharge: Various Above Grade	Lot Topography: Flat	Walls & Wall Structures: Brick
Limitations			
Exterior Inspection from Ground Level Storage in Garage			
Observations/Recommendations			
<p> **Gutters/Downspouts: requires maintenance/cleaning extend 6-ft away from house </p> <p> **Window Well: recommended at front </p> <p> **Walk(s)/Driveway(s): seal gaps/cracks along wall </p>

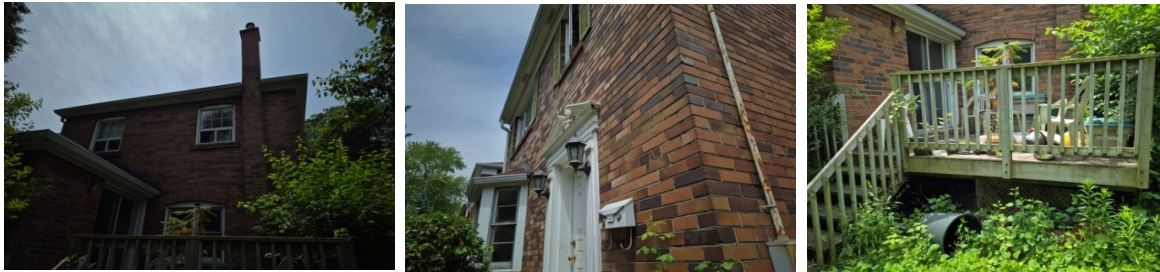
<p> WALL SURFACES: overall in good repair, paint/maintenance wood components as required </p> <p> DOORS/WINDOWS: overall in good repair </p> <p> DECK: replace floor boards as required </p>

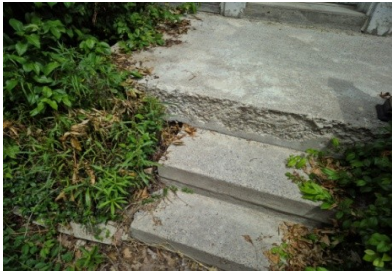
<p> ATTACHED GARAGE: car door requires adjustment </p> <p> PORCH: general concrete maintenance </p>

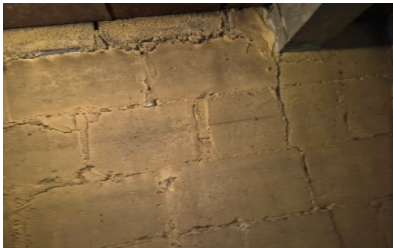
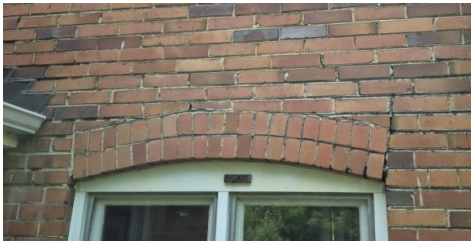
REFERENCE LINK		http://redbrickinspections.ca/docs/4_Structure_Reference_Guide.pdf		
117 South Kingsway		STRUCTURE		June 27 2025
Description				
Configuration: Basement:	Foundations: Masonry Block	Floor : Wood Joists	Walls : Masonry (Double-Brick)	Roof/Ceiling Framing: Wood Rafters/Joists
Limitations				
Restricted Access to: Wall Space	Foundation Wall Not Visible: <u>80</u> % Roof Space Inspected From Access Hatch			
Observations/Recommendations				
<p>overall well built house</p> <p>FOUNDATIONS: typical settlement cracks</p> <p>WALLS: overall in good repair</p> <p>Masonry Arch: typical settlement cracks, minor repair</p> <div style="display: flex; justify-content: space-around;">

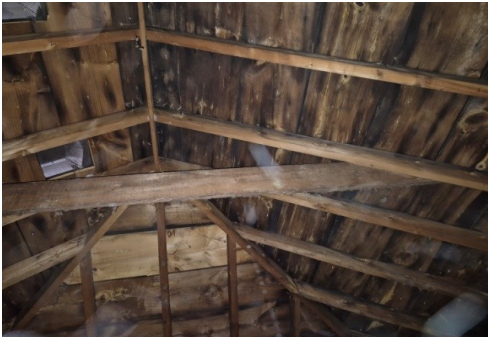
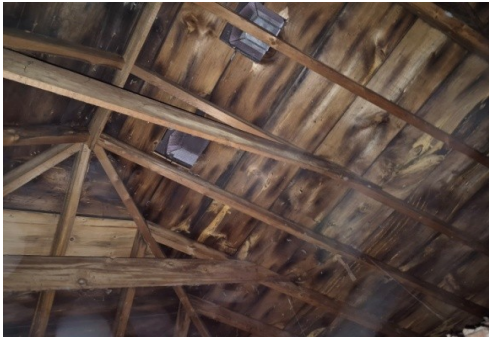
</div> <p>ROOF: overall in good repair</p> <div style="display: flex; justify-content: space-around;">

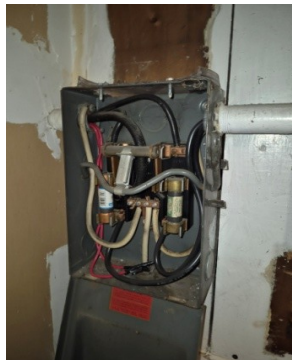
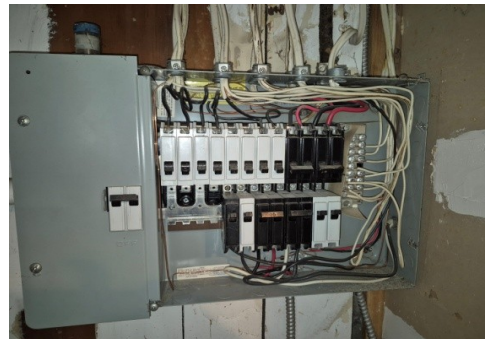
Limitations**Main Disconnect Cover Not Removed****Observations/Recommendations****SERVICE ENTRANCE:**Mast: **upgrade with service size**Service Size: **upgrade to 100 amp**Main Disconnect: **remove with above upgrades**SERVICE PANEL: **overall in good repair**

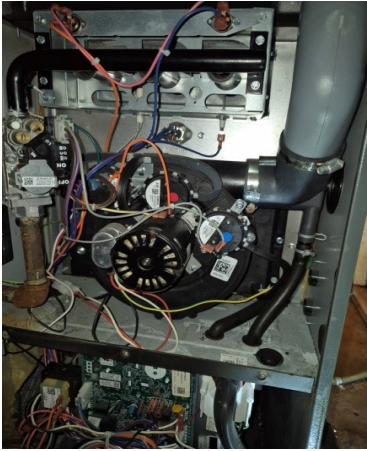
REFERENCE LINK		http://redbrickinspections.ca/docs/6_Heating_Reference_Guide.pdf			
117 South Kingsway		HEATING		June 27 2025	
Description					
Description:	Efficiency:	Rated Input:	Approx. Age:	Life Expectancy:	Fuel Type: Shut Off at:
Forced Air Furnace:	High	60 x1000BTU/hr	5 yrs.	20 yrs.	Gas Meter-Exterior
Exhaust Vent Arrangement:					
Limitations				Furnace Performance	
Heat Loss Calculations Not Done				Supply Temp F:	
Heat Exchanger- Inaccessible				Return Temp F:	
Observations/Recommendations					
<div>FORCED AIR FURNACE: service annually</div> <div>Filter: replace 1-per-3 months</div> <div>

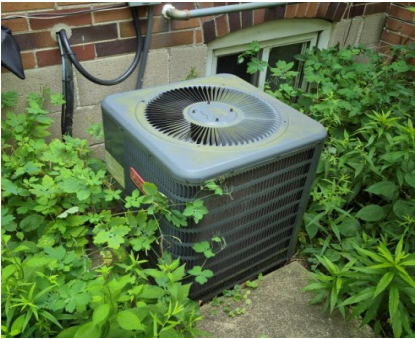
REFERENCE LINK	http://redbrickinspections.ca/docs/7_AC_Heat_Pump_Reference_Guide.pdf		
117 South Kingsway	COOLING/Heat Pumps		June 27 2025
Description			
Description:	Cooling Capacity:	Approx. Age:	Typical Life Expectancy:
Air Conditioner (air-cooled):	24 x1,000 BTU/hr	10 yrs. old	10 to 15 yrs.
Limitations			Cooling Performance
			Supply Temp F: 60
			Return Temp F: 75
Observations/Recommendations			
<p>AIR CONDITIONER: service annually</p> <div>

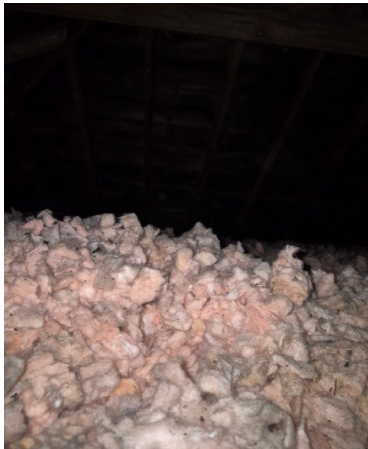
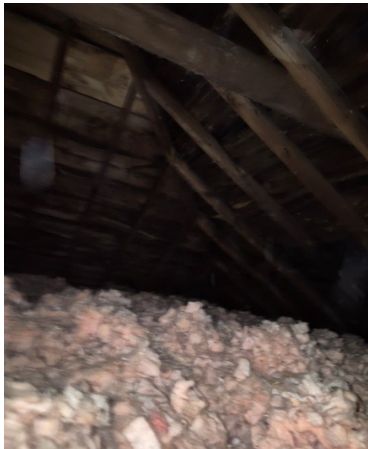
REFERENCE LINK		http://redbrickinspections.ca/docs/8_Insulation_Ventilation_Reference_Guide.pdf		
117 South Kingsway		INSULATION/VENTILATION		June 27 2025
Description				
Material:	Location	R-Value	Air/Vapour Barrier:	Venting:
Fiberglass:	Main Roof:	32	Kraft Paper	Roof
Limitations				
Roof Space Inspected from Access Hatch Access Not Gained To Wall Space				
Observations/Recommendations				
ROOF SPACE: insulation and ventilation is adequate upgrading insulation can improve comfort and efficiency				
Roof Access Hatch: insulate and weather-strip access hatch to roof space				
<div><div>

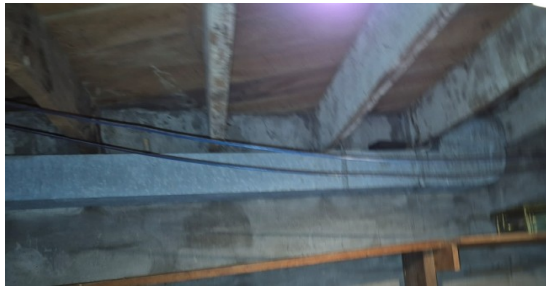
</div></div>				
Comments: basement: ducts at rear: insulate to improve efficiency				
<div>
