HOME INSPECTION REPORT

74 Humberview Rd
Toronto

Prepared by: Bob Papadopoulos P.Eng., RHI *

Inspection Date: [Sept 16 2025](#)

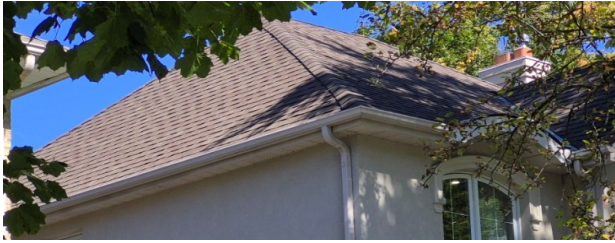
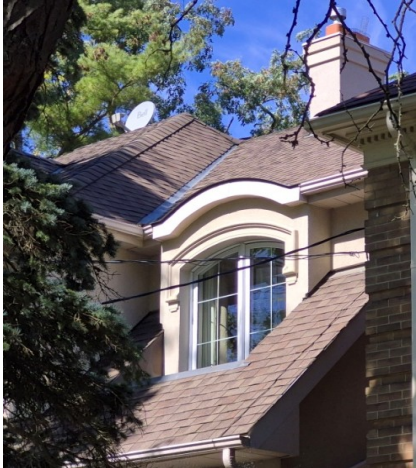
REFERENCE LINK		http://redbrickinspections.ca/docs/2_Roofing_Reference_Guide.pdf		
74 Humberview Rd		ROOFING/Chimneys		Sept 16 2025
Description				
Roofing Material: Asphalt Shingles:	Location: Slope:	Leakage Probability: Low	Chimney(s) Type: Stucco:	Location: Central
Limitations				
Roof Inspected By: From Grade	Access Limited By: Height Tree		Chimney Access Limited By: Height	
Observations/Recommendations				
<p>Tree Branches: retain arbourist for annual monitoring/trimming</p> <p>Sloped Surface: overall surface in good repair</p> <div style="display: flex; justify-content: space-around;">

</div> <p>Chimney(s): overall in good repair</p>				
<p>Note: Recommend Annual Maintenance Contract for Roof Surface, Flashing Details and Chimney(s)</p>

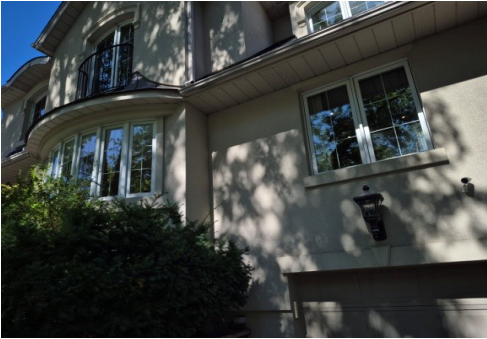
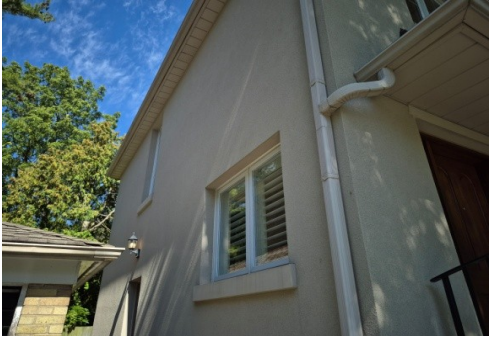
REFERENCE LINK		http://redbrickinspections.ca/docs/3_Exterior_Reference_Guide.pdf	
74 Humberview Rd		<div>EXTERIOR</div> <div>Sept 16 2025</div>	
Description			
Gutters & Downspouts: Aluminum:	Downspout(s) Discharge: Various Above Grade	Lot Topography: Flat Away From House	Walls & Wall Structures: Synthetic Stucco
Limitations			
Exterior Inspection from Ground Level		Car and Storage in Garage	
Flora Against Building Restricted Inspection			
Observations/Recommendations			
<p>**Gutters/Downspouts: requires maintenance/cleaning</p> <p>WALL SURFACES: overall in good repair</p> <p>DOORS/WINDOWS: overall in good repair</p> <div>

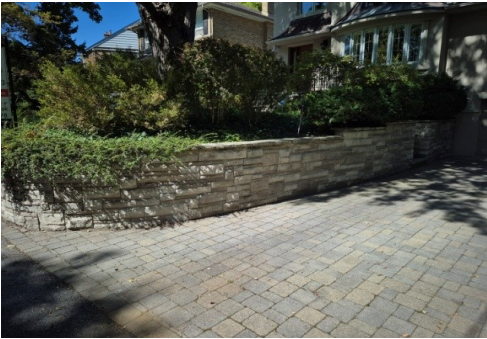
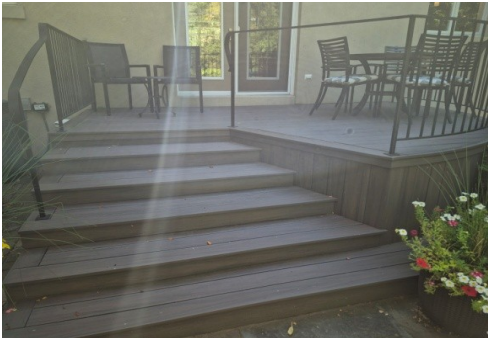
</div> <p>DECK overall in good repair, high quality materials</p> <p>PORCH overall in good repair</p> <p>**Landscaping: good quality installations</p> <p>**Walk(s)/Driveway(s): newer installations</p> <p>RETAINING WALL(s): newer installations</p> <div>

<p>Note: Maintain Gutters & Downspouts annually. Extend Downspouts at least 6-feet away from the house</p> <p>** Any or all these items may contribute to Basement Leakage. Please see Interior Page</p>

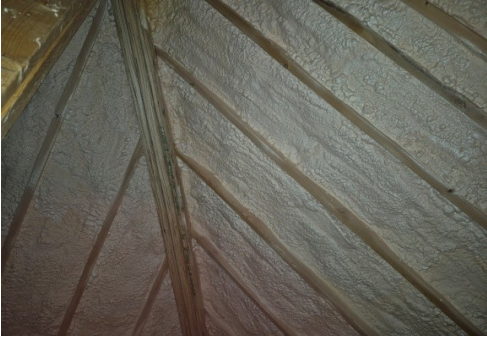
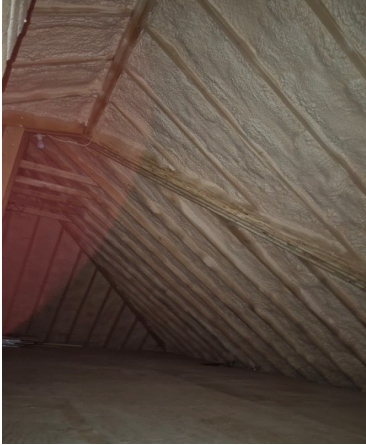
REFERENCE LINK		http://redbrickinspections.ca/docs/4_Structure_Reference_Guide.pdf		
74 Humberview Rd		STRUCTURE		Sept 16 2025
Description				
Configuration: Basement:	Foundations: Masonry Block	Floor : Wood Joists	Walls : Masonry (Stucco Finish) Wood Frame(Stucco Finish)	Roof/Ceiling Framing: Wood Rafters/Joists
Limitations				
Restricted Access to: Wall Space	Foundation Wall Not Visible: <u>80</u> % Roof Space Inspected From Access Hatch			
Observations/Recommendations				
<p>overall well older built house with newer additions</p> <div style="display: flex; justify-content: space-around; align-items: flex-start;">

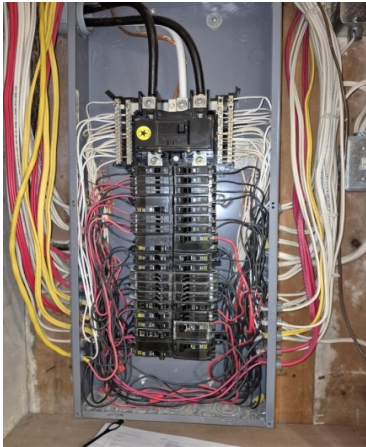
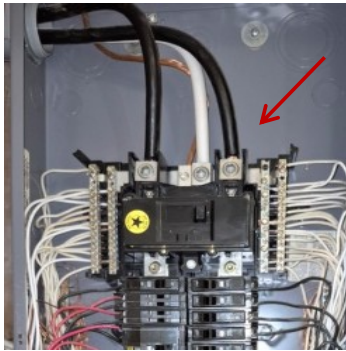
REFERENCE LINK	http://redbrickinspections.ca/docs/5_Electrical_Reference_Guide.pdf		
74 Humberview Rd	ELECTRICAL		Sept 16 2025
Description			
Service Size: 200	AMP (240volts)	Service Entrance Cable:	Distribution Wire:
Main Disconnect/Service Box		Location: Overhead	Copper
Rating: 200 AMP		Type of material: Not Visible	Grounded & Ungrounded
Description: Breakers			
Location: Garage			
Distribution Panel	System Grounding:		
Rating: 200 AMP	Description: Copper		
Description: Breakers	Location: Water Pipe	Ground Fault Circuit Interrupter:	
Location: Basement		Location: Outside	
Auxiliary Panel(s):	Outlets		Bathroom(s)
Rating: AMP	Description: Grounded/Ungrounded		
Description:	Number of Outlets: Typical	Arc Fault Circuit Interrupter:	
Location:		Location:	
Limitations			
Main Disconnect Cover Not Removed			
Observations/Recommendations			
<p>Main Disconnect: missing face safety inside of panel - ideally should provide</p> <p>SERVICE ENTRANCE: overall in good repair</p> <p>SERVICE PANEL: crowded, double taps (two wires connect to one breaker), install sub-panel if required, overall in good repair</p>

</div>			
<p>Ungrounded Outlet(s): these have been provided with GFCI's (ground fault circuit interrupters) for improved safety</p> <p>BRANCH WIRING: ungrounded wiring to outlets in older house areas where GFCI's installed,</p> <p>Knob & Tube: none observed based on random sampling</p>			
<p>Note 1: All recommendations are safety issues - Treat them as high priority.</p> <p>Note 2: Please ensure accurate labelling on panels.</p>

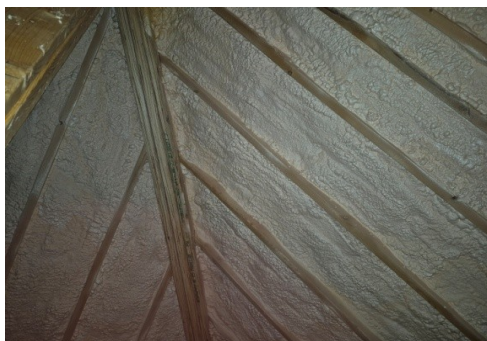
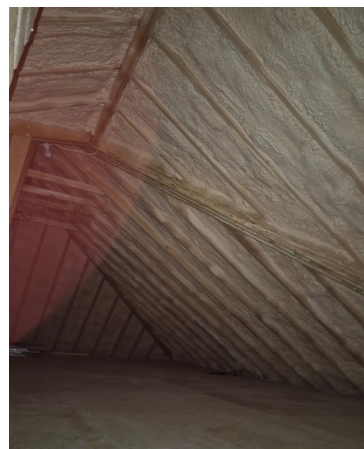
ROOF SPACE: spray foam insulation installed which is above average

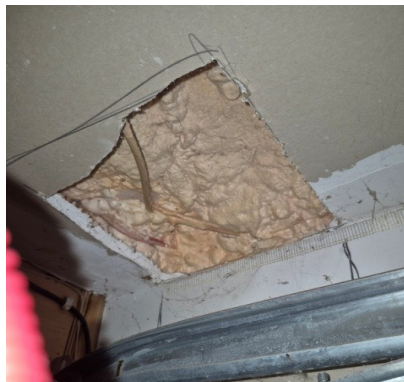
FLOORS: garage ceiling spray foam insulation installed which is above average
