# HOME INSPECTION REPORT

8 Grenadier Ravine Dr  
Toronto

Prepared by: Bob Papadopoulos P.Eng., RHI \*

Inspection Date: [Sept 19 2025](#)

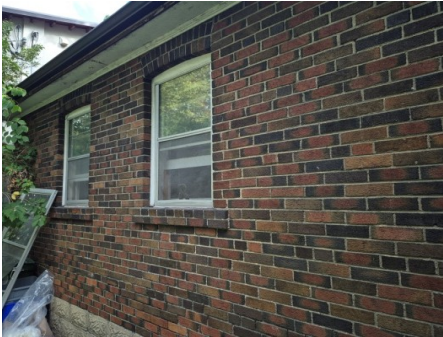
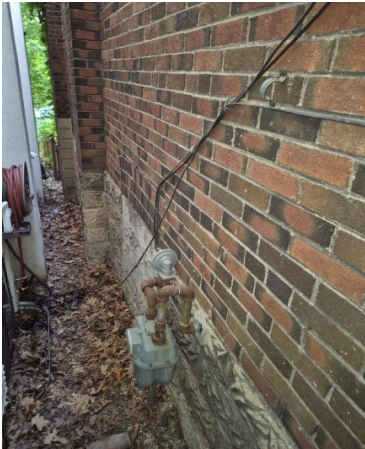
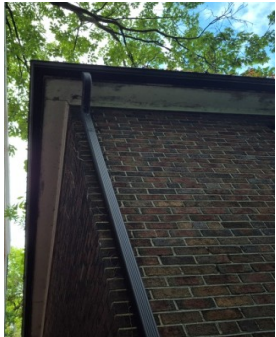
REFERENCE LINK		<a href="http://redbrickinspections.ca/docs/3_Exterior_Reference_Guide.pdf">http://redbrickinspections.ca/docs/3_Exterior_Reference_Guide.pdf</a>	
8 Grenadier Ravine Dr		<b>EXTERIOR</b>	
		Sept 19 2025	
<b>Description</b>			
Gutters & Downspouts: Aluminum:	Downspout(s) Discharge: Various Above Grade	Lot Topography: Away From House House Above Ravine	Walls & Wall Structures: Brick
<b>Limitations</b>			
Exterior Inspection from Ground Level Flora Against Building Restricted Inspection			
<b>Observations/Recommendations</b>			
<p><b>**Gutters/Downspouts:</b> requires maintenance/cleaning</p> <p>WALL SURFACES: overall in good repair  DOORS/WINDOWS: require general repairs and maintenance  or replace windows  Soffit &amp; Facia: require general repairs and maintenance, trim vines</p> <div>

<p>Note: Maintain Gutters &amp; Downspouts annually. Extend Downspouts at least 6-feet away from the house</p> <p><b>** Any or all these items may contribute to Basement Leakage. Please see Interior Page</b></p>

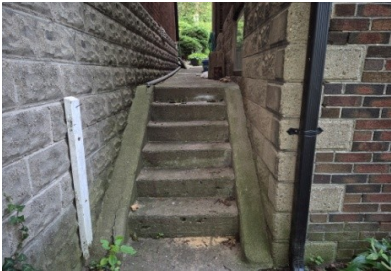
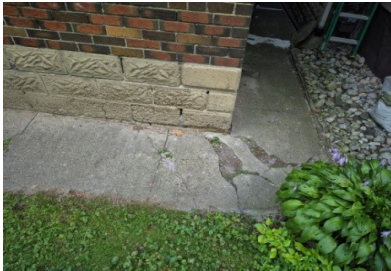
</div> <p>Step(s): provide hand railings for safety  <b>**Walk(s):</b> requires general repairs and maintenance</p> <div>

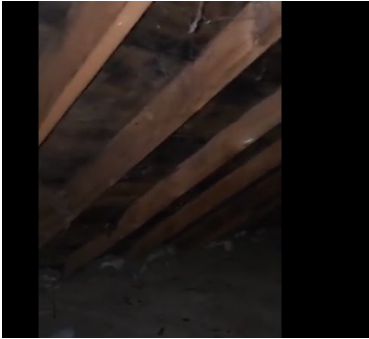
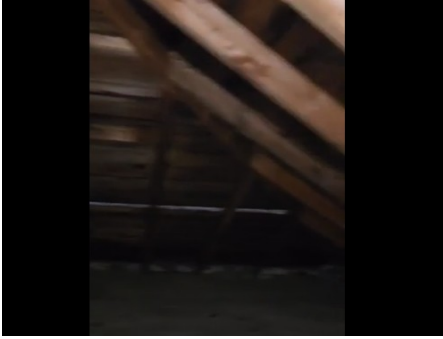
REFERENCE LINK		<a href="http://redbrickinspections.ca/docs/4_Structure_Reference_Guide.pdf">http://redbrickinspections.ca/docs/4_Structure_Reference_Guide.pdf</a>		
8 Grenadier Ravine Dr		<b>STRUCTURE</b>		Sept 19 2025
<b>Description</b>				
Configuration: Basement:	Foundations: Masonry Block	Floor : Wood Joists	Walls : Masonry (Double-Brick)	Roof/Ceiling Framing: Wood Rafters/Joists
<b>Limitations</b>				
Restricted Access to: Wall Space	Foundation Wall Not Visible: _____ % Roof Space Inspected From Access Hatch provided by client			
<b>Observations/Recommendations</b>				
<p>ROOF: overall in good repair</p> <div style="display: flex; justify-content: space-around; align-items: flex-start;">

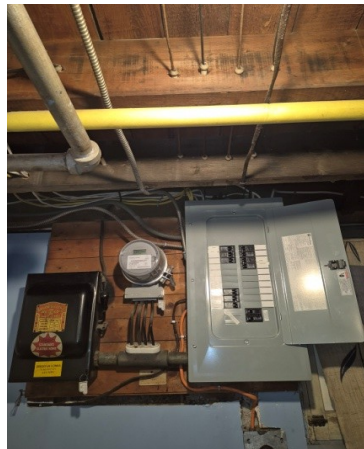
**Limitations****Main Disconnect Cover Not Removed****Observations/Recommendations**SERVICE ENTRANCE: **overall in good repair**Main Disconnect: **older though overall in good repair**SERVICE PANEL: **newer, overall in good repair**

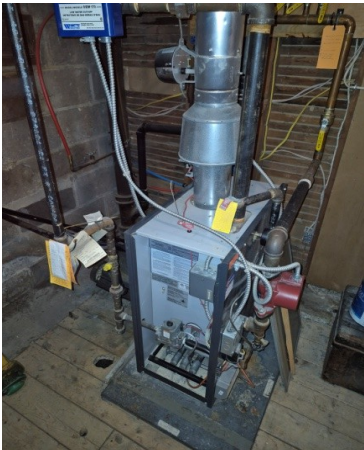
REFERENCE LINK		<a href="http://redbrickinspections.ca/docs/6_Heating_Reference_Guide.pdf">http://redbrickinspections.ca/docs/6_Heating_Reference_Guide.pdf</a>	
8 Grenadier Ravine Dr		HEATING	
		Sept 19 2025	
Description			
Description:	Efficiency:	Rated Input:	Approx. Age:
Hot Water Boiler:	Low	75 x1000BTU/hr	22 yrs.
			Life Expectancy:
			20+ yrs.
			Fuel Type:
			Gas
			Shut Off at:
			Meter-Exterior
Exhaust Vent Arrangement:			
None Found			
Limitations			Boiler Performance
Heat Loss Calculations Not Done			Pressure lbs/in2:
System Shut Off/Inoperative			10
Heat Exchanger- Inaccessible			
Observations/Recommendations			
Chimney Liner: not determined if present - install if required			
HOT WATER BOILER: service annually			
recommend obtaining replacement parts/servicing contract

Radiator(s): monitor/repair valves as required

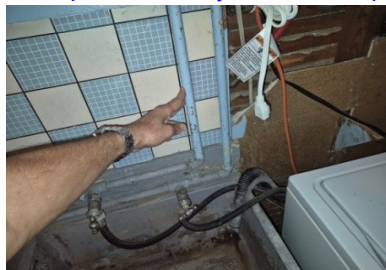
Galvanized Steel: [older, typically requires replacement for insurance purposes](#)  
[lower pressure likely due to older pipes](#)
