HOME INSPECTION REPORT

9 Humbercrest Point

Toronto

Inspection Date: [Sept 25 2025](#)

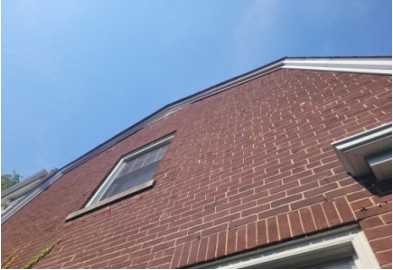
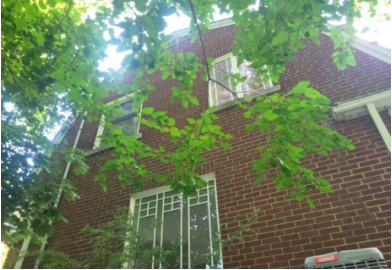
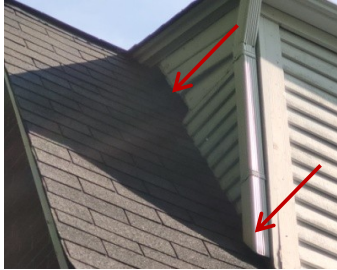
REFERENCE LINK		http://redbrickinspections.ca/docs/3_Exterior_Reference_Guide.pdf	
9 Humbercrest Point		<div>EXTERIOR</div> <div>Sept 25 2025</div>	
Description			
Gutters & Downspouts: Aluminum:	Downspout(s) Discharge: Below/Above Grade	Lot Topography: Flat Away From House House Above Ravine Towards House	Walls & Wall Structures: Brick Wood siding Masonry Retaining Wall Wood Retaining Wall
Limitations			
Exterior Inspection from Ground Level			
Observations/Recommendations			
<p> **Gutters/Downspouts: requires maintenance/cleaning ** Downspouts: extend to lower gutter at dormers **Window wells: provide window well covers </p> <p> WALL SURFACES: Brick: overall in good repair Wood siding: overall in good repair, minor repair required at dormer - north edge </p>			
<div>

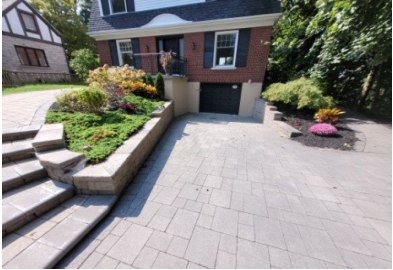
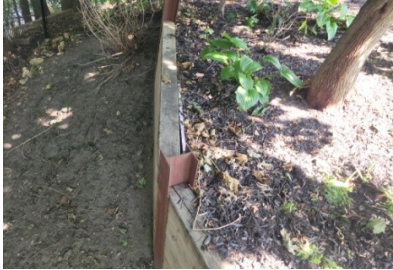
</div>			
<p>DOORS/WINDOWS: overall in good repair</p> <p> PORCH overall in good repair DECK overall in good repair </p> <p>ATTACHED GARAGE: overall in good repair</p> <p> **Driveway(s): monitor drain, service annually</p> <p>RETAINING WALL(s): overall in good repair</p>

</div>			
<p>Note: Maintain Gutters & Downspouts annually. Extend Downspouts at least 6-feet away from the house</p> <p>** Any or all these items may contribute to Basement Leakage. Please see Interior Page</p>

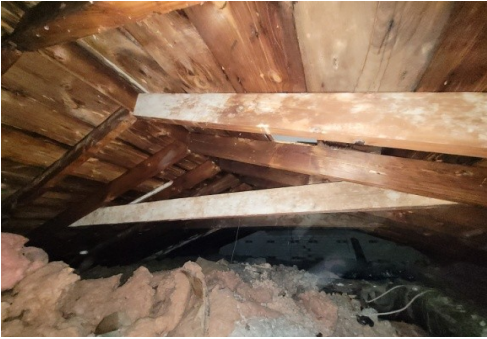
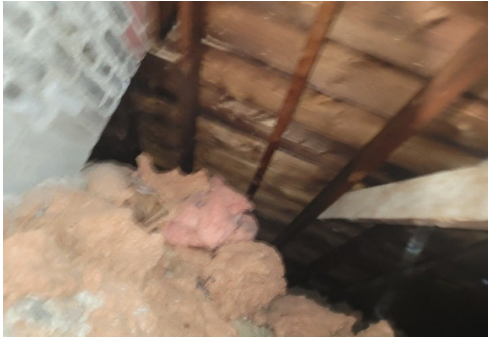
REFERENCE LINK		http://redbrickinspections.ca/docs/4_Structure_Reference_Guide.pdf		
9 Humbercrest Point		STRUCTURE		Sept 25 2025
Description				
Configuration: Basement:	Foundations: Masonry Block	Floor : Wood Joists	Walls : Masonry (Double-Brick) Wood Frame (Siding)	Roof/Ceiling Framing: Wood Rafters/Joists
Limitations				
Restricted Access to: Wall Space	Foundation Wall Not Visible: <u>90</u> % Roof Space Inspected From Access Hatch			
Observations/Recommendations				
<p>overall well built house</p> <p>ROOF: overall in good repair</p> <div style="display: flex; justify-content: space-around;">

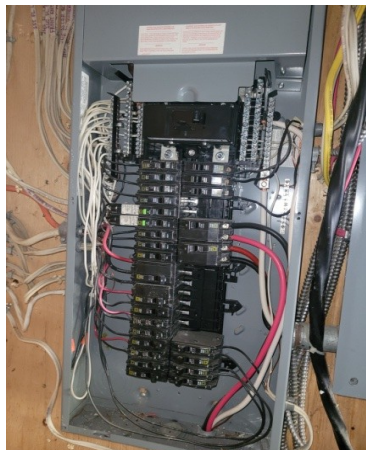
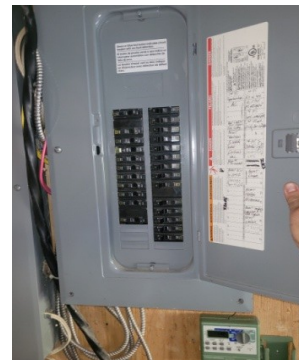
SERVICE ENTRANCE: overall in good repair
 SERVICE PANEL: overall in good repair
 Auxiliary Panel: overall in good repair

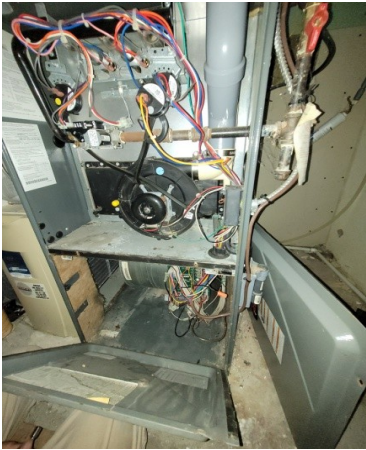
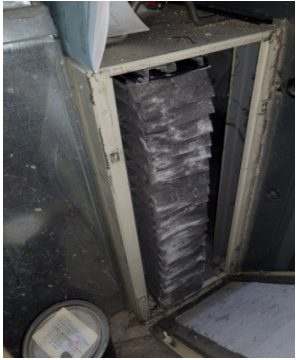
REFERENCE LINK	http://redbrickinspections.ca/docs/6_Heating_Reference_Guide.pdf							
9 Humbercrest Point		HEATING				Sept 25 2025		
Description								
Description:	Efficiency:	Rated Input:	Approx. Age:	Life Expectancy:	Fuel Type:	Shut Off at:		
Forced Air Furnace:	High	70 x1000BTU/hr	16 yrs.	20 yrs.	Gas	Meter-Exterior		
Exhaust Vent Arrangement:		Plastic Through-Wall Vent						
Limitations						Furnace Performance		
Heat Loss Calculations Not Done						Supply Temp F:		
Heat Exchanger- Inaccessible						Return Temp F:		
Observations/Recommendations								
<p>FORCED AIR FURNACE: service annually recommend obtaining replacement parts/servicing contract Filter: replace 1-per-6 months</p> <div>

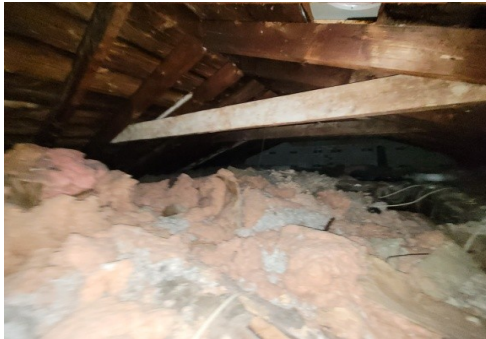
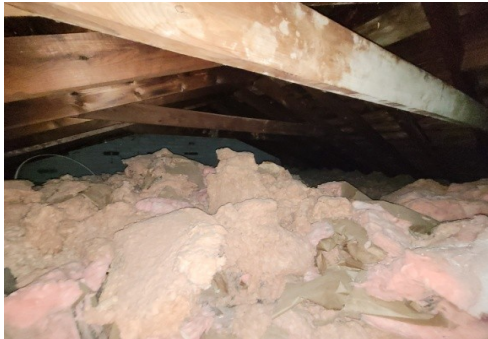
REFERENCE LINK		http://redbrickinspections.ca/docs/8_Insulation_Ventilation_Reference_Guide.pdf		
9 Humbercrest Point		INSULATION/VENTILATION		Sept 25 2025
Description				
Material:	Location	R-Value	Air/Vapour Barrier:	Venting:
Fiberglass:	Main Roof:	40	None Found	Roof Gable Heat Recovery Ventilator
Limitations				
Access Not Gained To Wall Space		Roof Space Inspected from Access Hatch		
Access Not Gained To Flat Roof				
Observations/Recommendations				
<p>ROOF SPACE: insulation and ventilation is adequate uneven distribution of insulation - improve/add insulation</p> <p>Roof Access Hatch: insulate and weather-strip access hatch to roof space</p> <div>

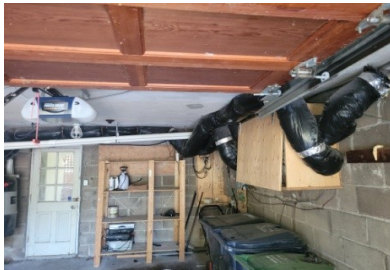
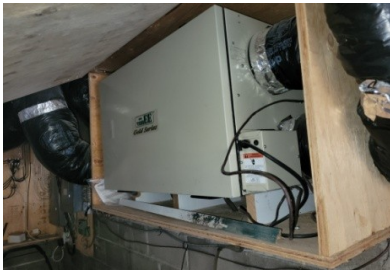
</div> <p>Heat Recover Ventilator: provides house with better air quality and efficiency see owners manual for proper use and maintenance</p> <p>Comments: unit is located in the Garage which is unsafe location if intent is to use garage for automobile/lawn mower or similar gas powered device- risk of CO entering house</p> <div>
