HOME INSPECTION REPORT

60 Hewitt Ave

Toronto

Inspection Date: [Sept 3 2025](#)

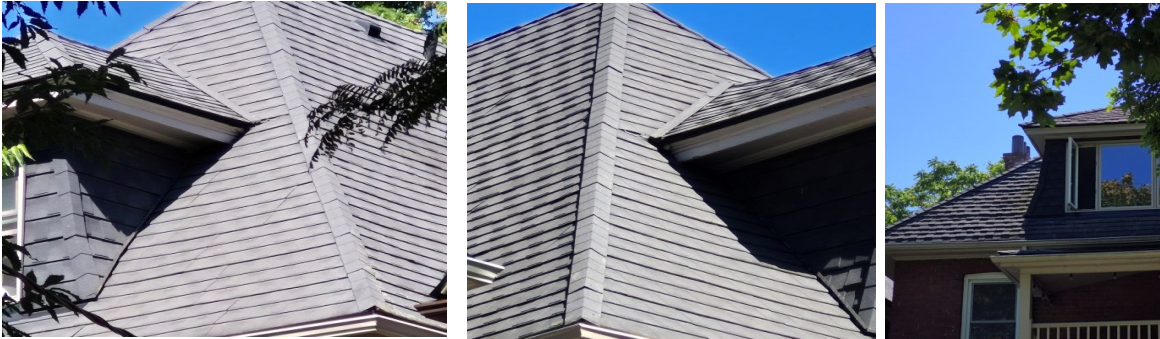
REFERENCE LINK		http://redbrickinspections.ca/docs/2_Roofing_Reference_Guide.pdf		
60 Hewitt Ave		ROOFING/Chimneys		Sept 3 2025
Description				
Roofing Material:	Location:	Leakage Probability:	Chimney(s) Type:	Location:
Metal:	Slope:	Low	Brick:	East
Metal:	Porch(s):	Low		
Limitations				
Roof Inspected By:	Access Limited By:	Chimney Access Limited By:		
Observations/Recommendations				
<p>Sloped Surface: metal shingles. overall surface in good repair, refer to warranty if available, service annually</p>

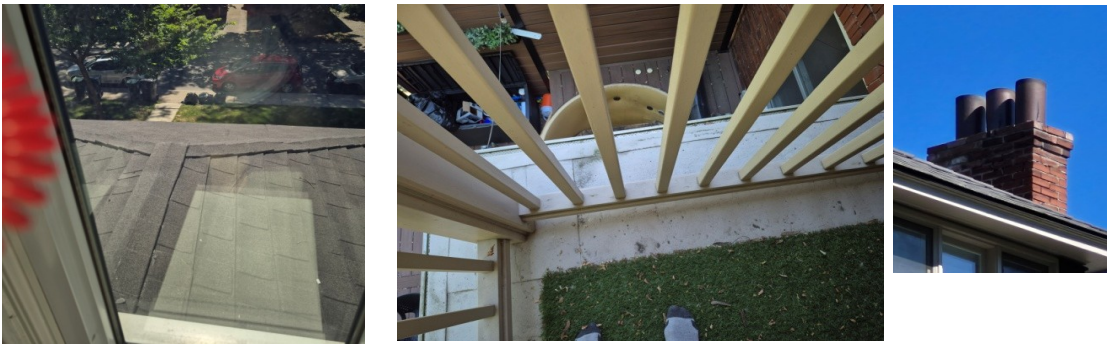
<p>Porch(s): rear flat: overall surface in good repair, seal seams around edge front: metal shingles. overall surface in good repair, refer to warranty if available, service annually</p>				
<p>Chimney(s): overall in good repair, install rain/screen cap to clay liner</p>

<p>Note: Recommend Annual Maintenance Contract for Roof Surface, Flashing Details and Chimney(s)</p>

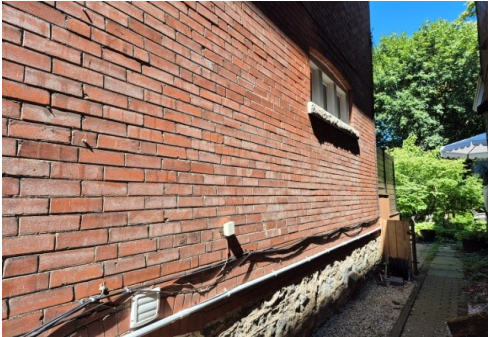
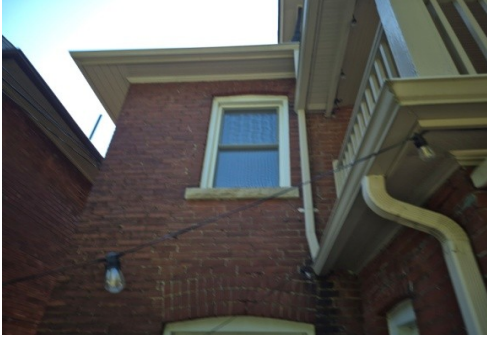
REFERENCE LINK		http://redbrickinspections.ca/docs/3_Exterior_Reference_Guide.pdf	
60 Hewitt Ave		<div>EXTERIOR</div> <div>Sept 3 2025</div>	
Description			
Gutters & Downspouts: Aluminum:	Downspout(s) Discharge: Various Above Grade	Lot Topography: Flat	Walls & Wall Structures: Brick
Limitations			
Exterior Inspection from Ground Level		Underside of Porch(es) Inspected from Access Door	
Restricted Access Under Deck(s)			
Observations/Recommendations			
<p>WALL SURFACES:</p> <p>Brick: overall in good repair</p> <p>DOORS/WINDOWS: overall in good repair</p> <div>

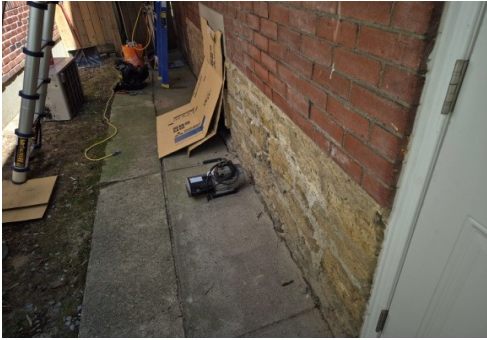
</div> <p>PORCH(es): overall in good repair, good quality materials</p> <p>**Walk(s): seal gaps along foundation wall</p> <div>

</div> <p>Note: Maintain Gutters & Downspouts annually. Extend Downspouts at least 6-feet away from the house</p> <p>** Any or all these items may contribute to Basement Leakage. Please see Interior Page</p>

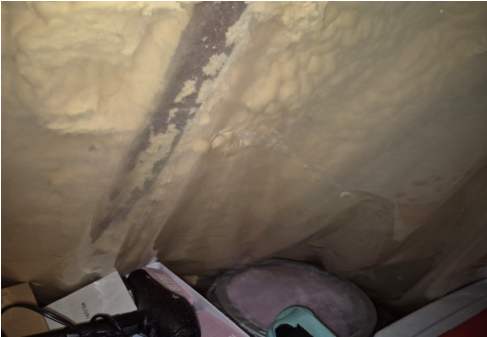
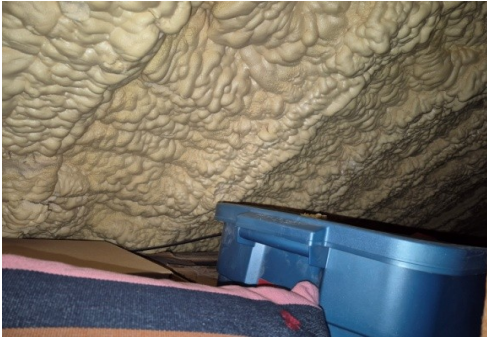
REFERENCE LINK		http://redbrickinspections.ca/docs/4_Structure_Reference_Guide.pdf		
60 Hewitt Ave		STRUCTURE		Sept 3 2025
Description				
Configuration: Basement:	Foundations: Stone	Floor : Wood Joists	Walls : Masonry (Double-Brick) Wood Frame (Siding)	Roof/Ceiling Framing: Wood Rafters/Joists
Limitations				
Restricted Access to: Roof Space	Foundation Wall Not Visible: <u>80</u> % Knee Wall Inspected From Access Hatch restricted access due to storage/insulation			
Observations/Recommendations				
<p>overall well built house</p> <p>ROOF: mostly not visible: knee walls in good repair where visible</p> <div style="display: flex; justify-content: space-around;">

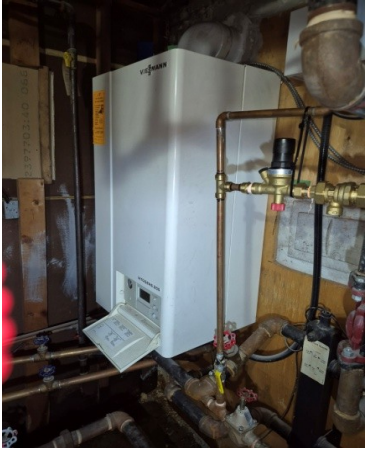
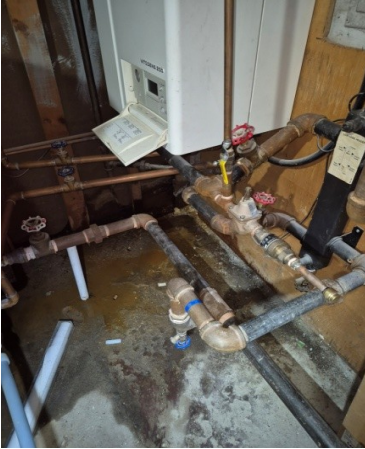
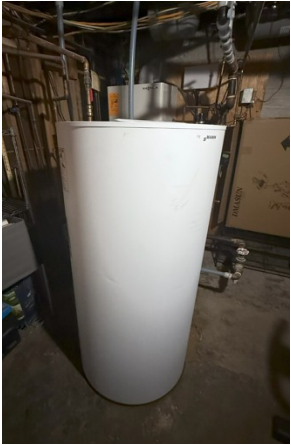
REFERENCE LINK	http://redbrickinspections.ca/docs/6_Heating_Reference_Guide.pdf					
60 Hewitt Ave		HEATING			Sept 3 2025	
Description						
Description:	Efficiency:	Rated Input:	Approx. Age:	Life Expectancy:	Fuel Type:	Shut Off at:
Hot Water Boiler:	High	125 x1000BTU/hr	15 yrs.	20 yrs.	Gas	Meter-Exterior
Combination System:						
Exhaust Vent Arrangement: Plastic Through-Wall Vent						
Limitations					Boiler Performance	
Heat Loss Calculations Not Done			Summer Test Procedure		Pressure lbs/in2: 35	
Heat Exchanger- Inaccessible						
Observations/Recommendations						
<p>COMBINATION SYSTEM: provides house heating and domestic hot water</p> <p>HOT WATER BOILER: service annually</p> <p>recommend obtaining replacement parts/servicing contract</p> <p>newly installed hot water tank</p>						
<div>

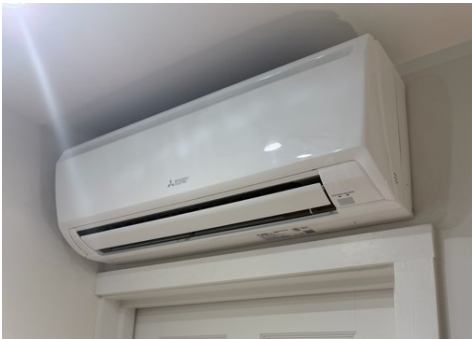
REFERENCE LINK	http://redbrickinspections.ca/docs/7_AC_Heat_Pump_Reference_Guide.pdf		
60 Hewitt Ave	COOLING/Heat Pumps		Sept 3 2025
Description			
Description:	Cooling Capacity:	Approx. Age:	Typical Life Expectancy:
Ductless (air-cooled)	12 x1,000 BTU/hr	new yrs. old	10 to 15 yrs.
Limitations			Cooling Performance
			Supply Temp F:
			Return Temp F:
Observations/Recommendations			
<p>DUCTLESS A/C: newly installed, service annually</p> <div>

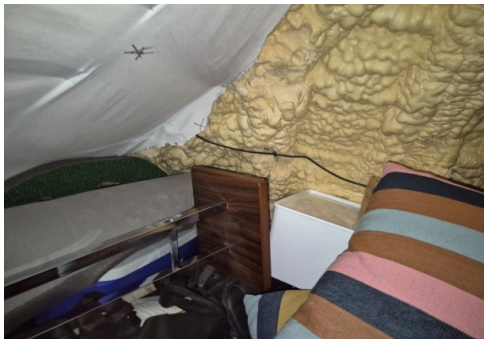
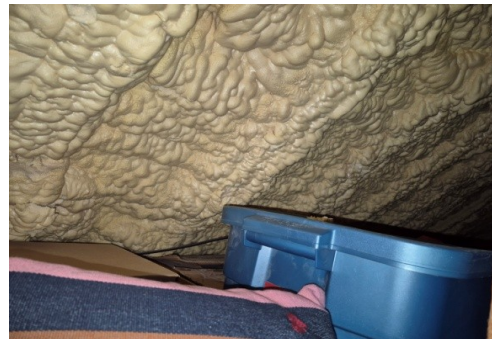
Knee Walls: insulation has been upgraded which will improve comfort and efficiency

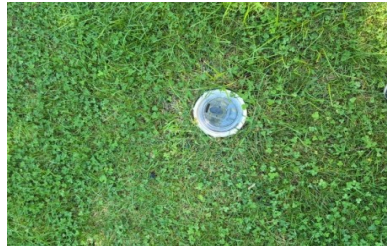
WASTE PIPING: [all piping examined was in good repair](#)
[new plastic cleanout pipe\(s\) at front yard indicates drain upgrades-](#)
[requires proper cap](#)
[recommend installing backflow valve to main waste drain](#)
