# HOME INSPECTION REPORT

171 St Johns Road

Toronto

Inspection Date: [Oct 4 2025](#)

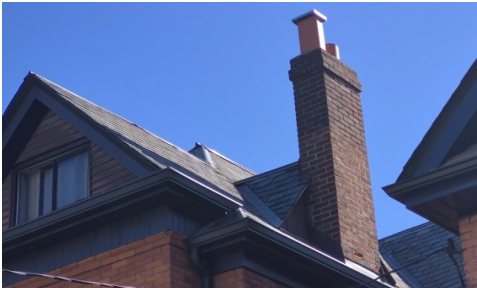
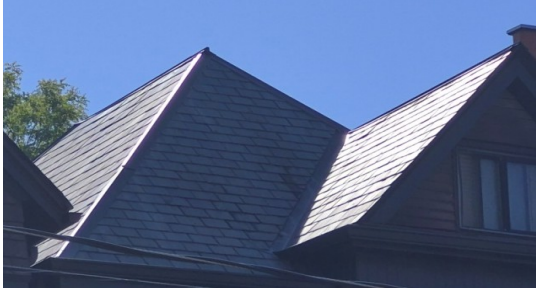
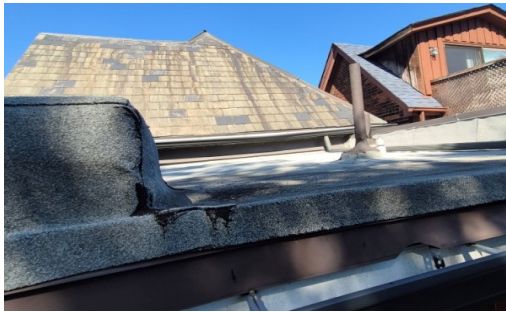
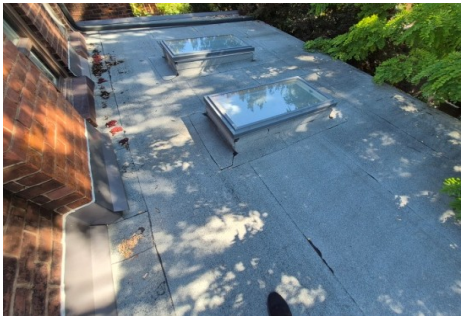
| <p>Tree Branches: <a href="#">retain arbourist for annual monitoring/trimming</a></p> <p>Sloped Surface: <a href="#">overall surface in good repair, slate shingles: ongoing monitoring and replace as required</a></p> <p>Chimney: <a href="#">overall in good repair</a></p> <div style="display: flex; justify-content: space-around;"> </div> <p>Flat Surface: <a href="#">overall surface in good repair</a></p> <p>Lower Flat: <a href="#">overall surface in good repair, skylights in good repair</a></p> <div style="display: flex; justify-content: space-around;"> </div> | | | | |

| <p><a href="#">Note: Recommend Annual Maintenance Contract for Roof Surface, Flashing Details and Chimney(s)</a></p> | | | | |

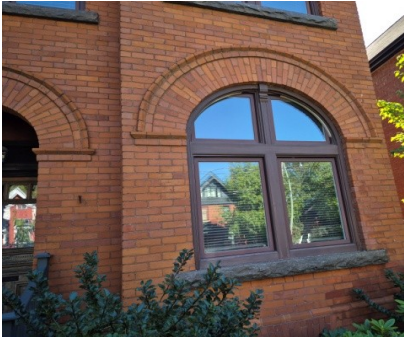
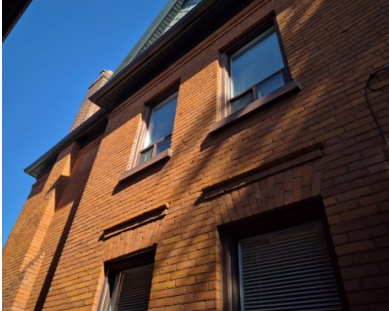
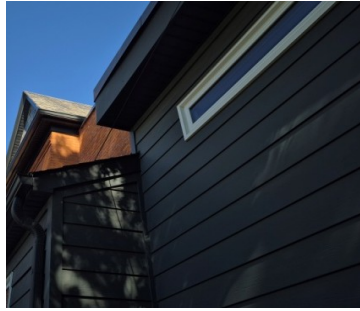
| <p>WALL SURFACES: overall in good repair</p> <p>DOORS/WINDOWS: overall in good repair</p> | | | |
| <p>**BASEMENT WALKOUT: typically should have drain at bottom landing, can be installed if renovating basement</p> | | | |
| <p>DETACHED GARAGE: overall well built</p> | | | |

| <p>Note: Maintain Gutters &amp; Downspouts annually. Extend Downspouts at least 6-feet away from the house</p> <p>** Any or all these items may contribute to <b>Basement Leakage</b>. Please see Interior Page</p> | | | |

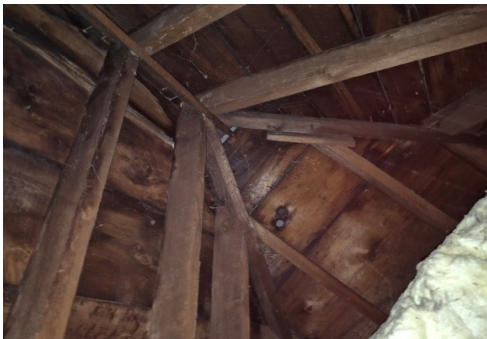
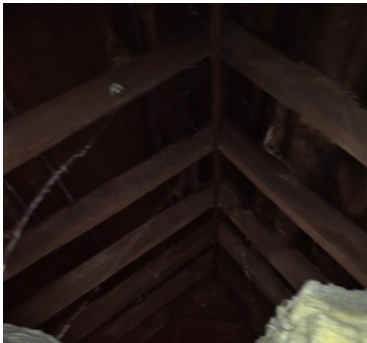
| <p>overall well built house</p> <p>ROOF: overall in good repair</p> <div></div> | | | | |

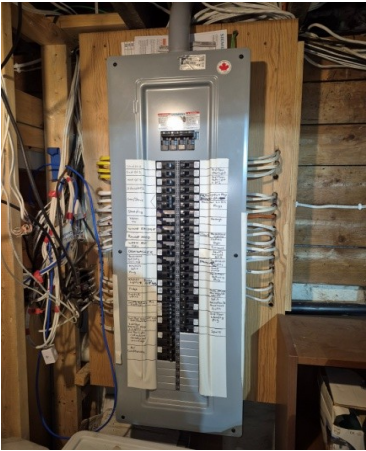
| <div>SERVICE ENTRANCE: overall in good repair</div> <div>SERVICE PANEL: overall in good repair</div> <div></div> <div>BRANCH WIRING: random sampling determined the wiring has been upgraded throughout</div> | | | |

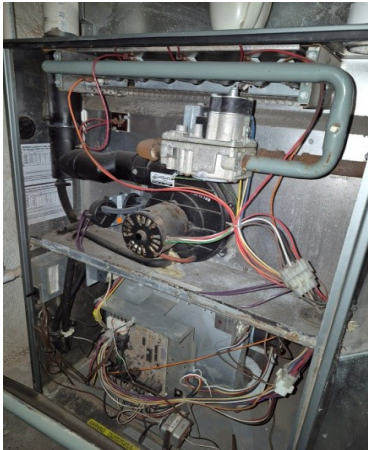
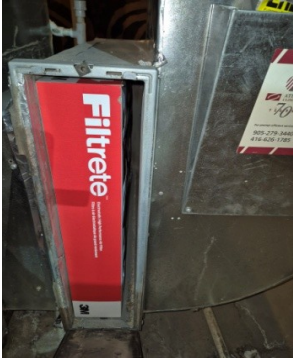
| <p>FORCED AIR FURNACE: <a href="#">service annually</a><br/><a href="#">continue servicing until replacement becomes necessary</a><br/><a href="#">recommend obtaining replacement parts/servicing contract</a></p> <p>Filter: <a href="#">replace 1-per-6 to 12 months</a></p> <div></div> | | | | | |

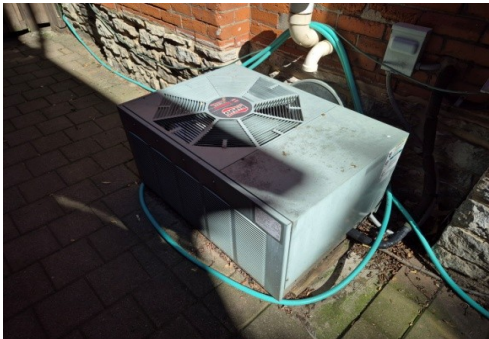
| <p>AIR CONDITIONER: old unit, continue servicing until replacement becomes necessary</p> <div></div> <p>Comments: 3rd level typically more difficult to cool- may require supplemental unit</p> | | | |

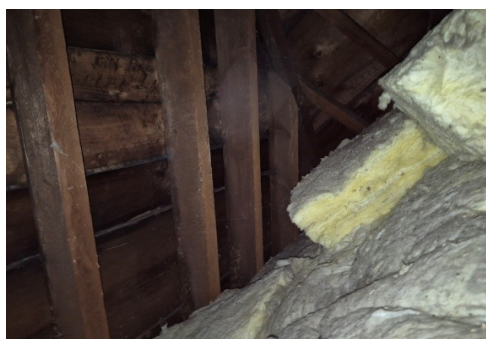
ROOF SPACE: insulation in roof is adequate  
uneven distribution of insulation - improve/add insulation

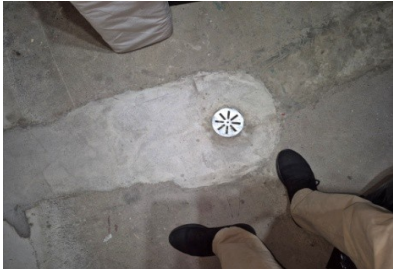
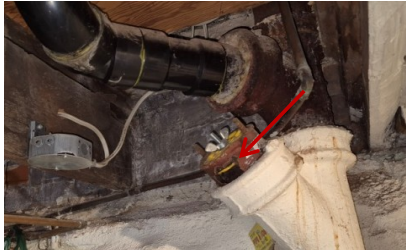
| <p>SUPPLY PIPING: all piping examined was in good repair</p> <p>WASTE PIPING: all piping examined was in good repair<br/> basement floor drain connected to sump pump - this discharges into main drain<br/> Stack: open connection can cause odours - seal</p> <div> </div> <p>Washroom(s): overall in good repair<br/> shower head rusting</p> <p>Kitchen(s) overall in good repair</p> | | |
