HOME INSPECTION REPORT

85 Watson Ave
Toronto

Prepared by: Bob Papadopoulos P.Eng., RHI *

Inspection Date: [Sept 26 2025](#)

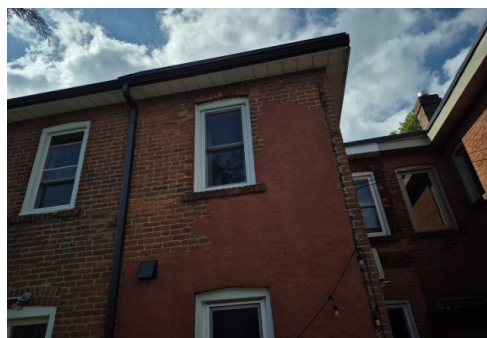
Brick: overall in good repair

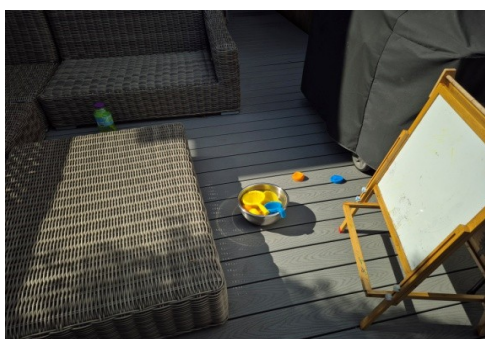
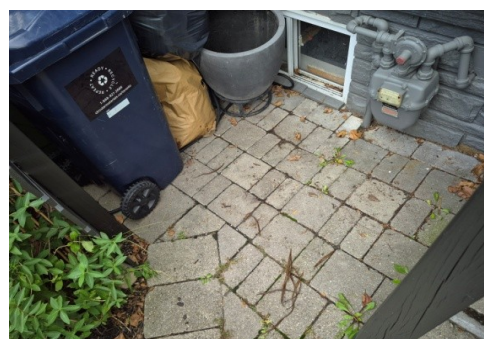
**Walk(s): front: monitor for water pooling: re-grade away from house if required

Note: Maintain Gutters & Downspouts annually. Extend Downspouts at least 6-feet away from the house

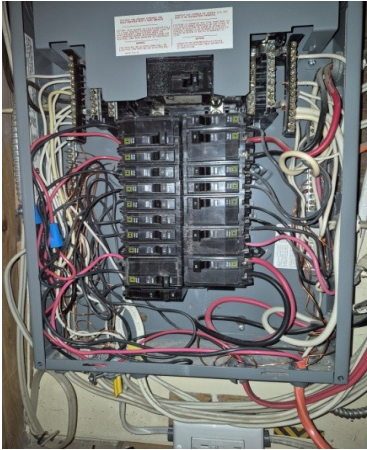
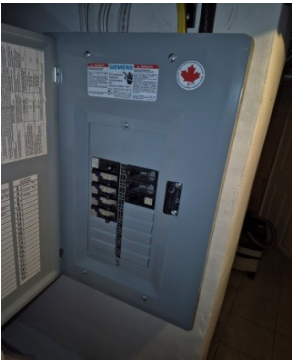
| SERVICE PANEL: overall in good repair | | | |
| Auxiliary Panel: overall in good repair | | | |

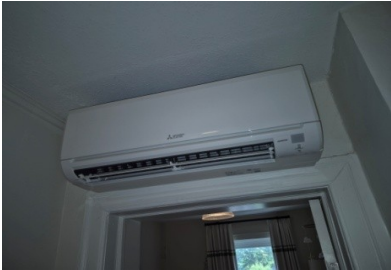
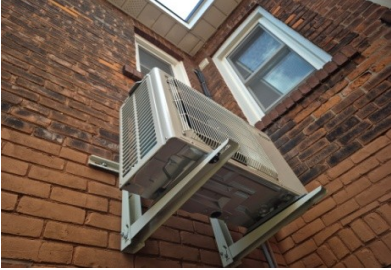
| DUCTLESS A/C: service annually | | | |
