HOME INSPECTION REPORT

3212 Dundas St W

Inspection Date: [Oct 15 2025](#)

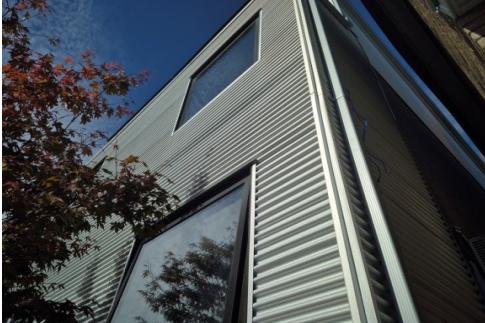
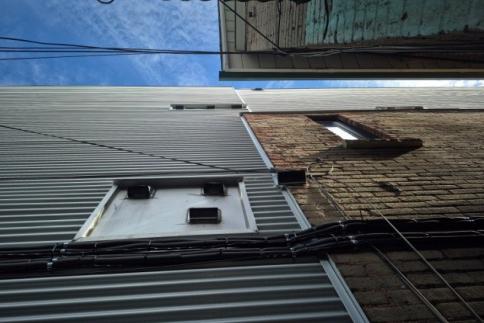
REFERENCE LINK	http://redbrickinspections.ca/docs/3_Exterior_Reference_Guide.pdf		
3212 Dundas St W	EXTERIOR		Oct 15 2025
Description			
Gutters & Downspouts: Aluminum:	Downspout(s) Discharge: Various Above Grade	Lot Topography: Flat	Walls & Wall Structures: Brick Metal Siding
Limitations			
Exterior Inspection from Ground Level			
Observations/Recommendations			
<p>**Gutters/Downspouts: newer installations in good condition</p> <p>WALL SURFACES: newer installations in good condition</p> <p>DOORS/WINDOWS: newer installations in good condition</p>

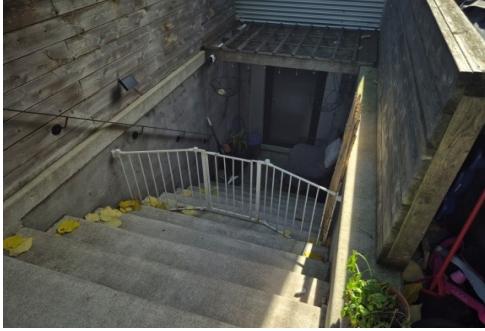
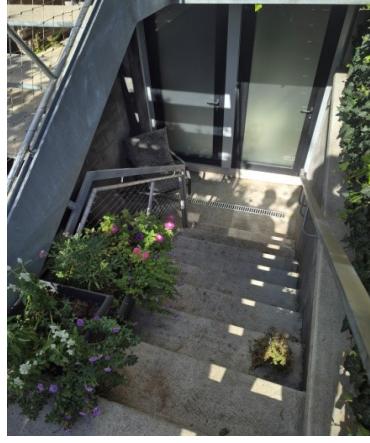
<p>PORCH newer installations in good condition</p>	<p>**BASEMENT WALKOUT: newer installations in good condition</p>

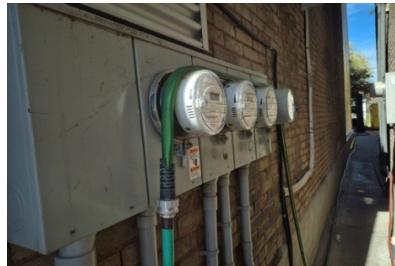
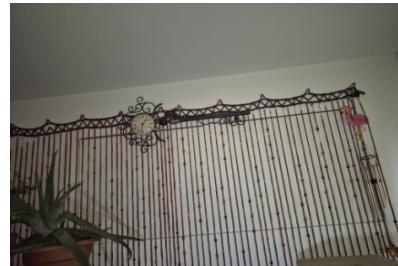
SERVICE ENTRANCE: **4** meter base (4 unit house), newer installations
 interior - could not access - cabinet restricted access

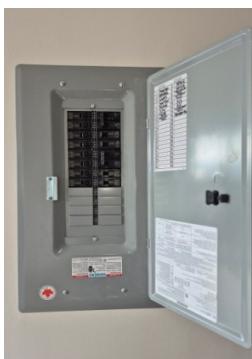
BRANCH WIRING: random sampling determined the wiring has been upgraded throughout
 SERVICE PANEL: **4** units: each unit has separate panel and meter
 1 common area panel in basement (connected to 2nd level unit meter)

Note 2: Please ensure accurate labelling on panels.

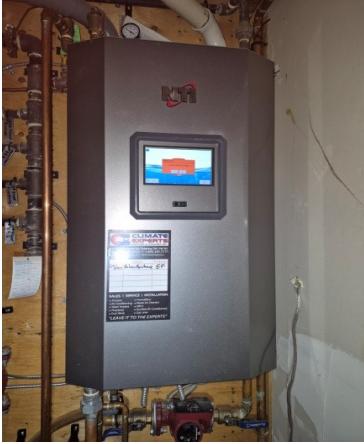
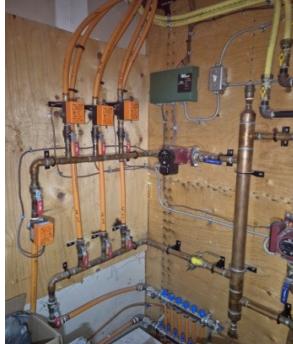
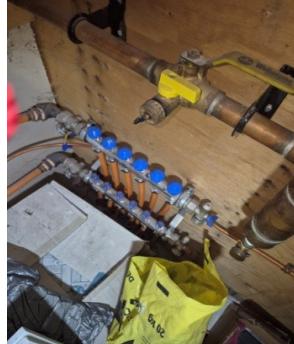
REFERENCE LINK	http://redbrickinspections.ca/docs/6_Heating_Reference_Guide.pdf	
3212 Dundas St W	HEATING	Oct 15 2025
Description		
Description: Hot Water Boiler: Efficiency: High Rated Input: 108 x1000BTU/hr Approx. Age: 9 yrs. Life Expectancy: 15 to 20 yrs. Fuel Type: Gas Shut Off at: Meter-Exterior		
Combination System:		
Hot Water Radiant Heat:		
Exhaust Vent Arrangement: Plastic Through-Wall Vent		
Limitations		
Heat Loss Calculations Not Done		Pressure lbs/in ² : 18
Heat Exchanger- Inaccessible		
Observations/Recommendations		
<p>THERMOSTAT: multi thermostats (4) for zone control provides better comfort/efficiency (hot water radiant floor)</p> <p>HOT WATER BOILER: requires servicing provides house heating and domestic hot water</p> <p>Hot Water Radiant Heat: each unit (4) provided with floor heating</p> <p>Piping: all piping examined was in good repair</p>

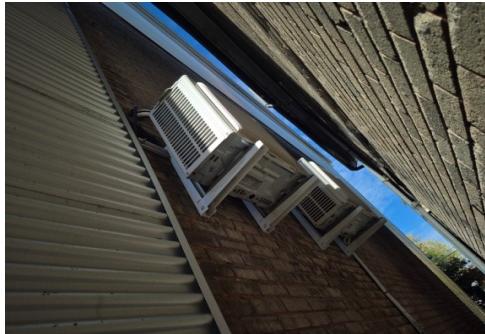
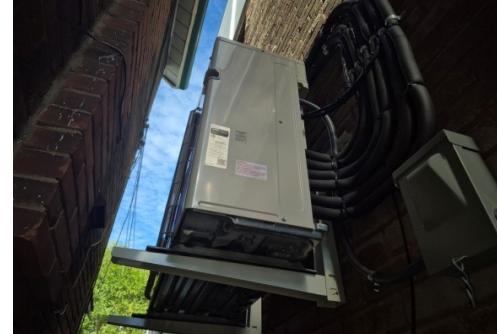
HEAT PUMP: 4 units (each unit multi zoned wall mounted)
unit provides cooling and supplemental heating

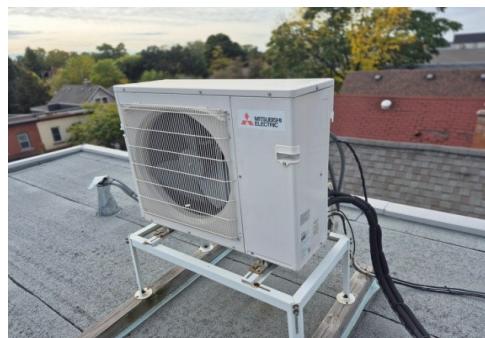
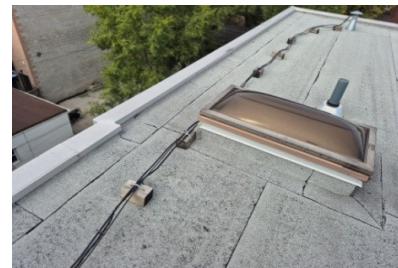
HEAT PUMP: roof unit (for 3rd level)

Refrigerant Lines: one set of refrigerant lines missing insulation - minor repair

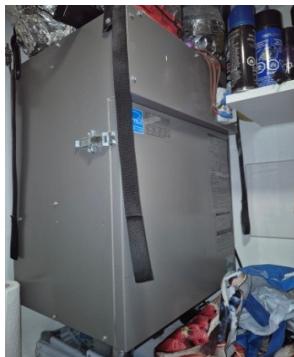
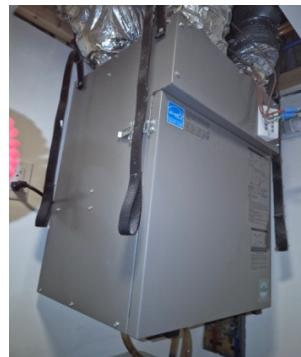
Heat Recover Ventilator: 3 units: basement, main level and 2nd level
provides house with better air quality and efficiency
see owners manual for proper use and maintenance
