HOME INSPECTION REPORT

33 Humber Trail

Toronto

Inspection Date: [Feb 4 2026](#)

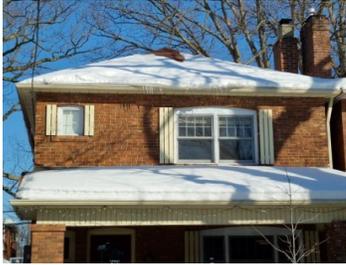
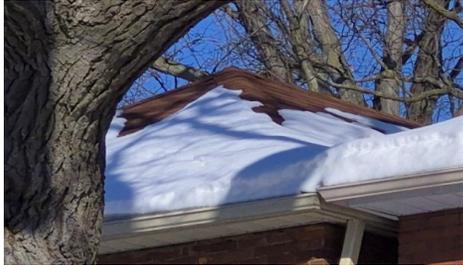
</div> <p>Garage: reported to be newly installed asphalt shingles typical life expectancy 20-yrs</p> <div style="text-align: center;">

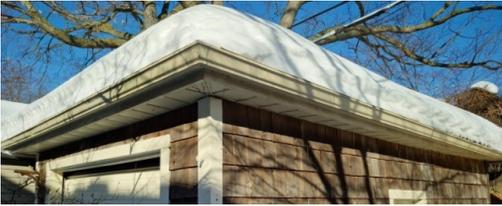
</div> <p>Chimney: overall in good repair</p>

<p>Note: Recommend Annual Maintenance Contract for Roof Surface, Flashing Details and Chimney(s)</p>

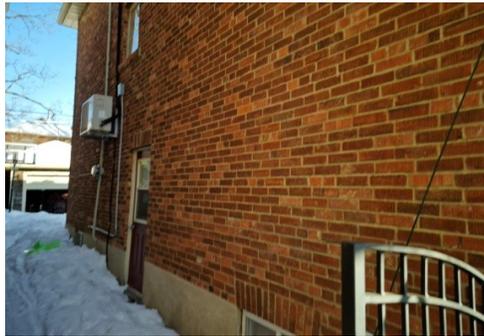
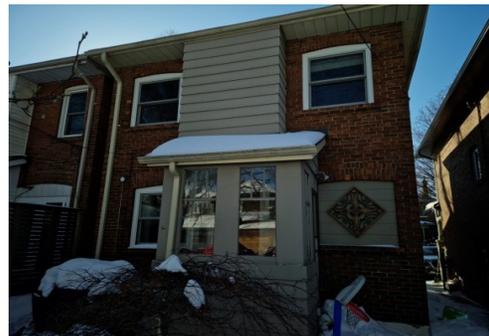
WALL SURFACES: overall in good repair
DOORS/WINDOWS: overall in good repair

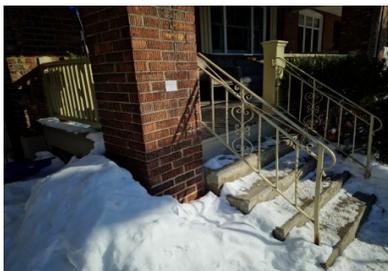
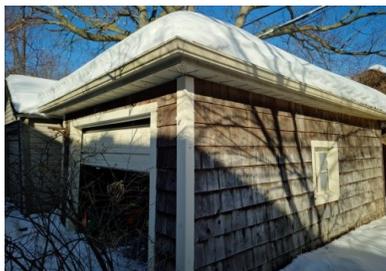
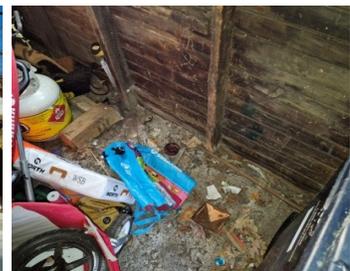
PORCH requires general maintenance
DETACHED GARAGE: older, typically ongoing repairs
bottom perimeter prone to rot - repair as required, budget to repair perimeter

Note: Maintain Gutters & Downspouts annually. Extend Downspouts at least 6-feet away from the house

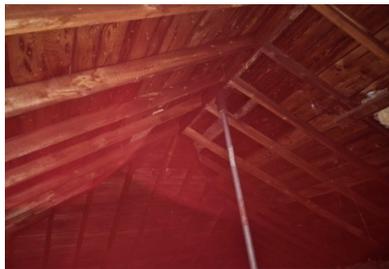
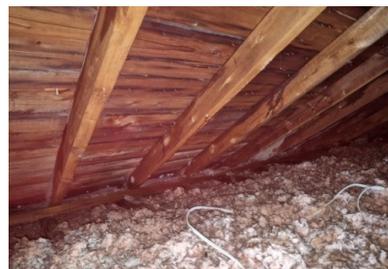
ROOF: overall in good repair
underside staining/frost typical for older house during colder months
see Ventilation page

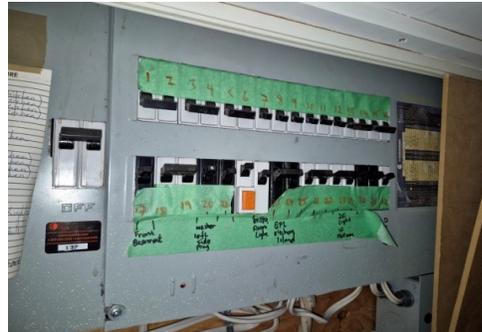
SERVICE ENTRANCE: overall in good repair, older mast
 SERVICE PANEL: overall in good repair
 panel obstructed by cabinet - cover not removed

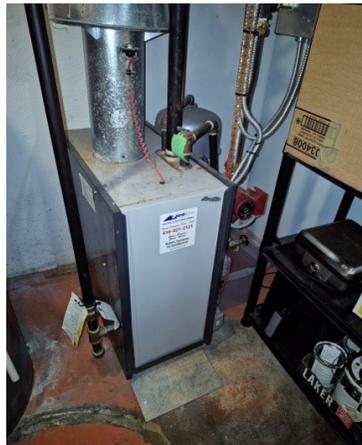
HOT WATER BOILER: continue servicing until replacement becomes necessary
 annual CO test mandatory for this type of unit
 recommend obtaining replacement parts/servicing contract
 presently back flow valve dripping - repair/replace - minor/typical
 safety valve tube rusting: prior leak- replace if required - minor/typical

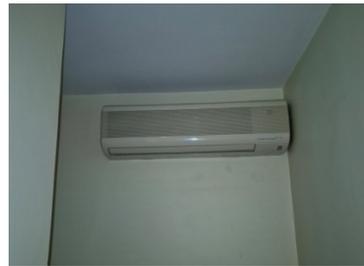
DUCTLESS A/C: not tested: should be serviced before using
old unit, continue servicing until replacement becomes necessary

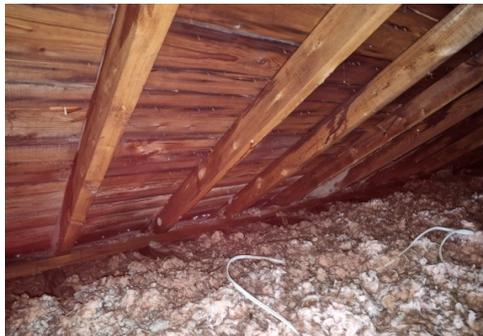
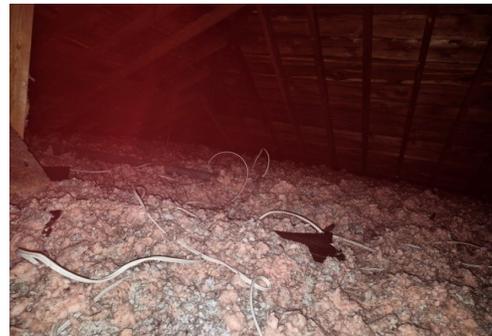
ROOF SPACE: recommend upgrading insulation to improve comfort and efficiency
 recommend installing vapour barrier
 recommend improving ventilation with soffit vents
 (ideally wires should be properly secured)

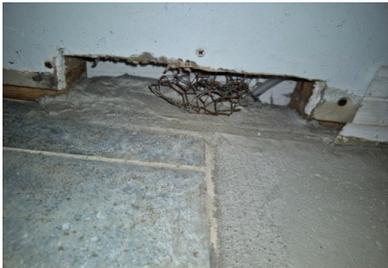
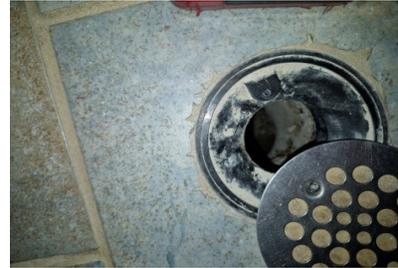
Basement Floor Drain: not visible: near boiler room door under partition wall- ideally should be open/visible

Piping: some drain upgrades noted under basement floor
main drain: recommend video-scan, risk of tree roots
recommend installing backflow valve to main waste drain

Comments: drain at rear of basement: this appears to be for drain access/servicing and should be sealed properly to avoid odours
