Your Inspection Report

59 Parkway Ave
Toronto, ON M6R 1T6

INSPECTION DATE:
Tuesday, February 17, 2026

RE: Report No. 96090, v.2
59 Parkway Ave
Toronto, ON
M6R 1T6

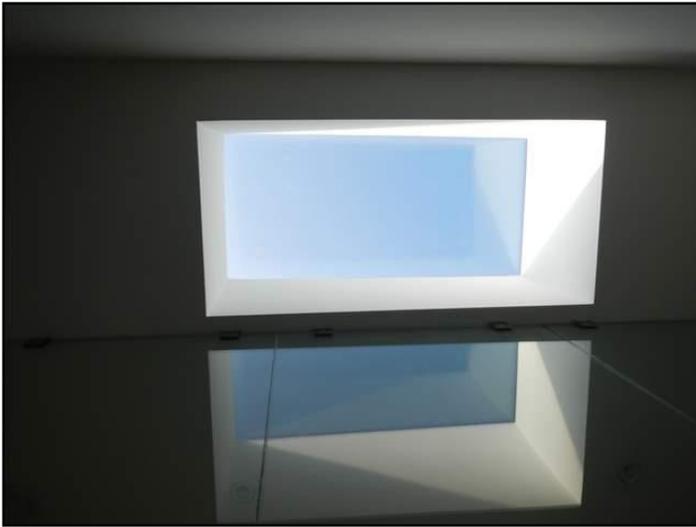
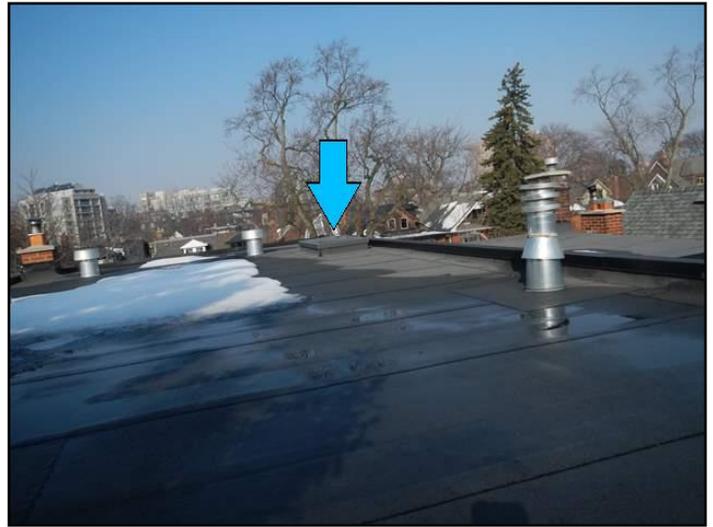
Condition: • Skylights are vulnerable areas

No evidence of water damage was noted during the inspection.

Skylights are vulnerable areas

Task: Monitor

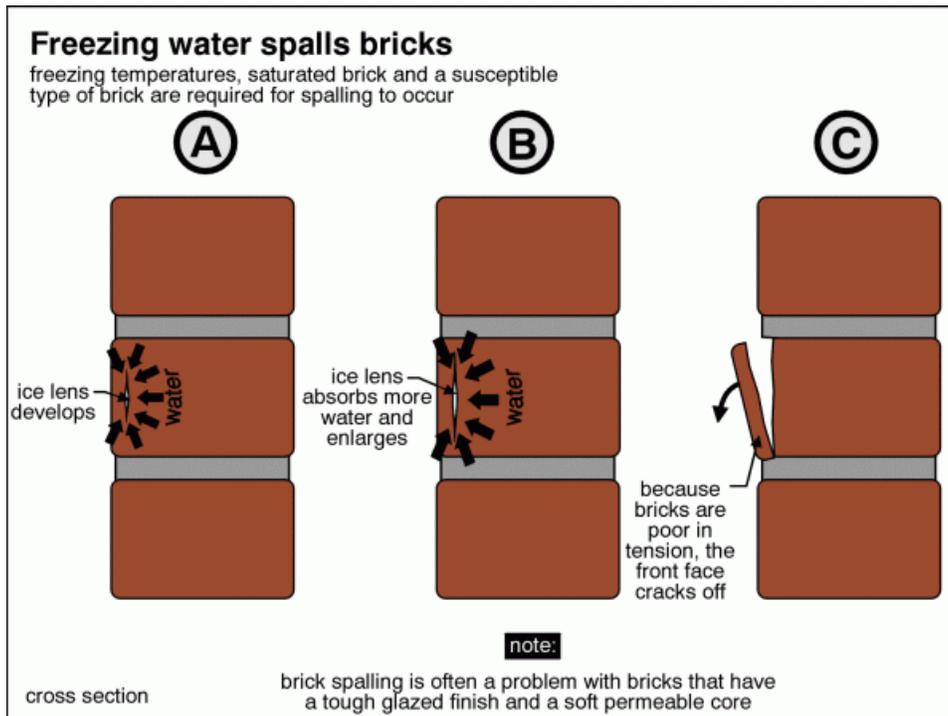
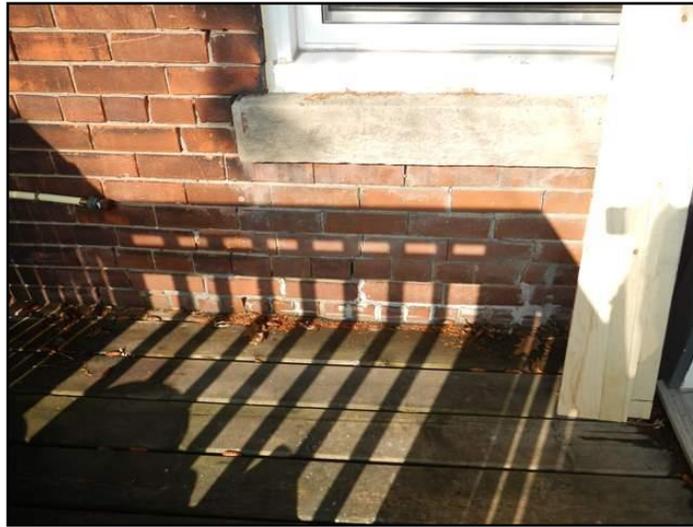
Condition: • [Spalling](#)

This is typical of most older homes.

Spalling

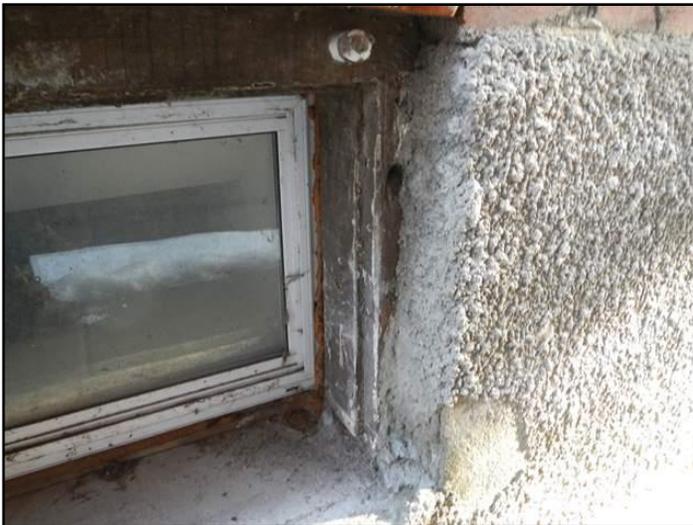
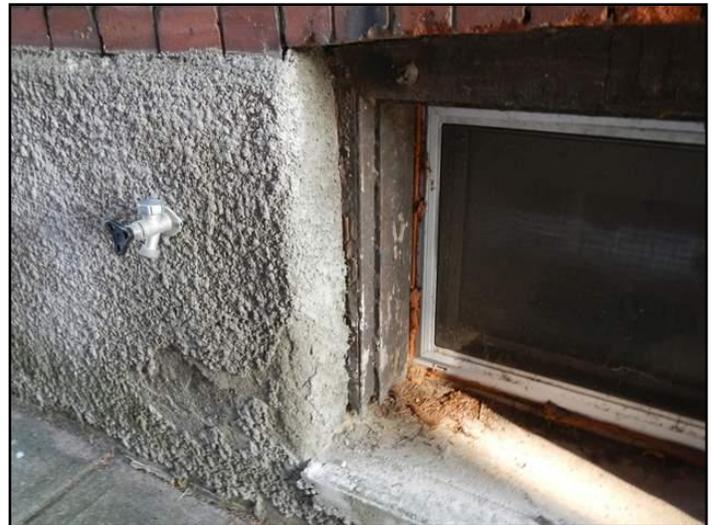
Condition: • Paint and caulking - deteriorated / missing

Paint and caulking - deteriorated / missing

Task: Improve

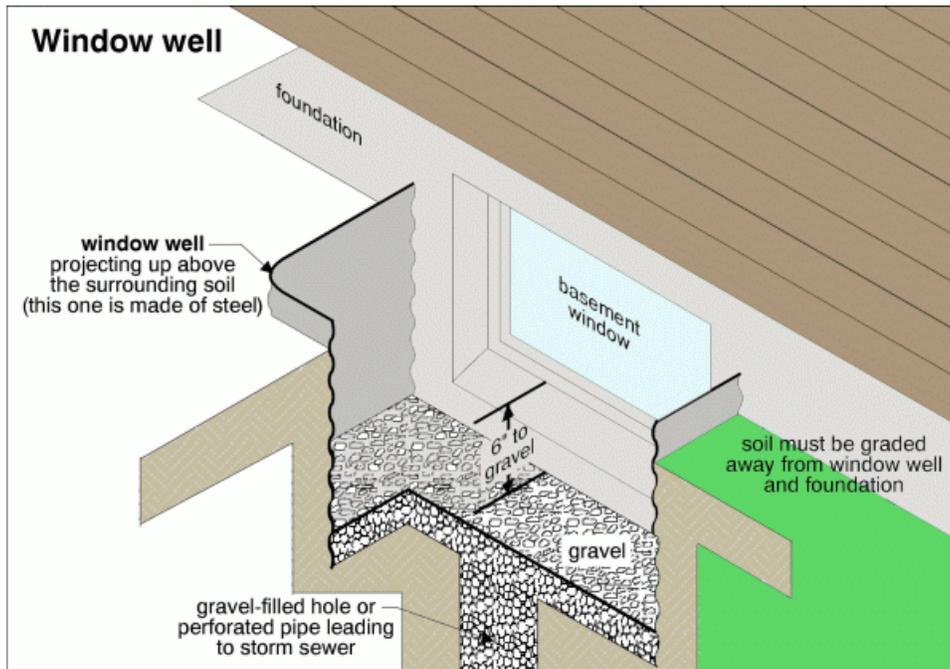
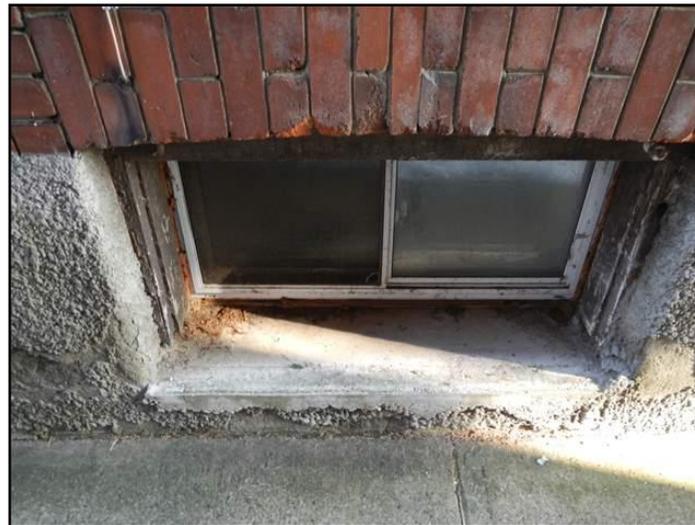
Condition: • Missing

Missing

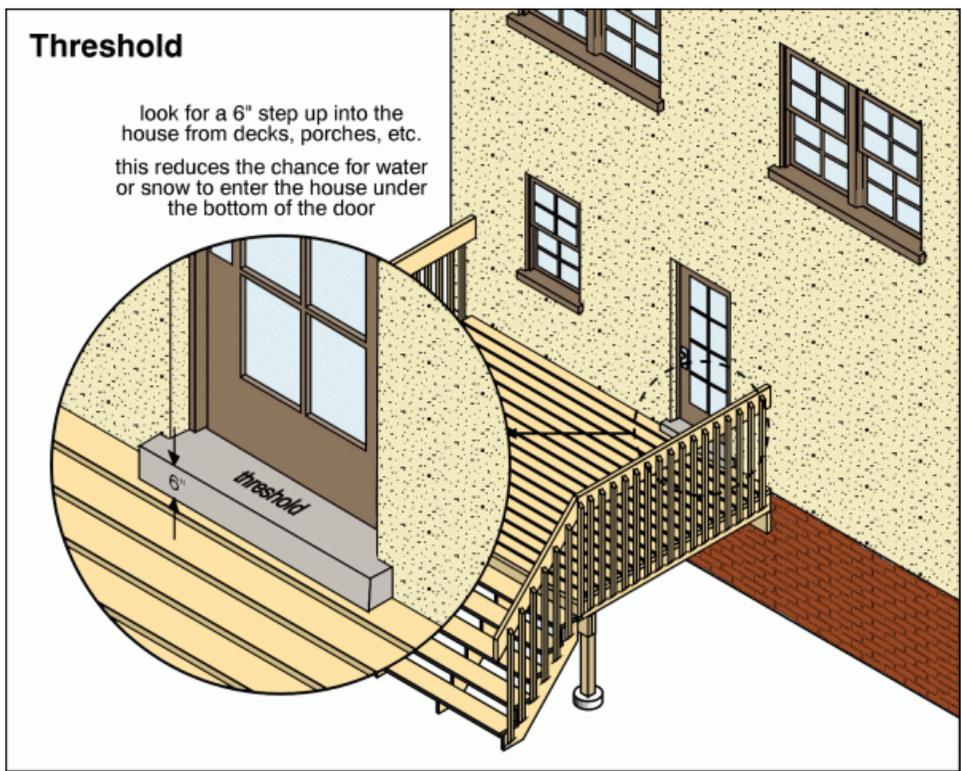
Condition: • Threshold - ineffective

Threshold - ineffective

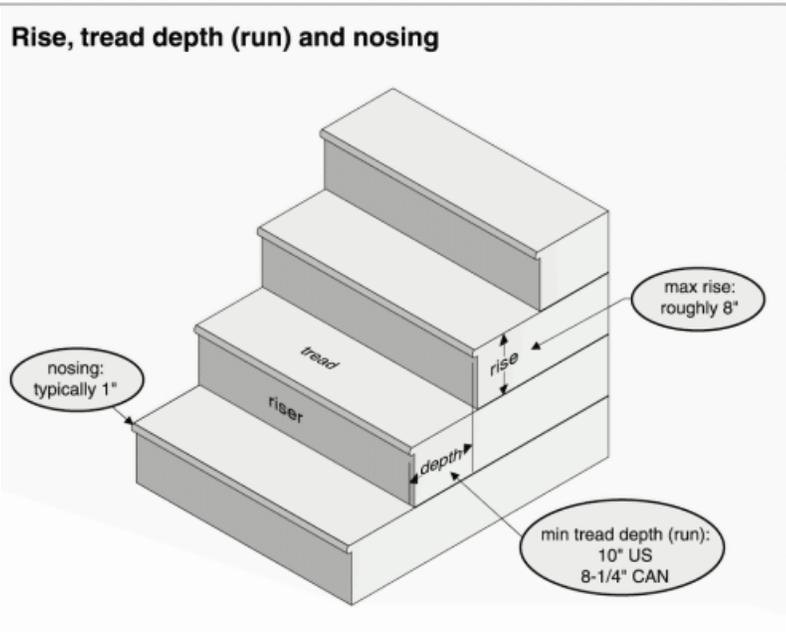
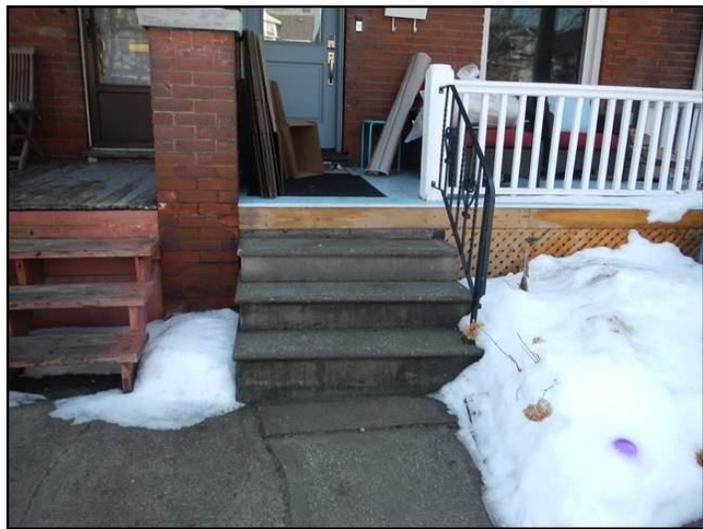
Condition: • [Stair rise too big or not uniform](#)

Stair rise too big or not uniform

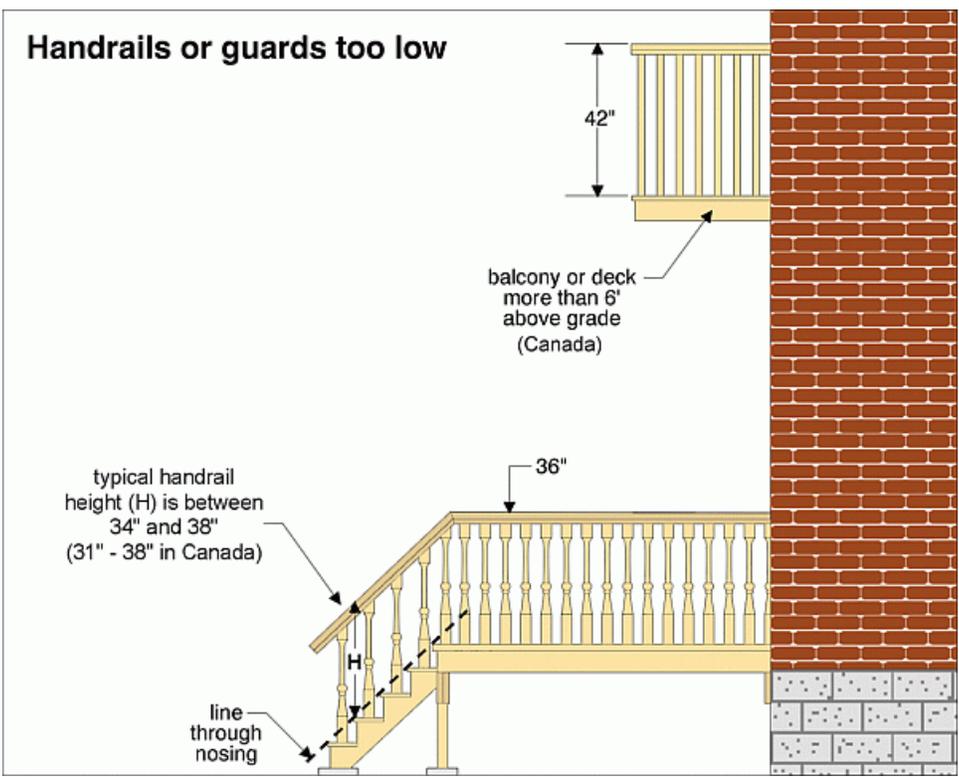
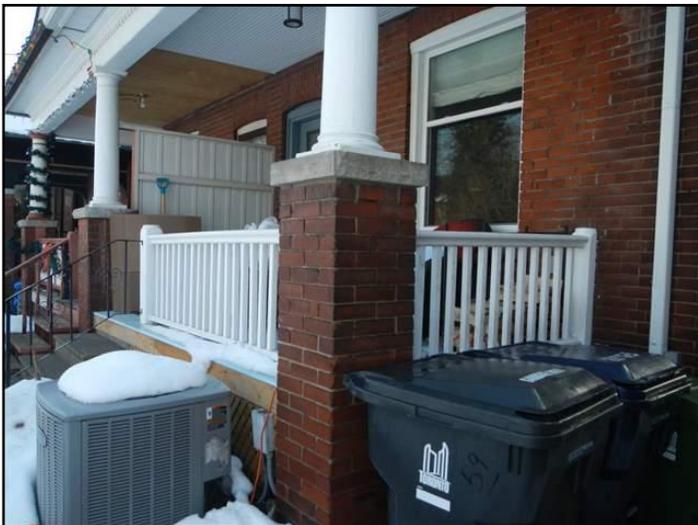
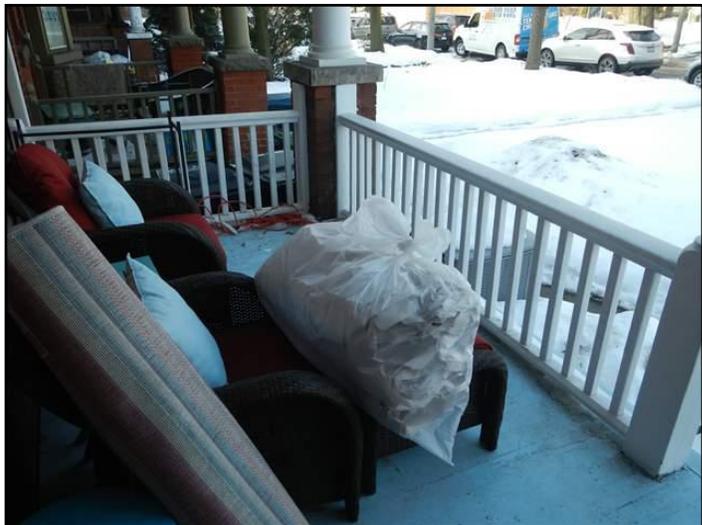
Condition: • [Too low](#)

Too low

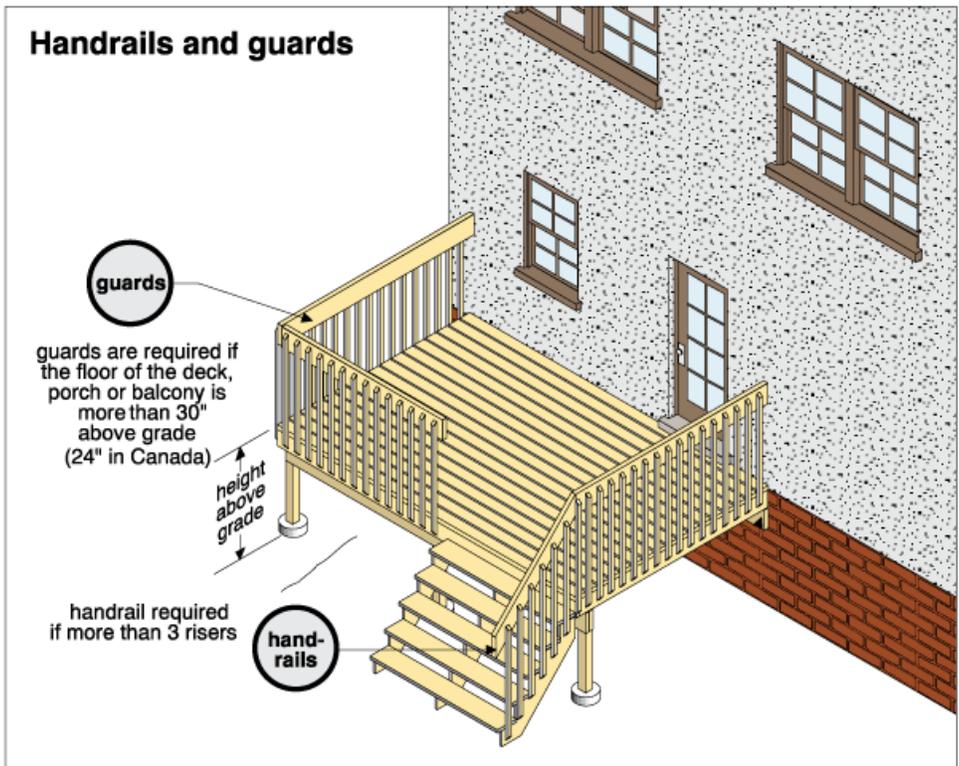
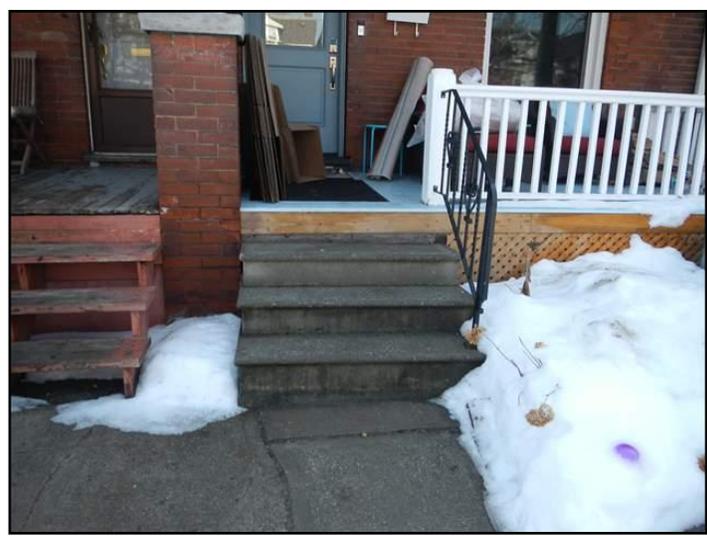
Condition: • [Missing](#)

Missing on one side.

Missing

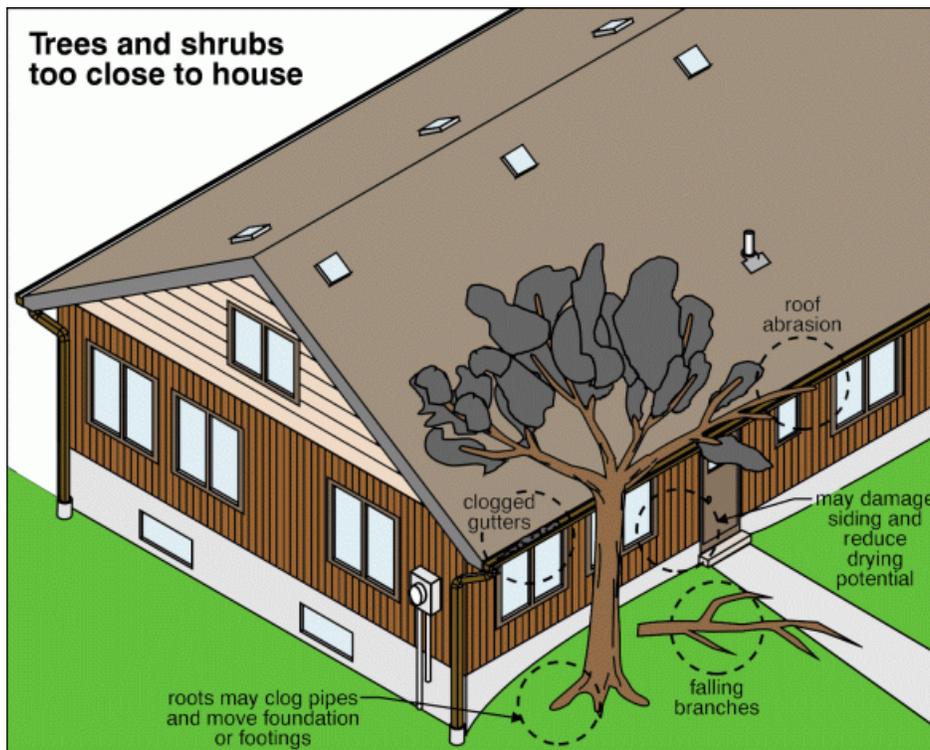
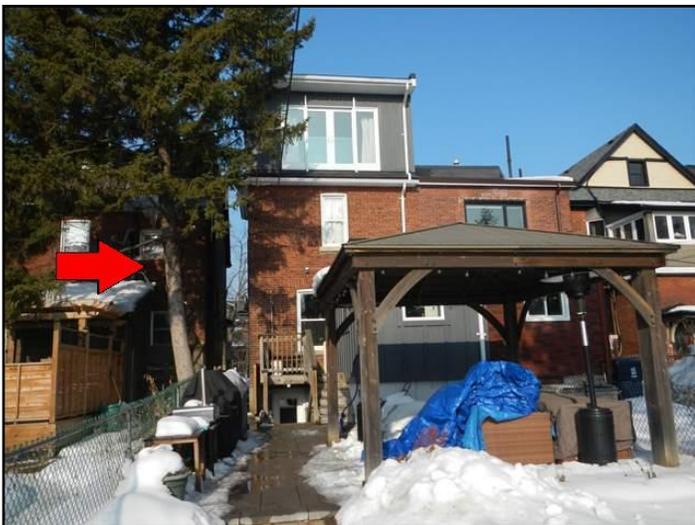
Condition: • Shrubs/Trees - too close to building (trimming needed)

Tree - too close

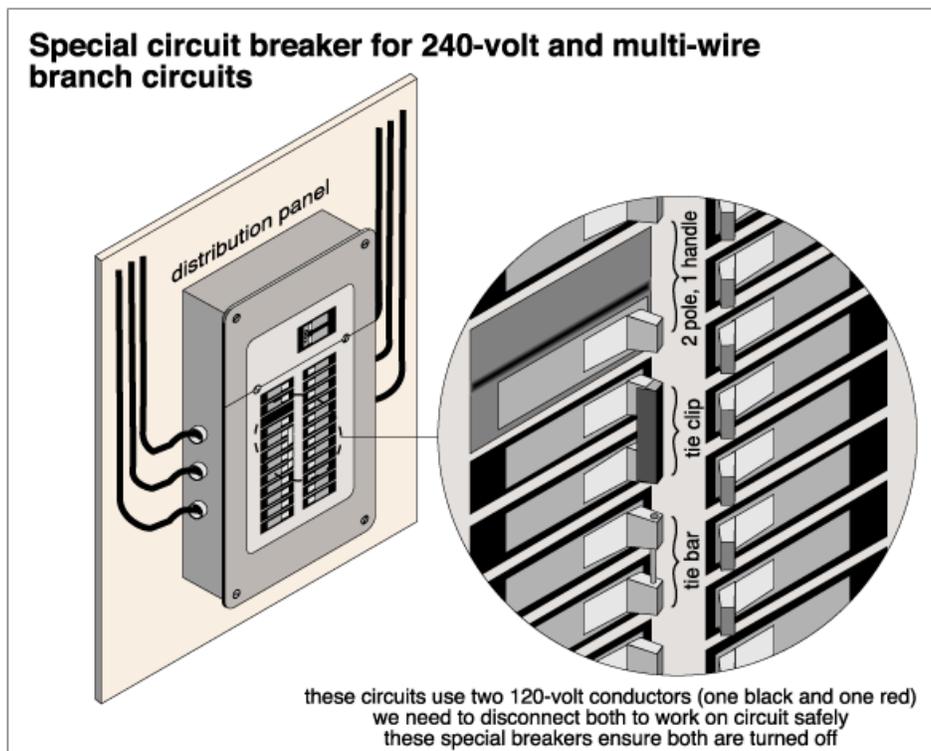
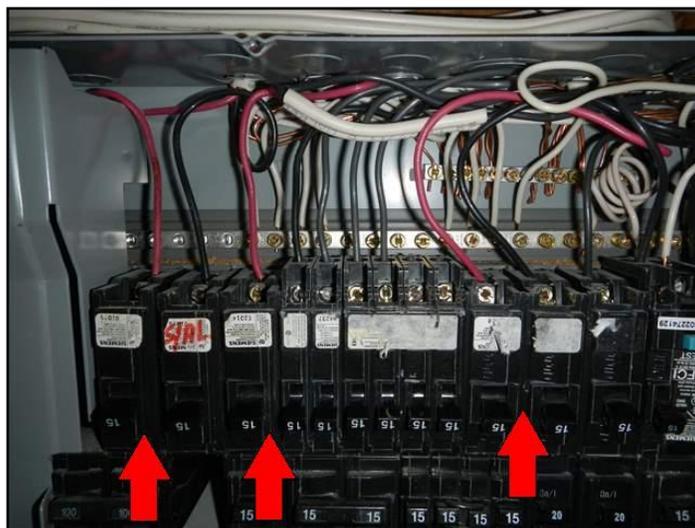
Condition: • [No links for multi-wire circuits](#)

No links for multi-wire circuits

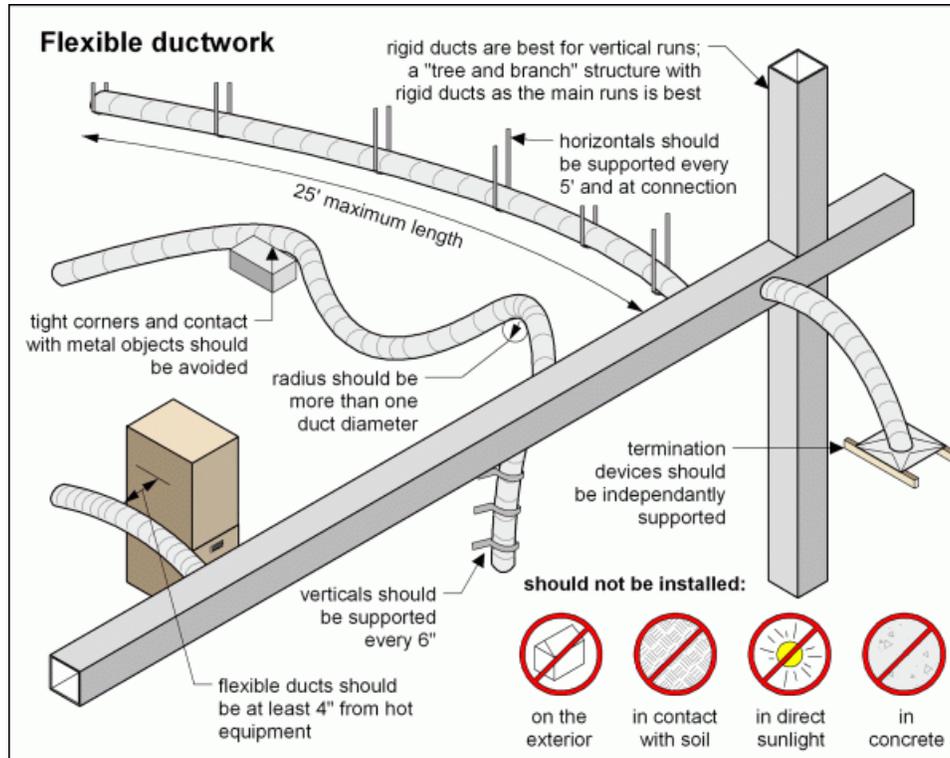
Condition: • [Excessively long runs, excessive elbows](#)

Task: Further evaluation / Improve

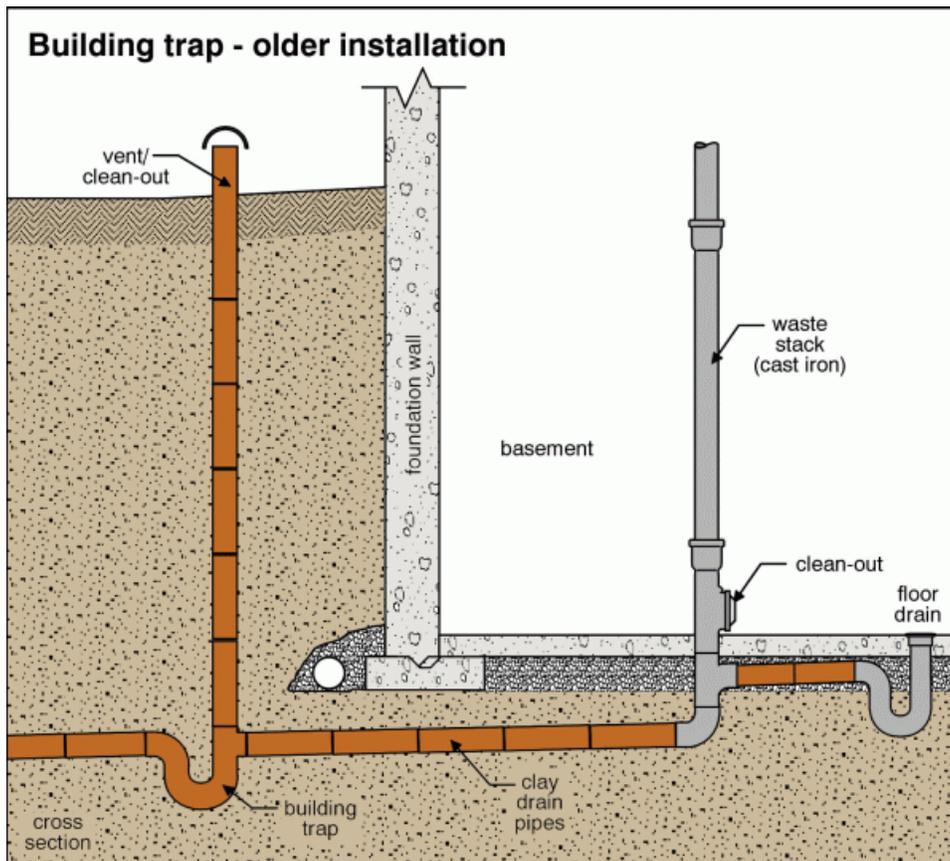
Condition: • Clean-outs missing or inaccessible

Task: Locate, or provide if missing

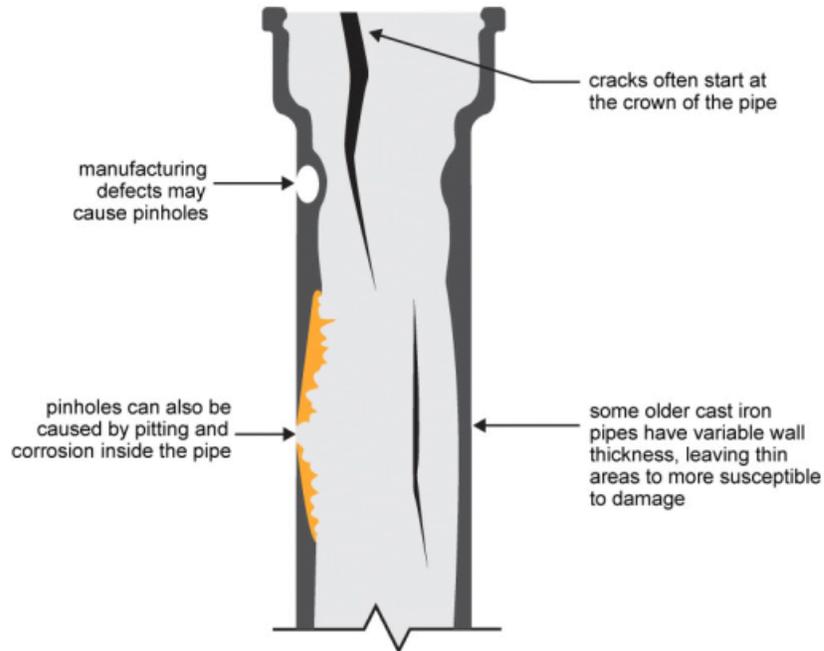
Condition: • The cast iron waste piping is near the end of its normal life expectancy and is prone to rusting through or splitting. Replacement may be required in the near future.

Pinholing and cracks in cast iron stacks

Task: Further evaluation Replace

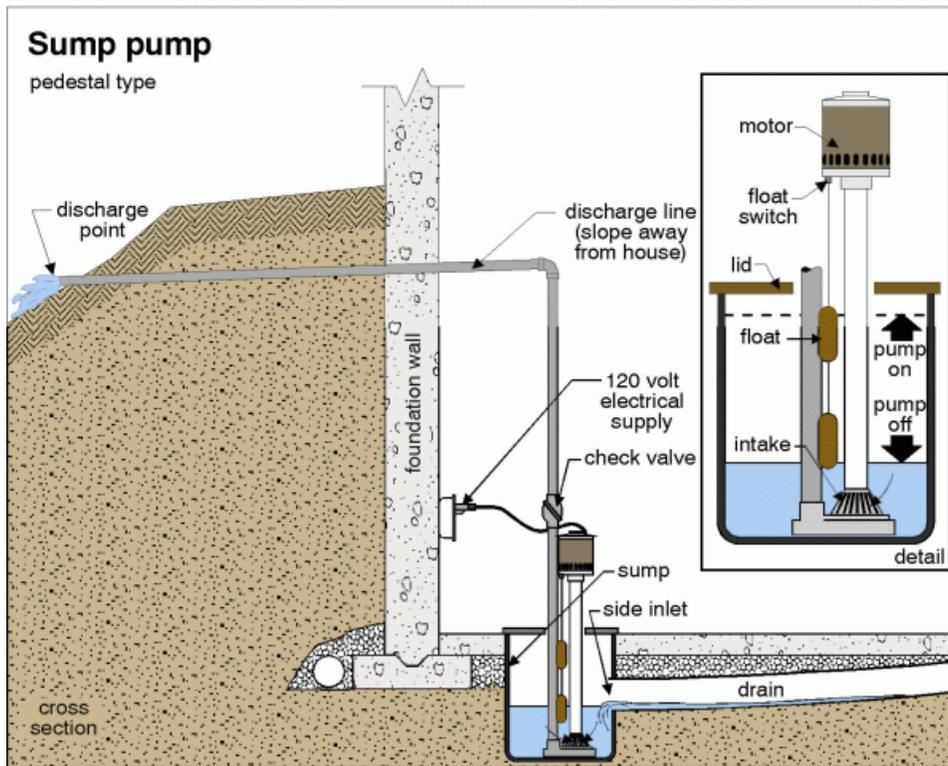
Condition: • Discharge pipe problems

The discharge point was not found. It may discharge into the sewer.

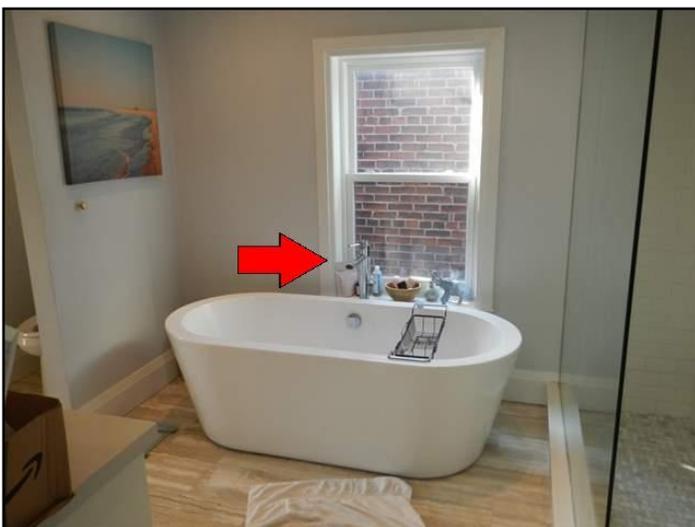
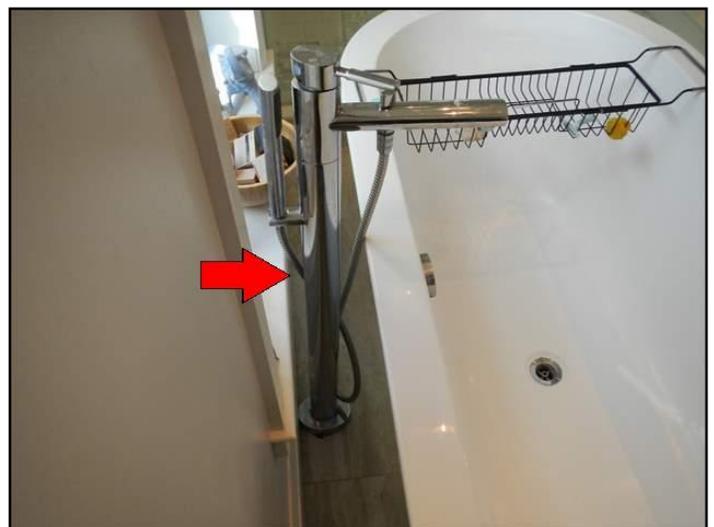
Condition: • Loose faucet

Loose faucet

Task: Further evaluation / Improve

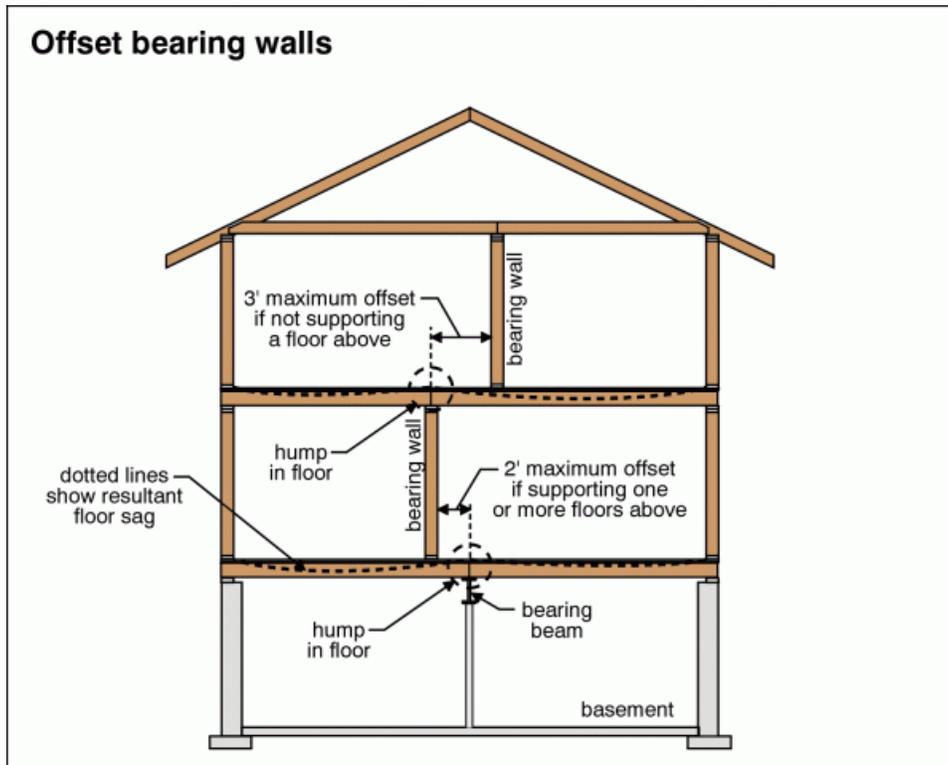
Condition: • Sloped

The floors slope significantly in the basement.

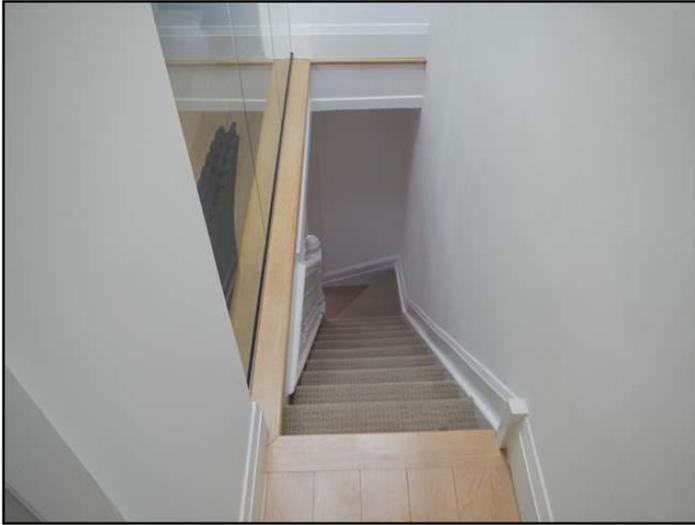
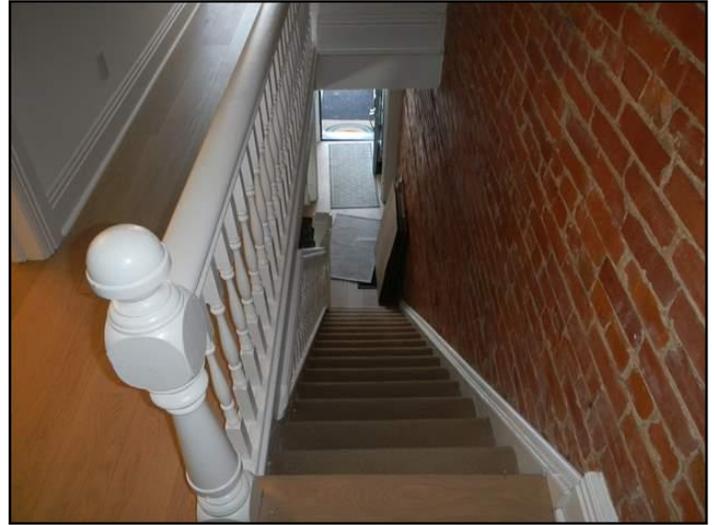
Condition: • Incomplete or not continuous railing

Incomplete or not continuous railing

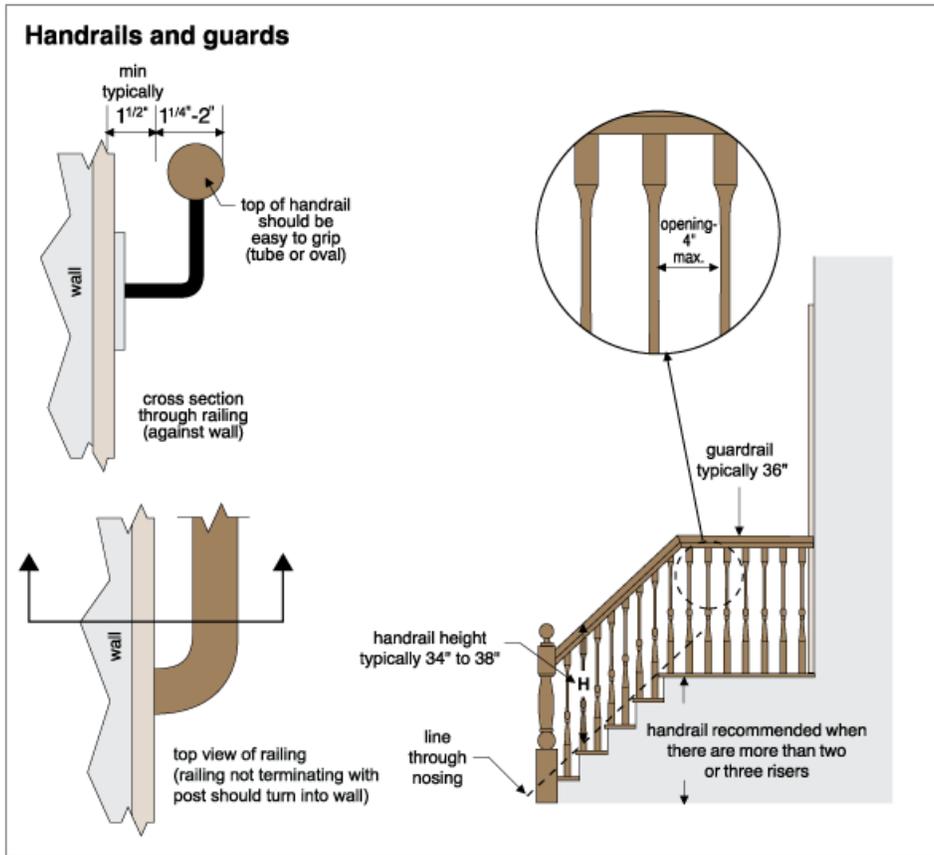
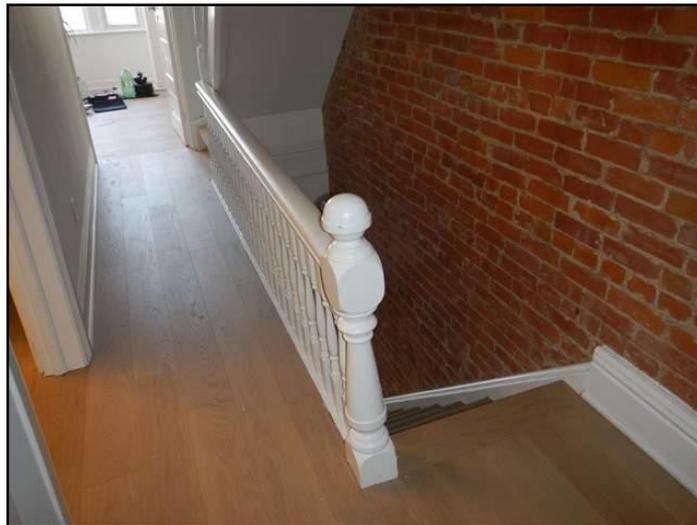
Condition: • [Too low](#)

Too low
