Your Inspection Report

19 Halford Ave
Toronto, ON M6S 4G1

INSPECTION DATE:
Wednesday, February 4, 2026

RE: Report No. 96014
19 Halford Ave
Toronto, ON
M6S 4G1

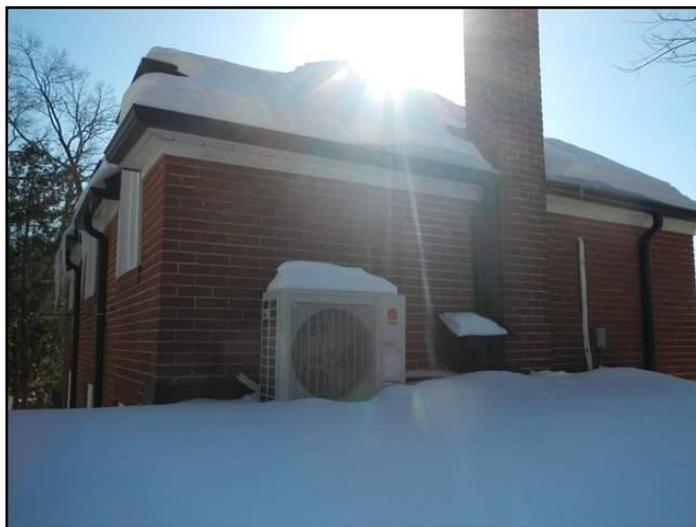
On the garage: covered with snow.

Not visible

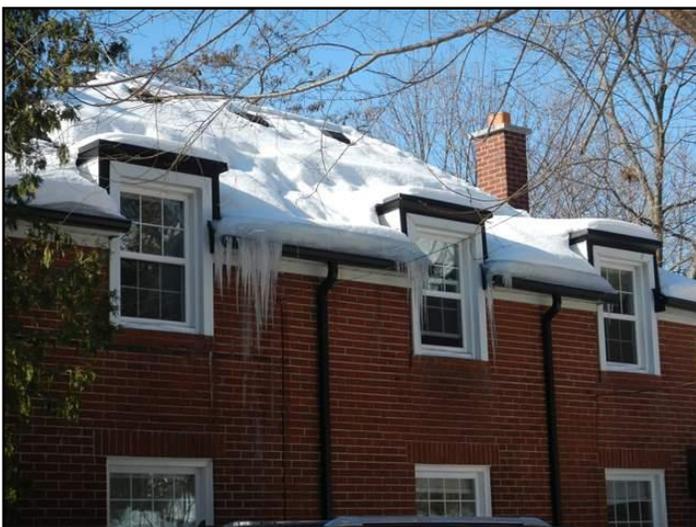
On the dormers.

Not visible

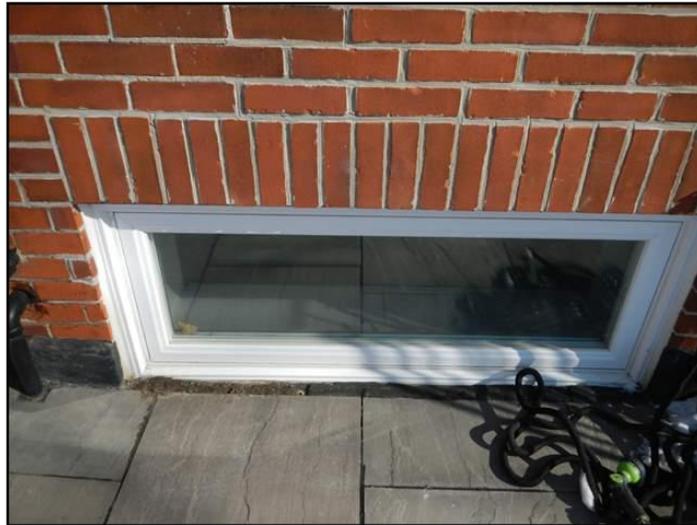
Condition: • Missing

Missing

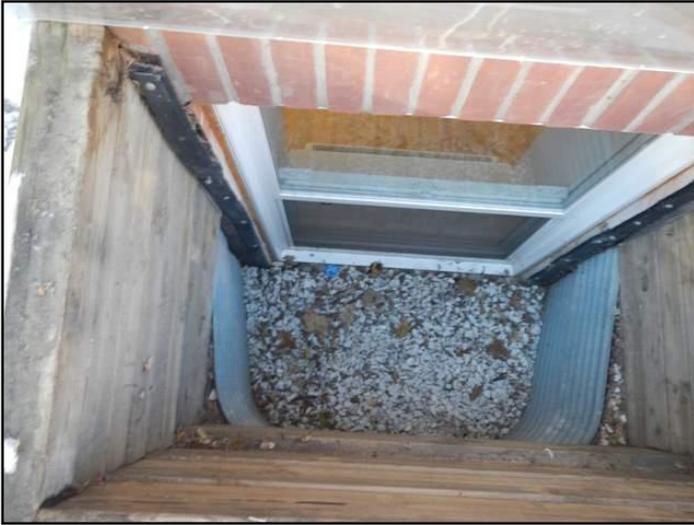
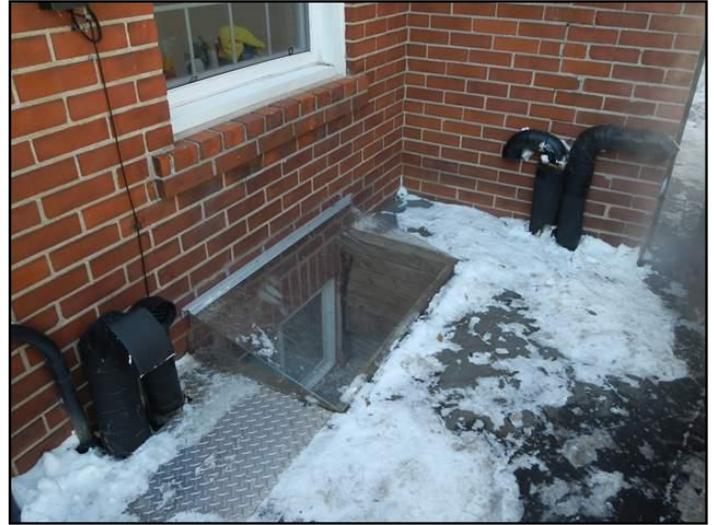
Condition: • Window close to grade in well

Window close to grade in well

Task: Further evaluation / Improve

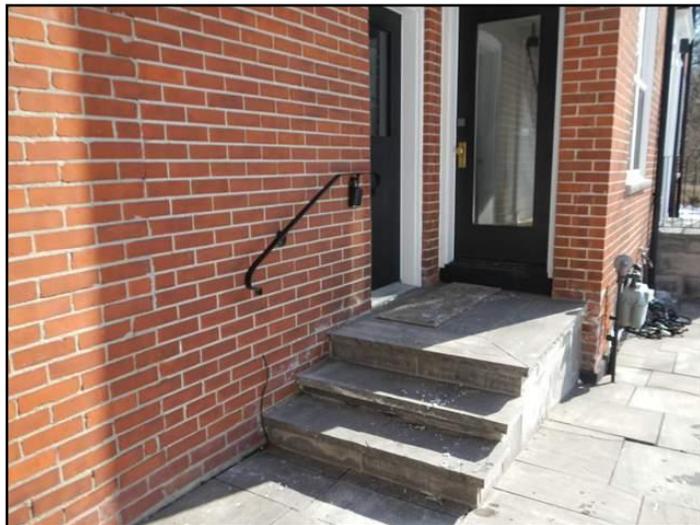
Missing on one side.

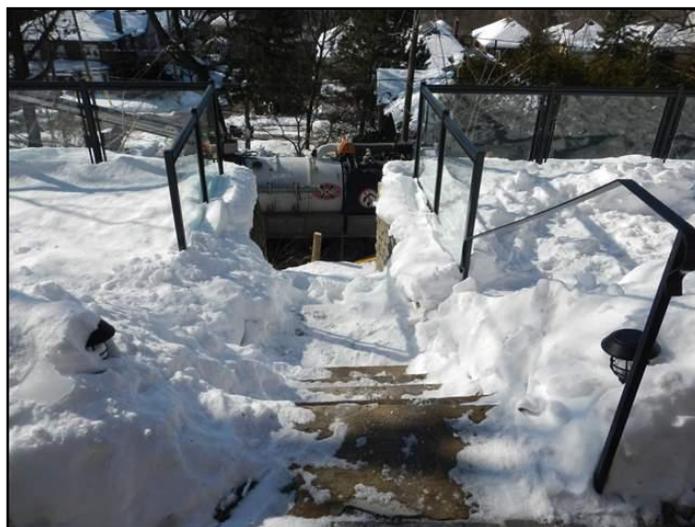
Condition: • [Missing](#)

Missing

Time: As soon as possible

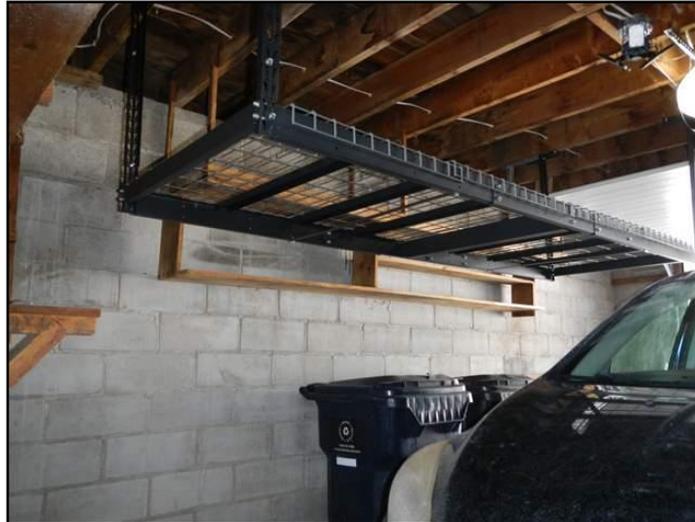
Condition: • Shelving - load capacity not determined

Shelving - load capacity ND -

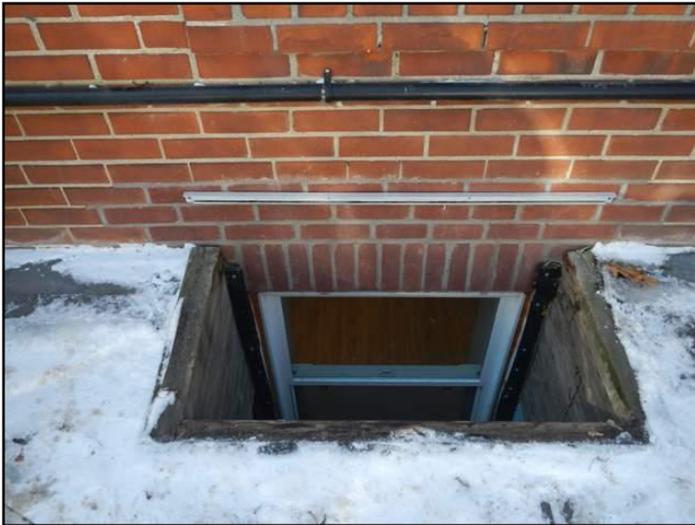
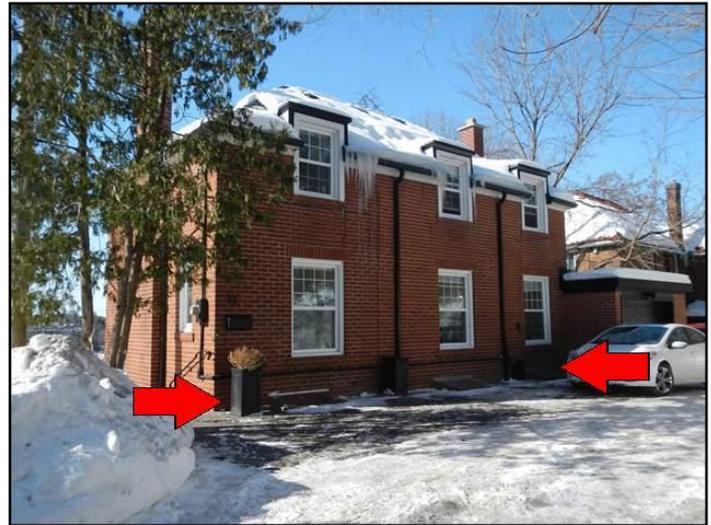
Condition: • At or below grade level

At or below grade level

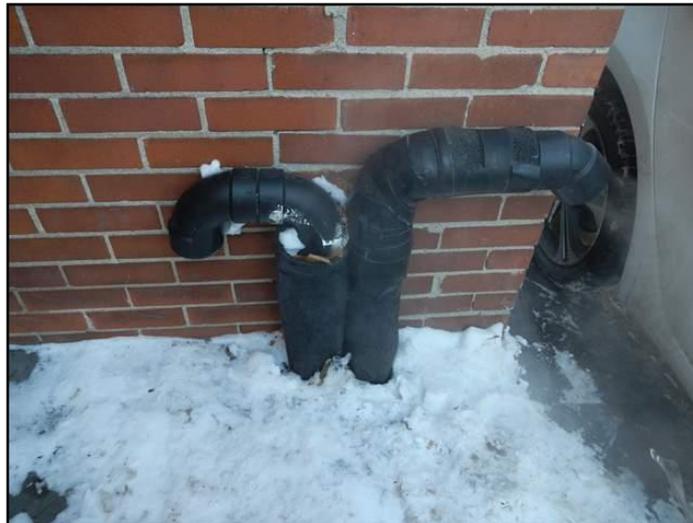
Condition: • Black ABS venting noted.

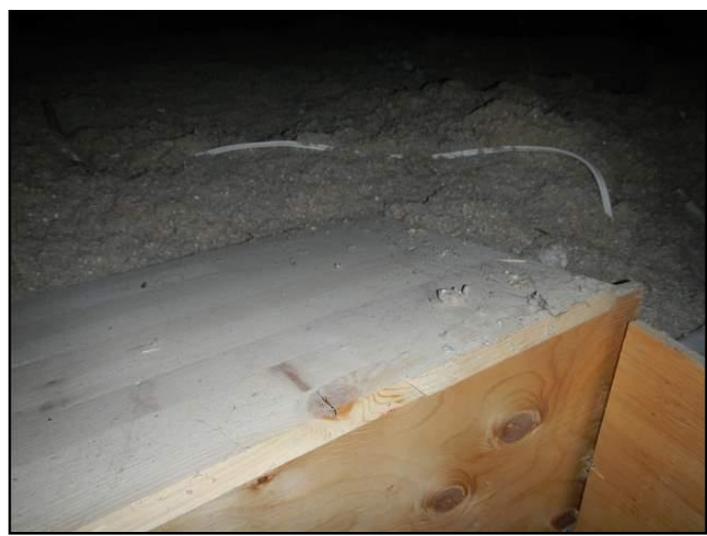
Condition: • [Not insulated and not weatherstripped](#)

Not insulated and not weatherstripped

Time: As soon as practical

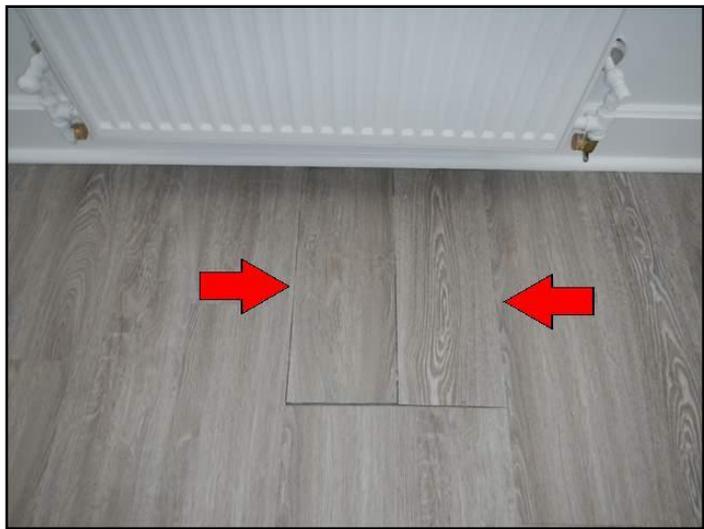
Condition: • Cover not removed

Cover not removed

Time: Twice a year

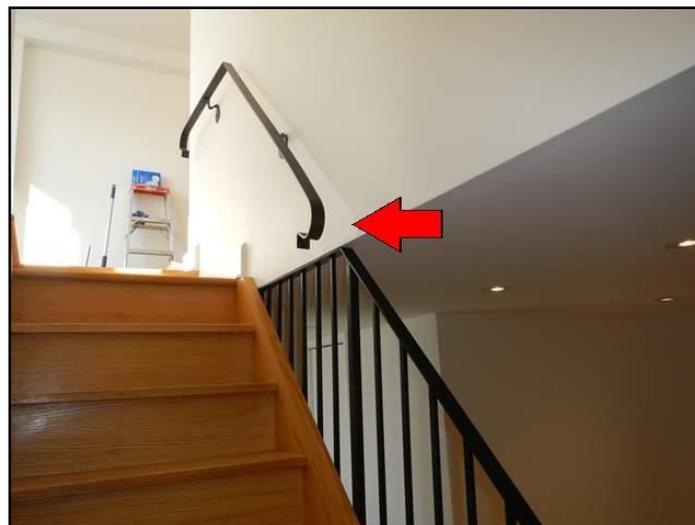
Condition: • Incomplete or not continuous railing

Not continuous railing
