# Your Inspection Report

349 Windermere Ave  
Toronto, ON M6S 3L1

**INSPECTION DATE:**  
Wednesday, January 28, 2026

RE: Report No. 95913  
349 Windermere Ave  
Toronto, ON  
M6S 3L1

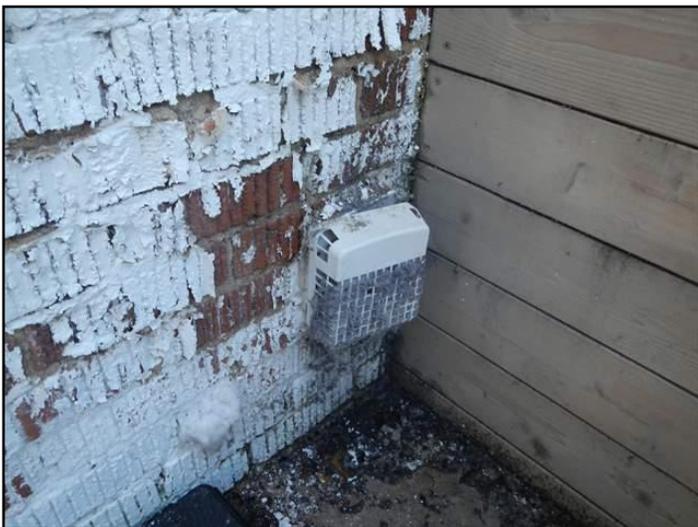
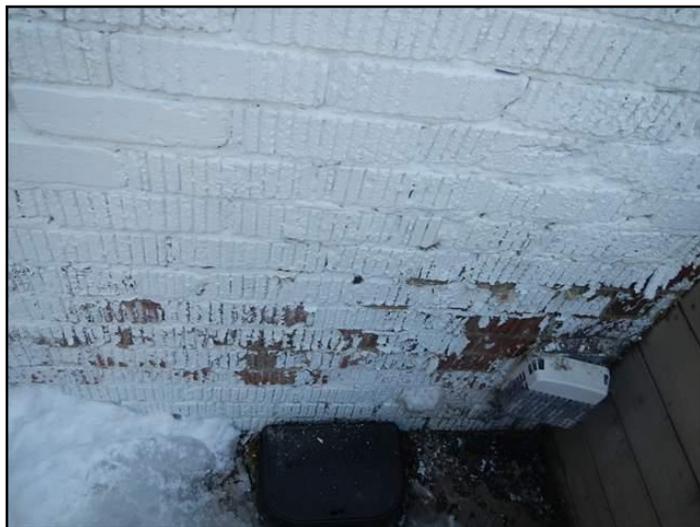
**Condition:** • The paint is peeling off the brick.

**Task:** Improve

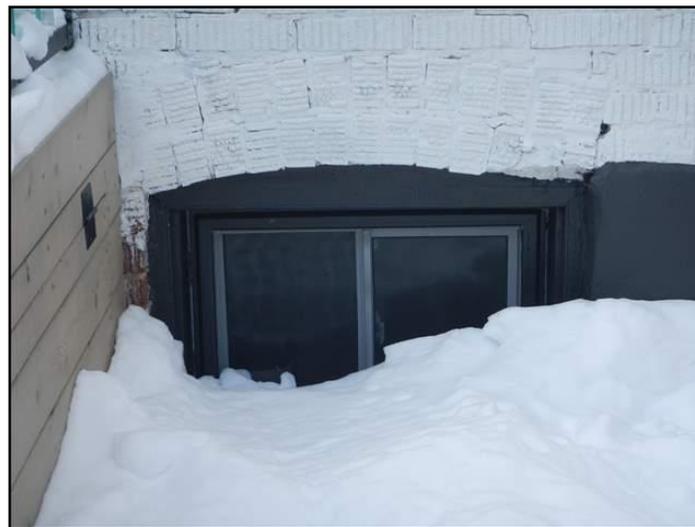
**Condition:** • Missing

Missing

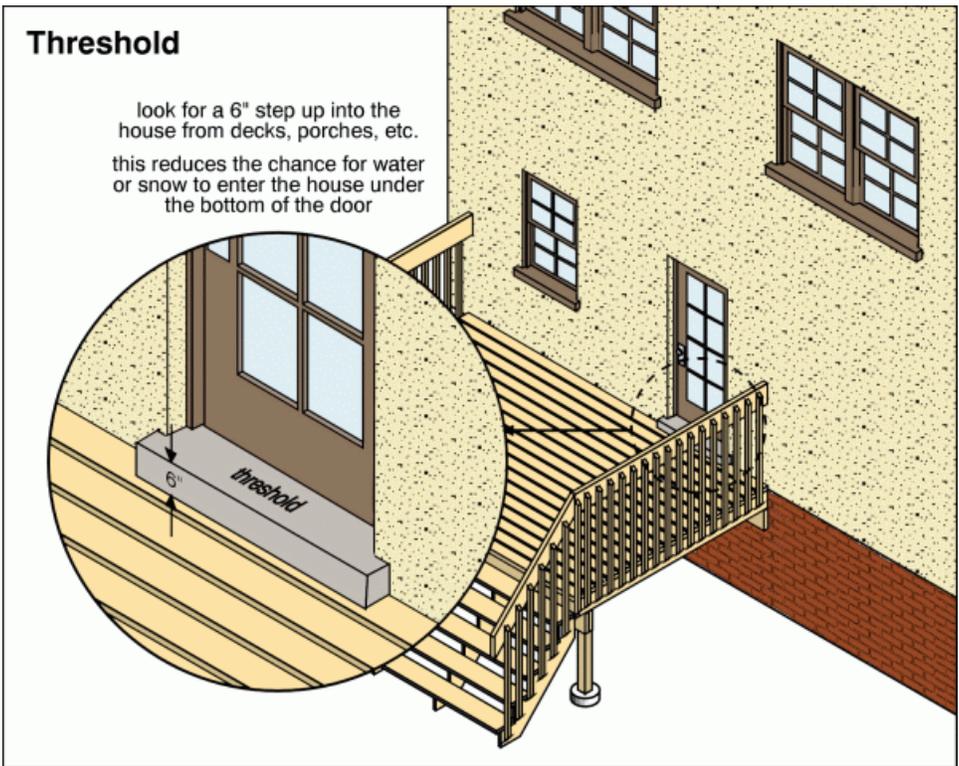
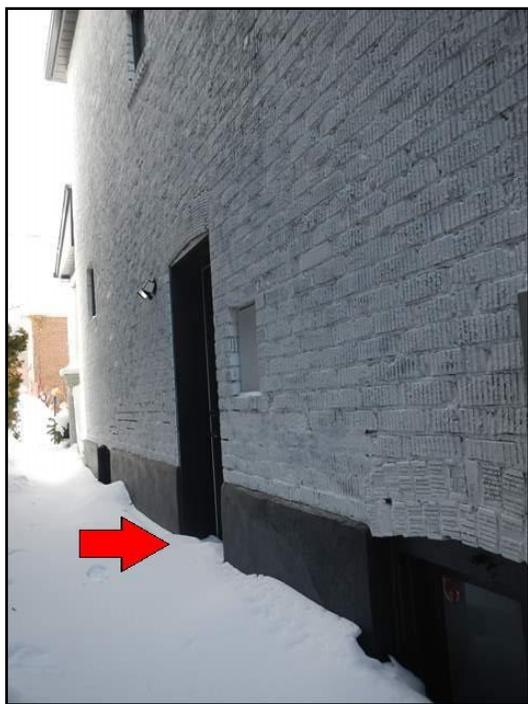
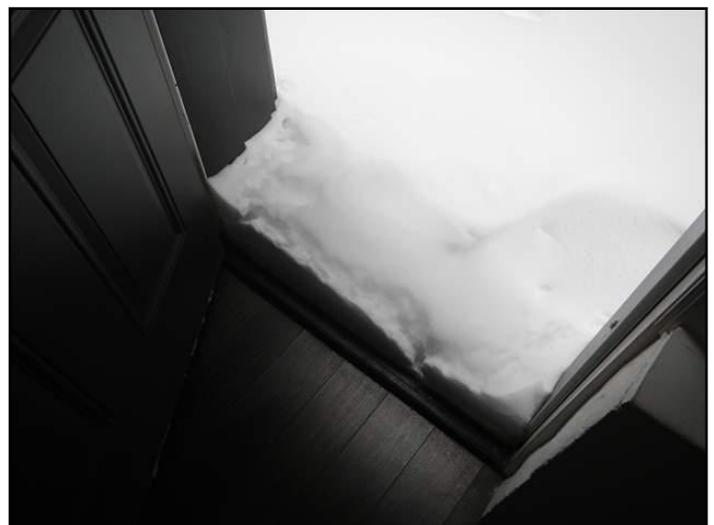
**Condition:** • Threshold height marginal

*Threshold height marginal*

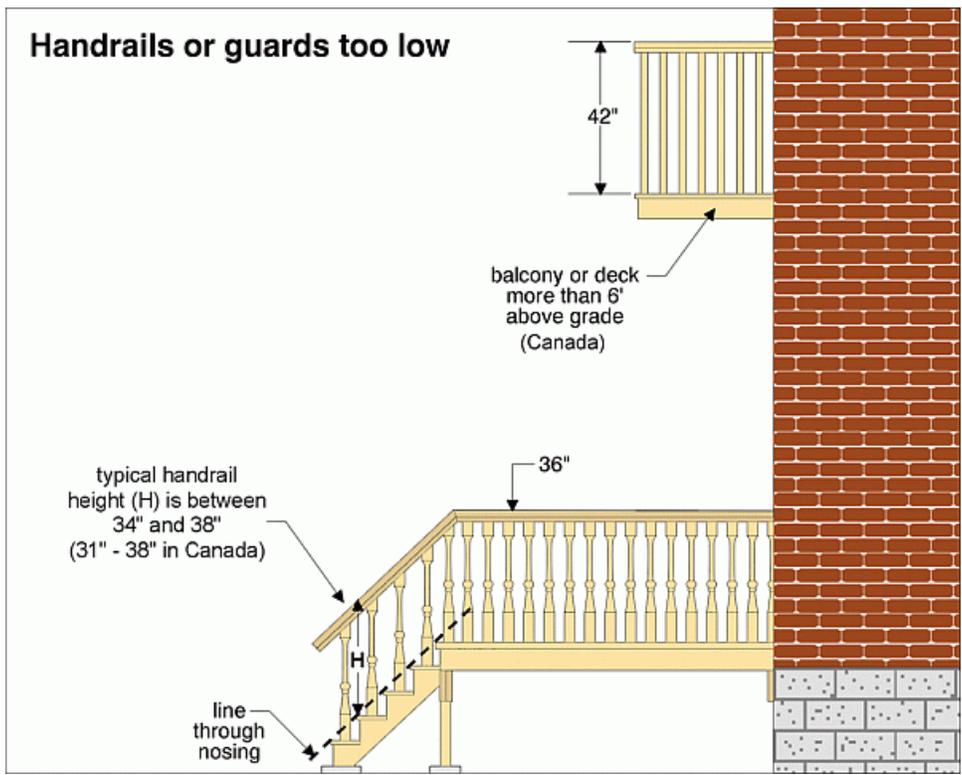
**Condition:** • [Too low](#)  
**Location:** Front Porch  
**Task:** Improve  
**Time:** As required

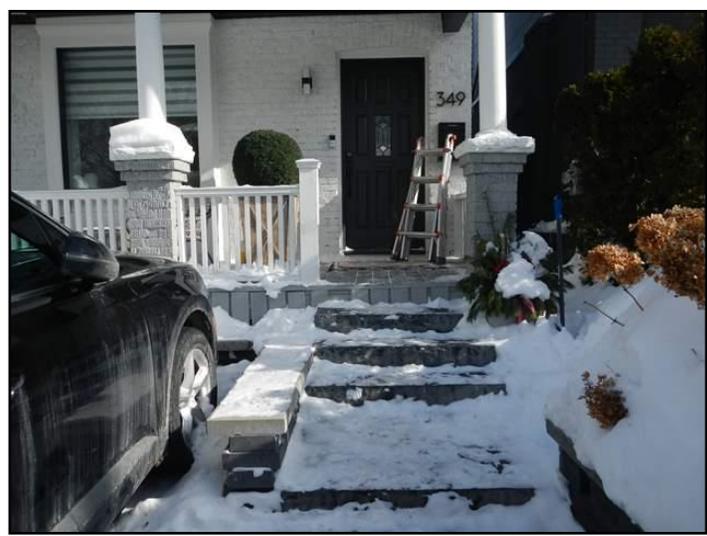
**Condition:** • Missing railings

*Missing railings*

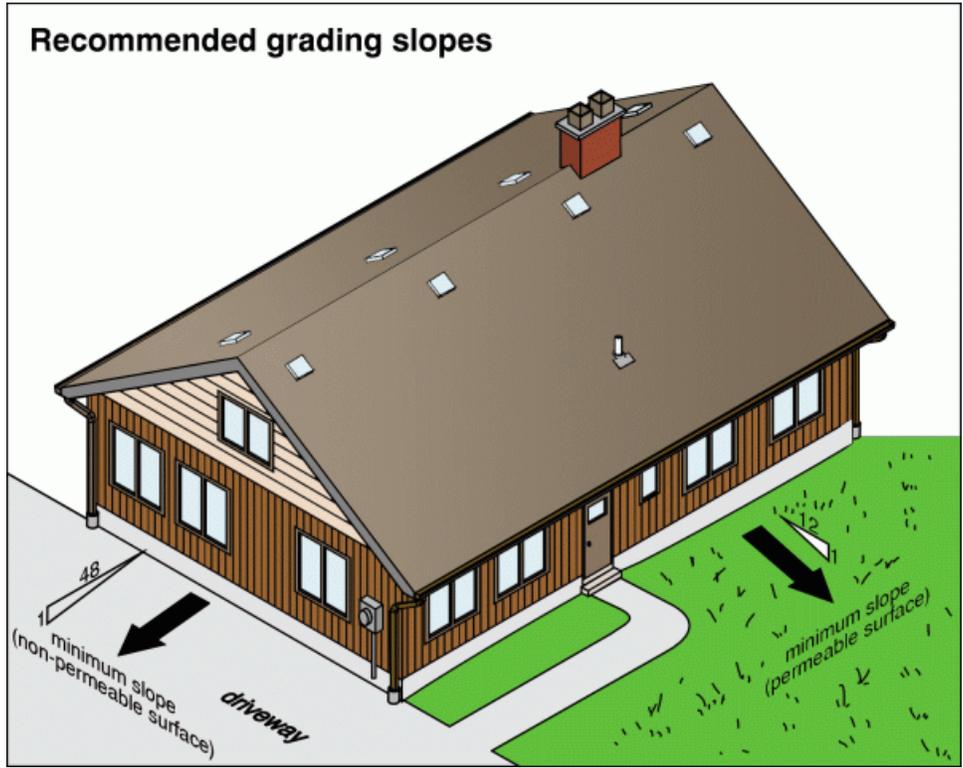
**Condition:** • [Improper slope or drainage](#)

**Task:** Improve slope to at least 1 inch per foot for the first 6 feet away from the home. Note: Less slope is needed on hard surfaces like driveways

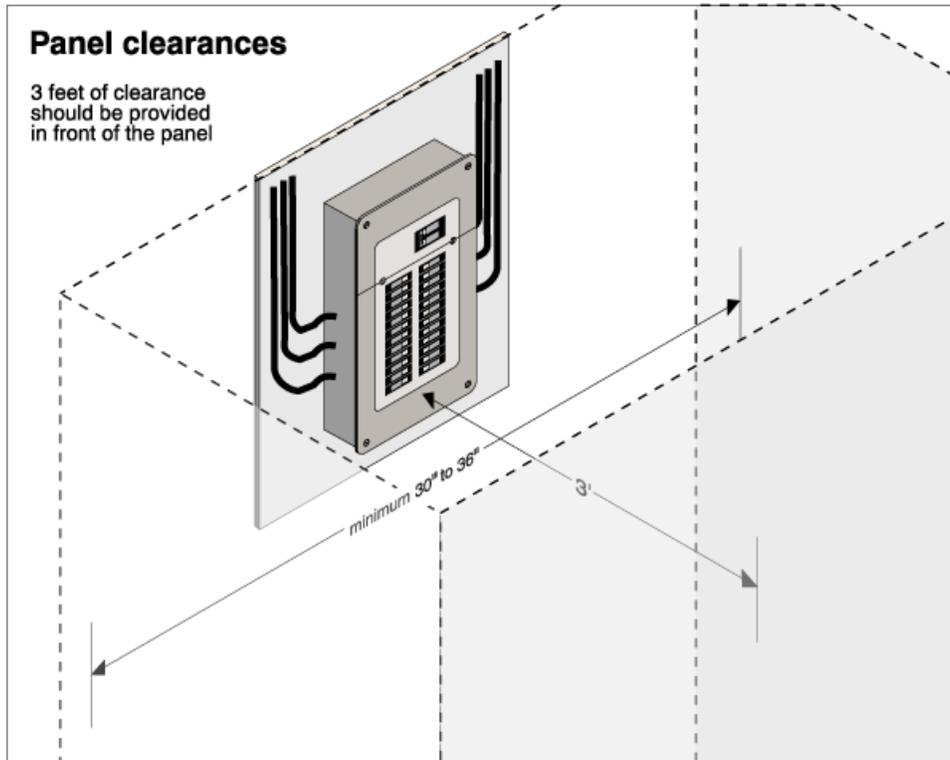
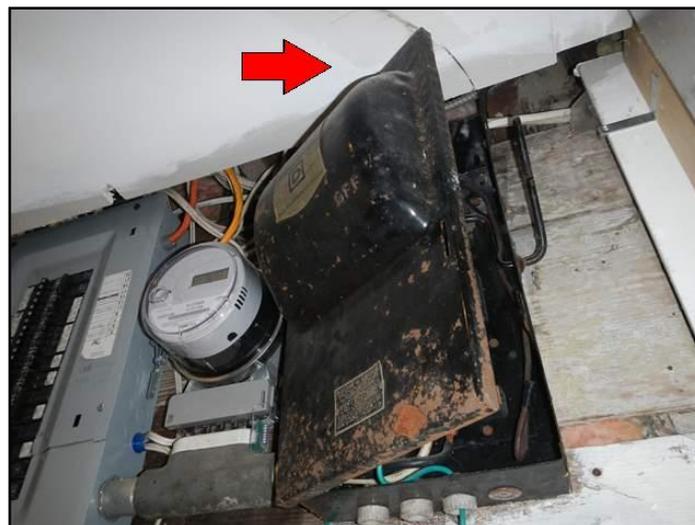
**Condition:** • [Poor access](#)

*Poor access: it hits the ceiling.*

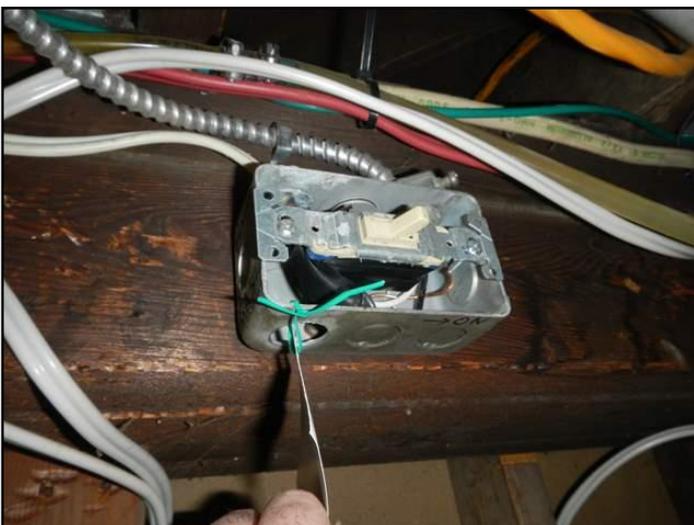
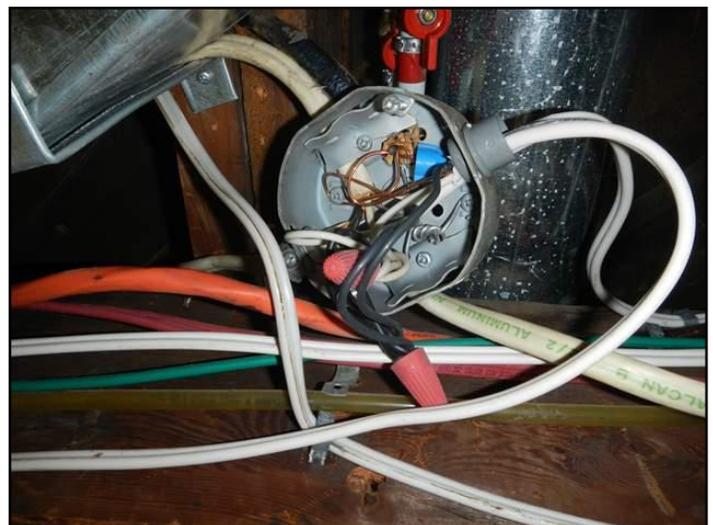
**Condition:** • [Missing](#)

Missing

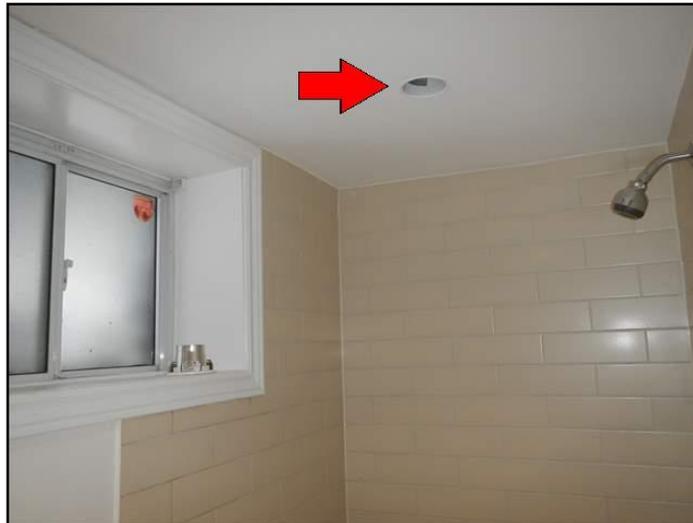
**Condition:** • [Conventional lights in wet areas](#)

*Conventional lights in wet areas*

**Task:** Replace

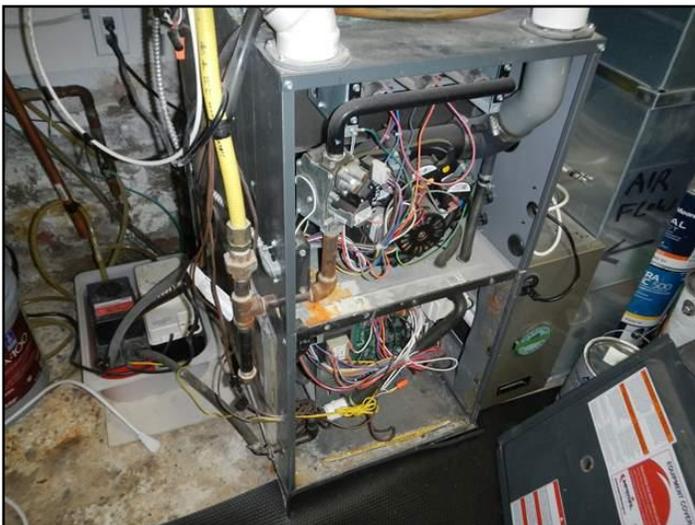
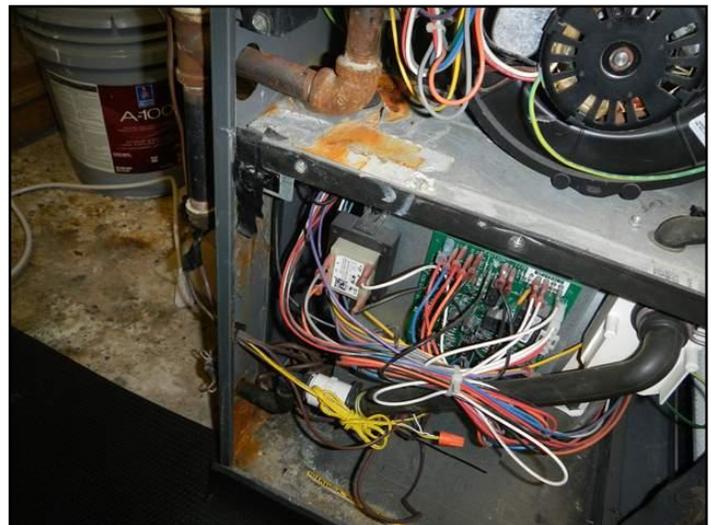
**Condition:** • Condensate leak

Condensate leak

**Task:** Further evaluation / Improve

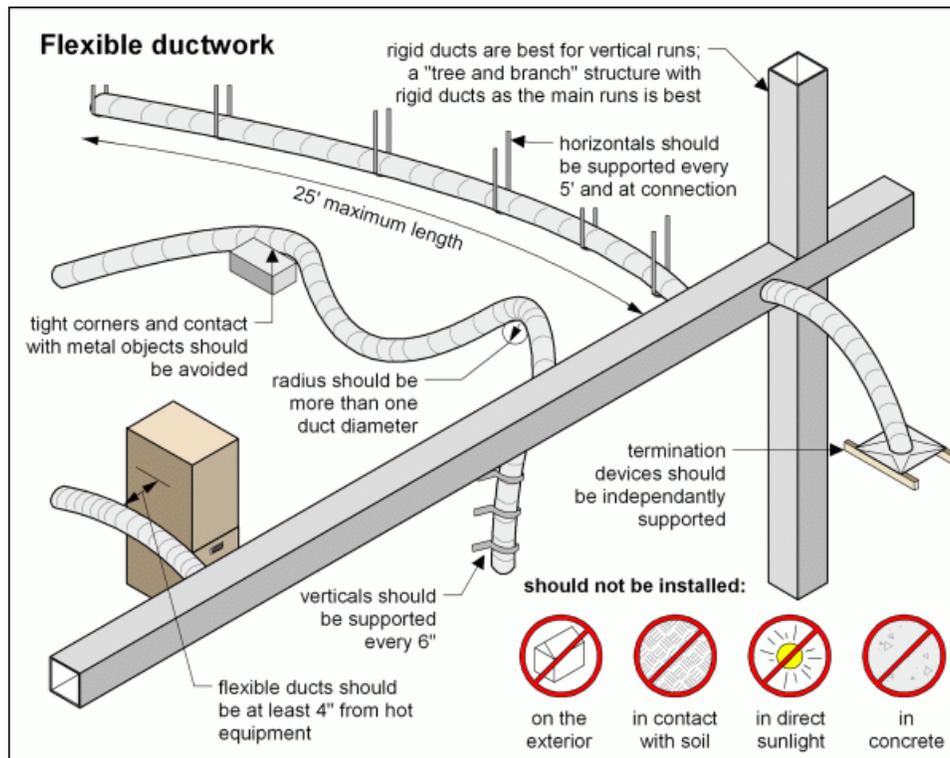
**Condition:** • [Excessively long runs, excessive elbows](#)

\*  
**Task:** Further evaluation / Improve  
**Time:** If necessary  
**Cost:** Not determined

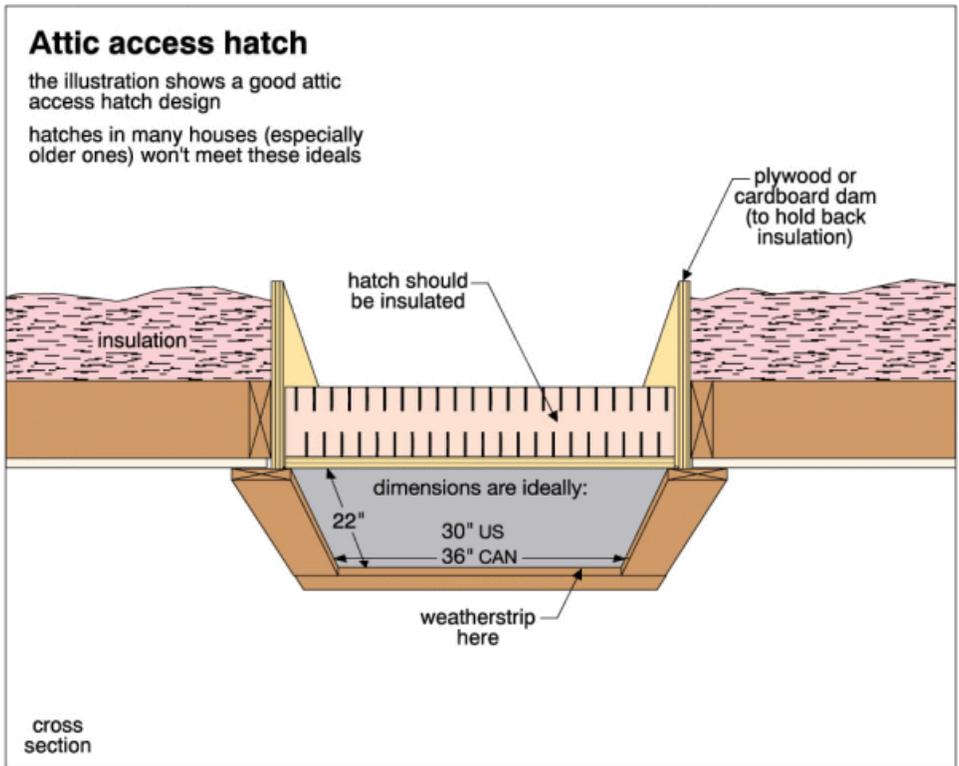
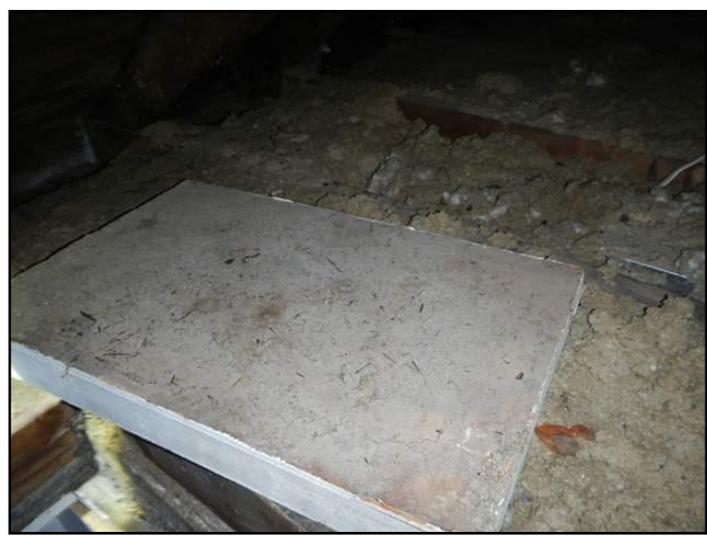
Condition: • [Not insulated and not weatherstripped](#)

*Not insulated and not weatherstripped*

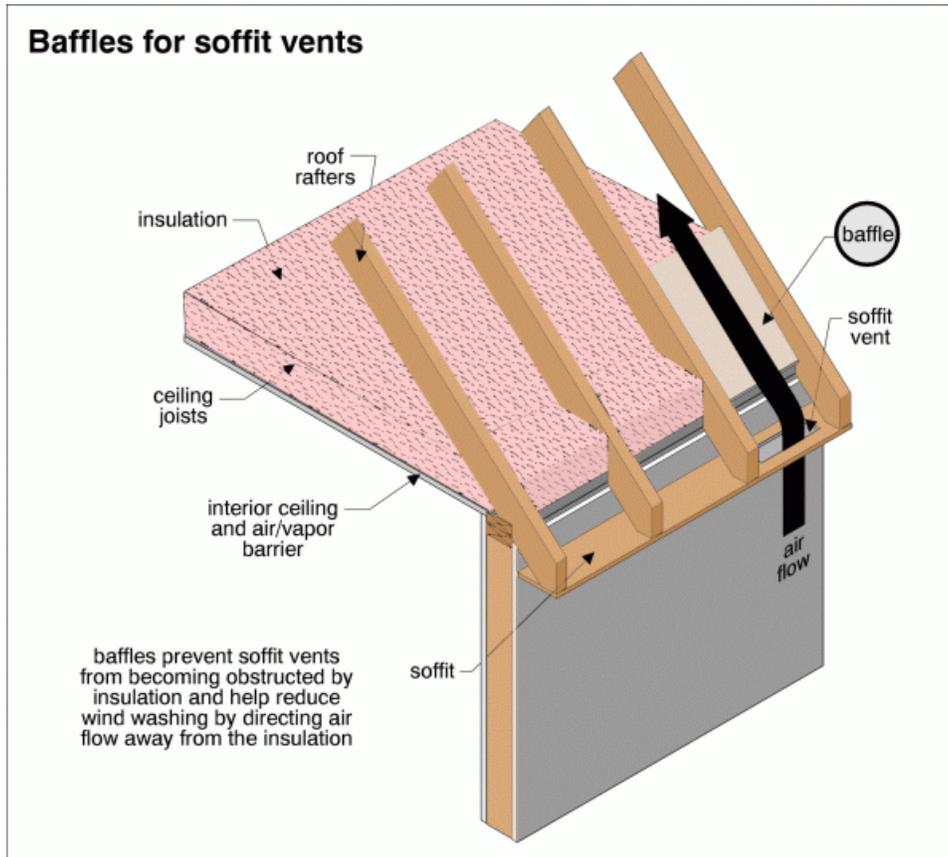
**Condition:** • Ventilation suspect

**Task:** Engage roofing specialist to inspect and advise.

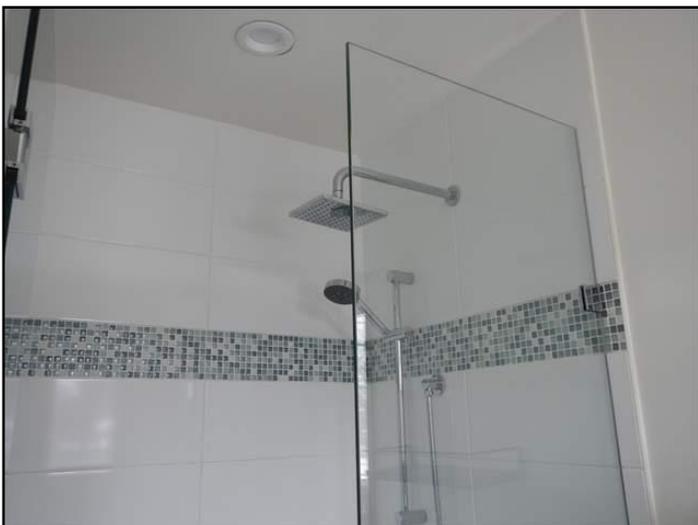
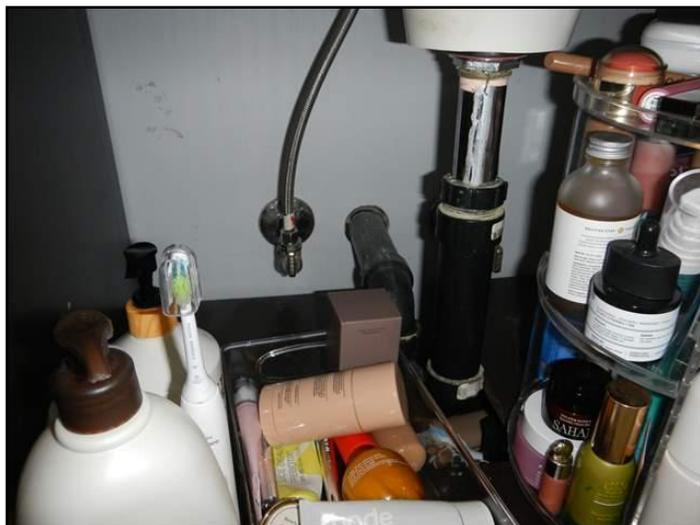
**Condition:** • Freezing risk - Pipes near unheated spaces are vulnerable to freezing. While relocation of the pipes is the best solution, adding insulation or heating cables may reduce the risk of freezing.

Freezing risk -

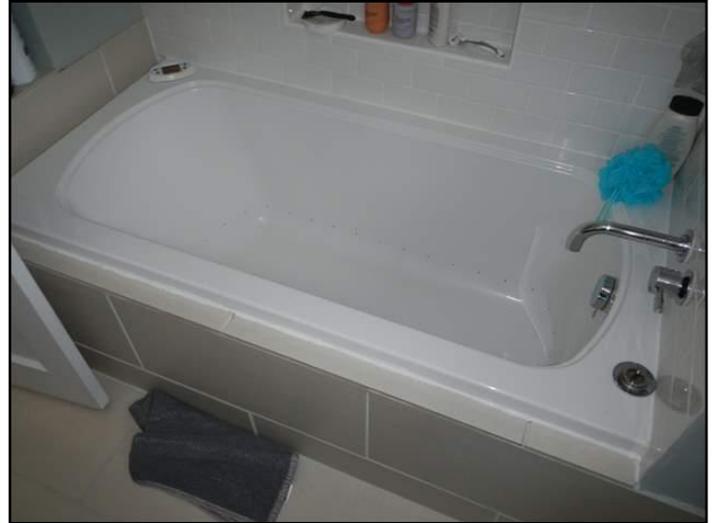
**Condition:** • Freezing risk - Pipes near unheated spaces are vulnerable to freezing. While relocation of the pipes is the best solution, adding insulation or heating cables may reduce the risk of freezing.

*Freezing risk -*

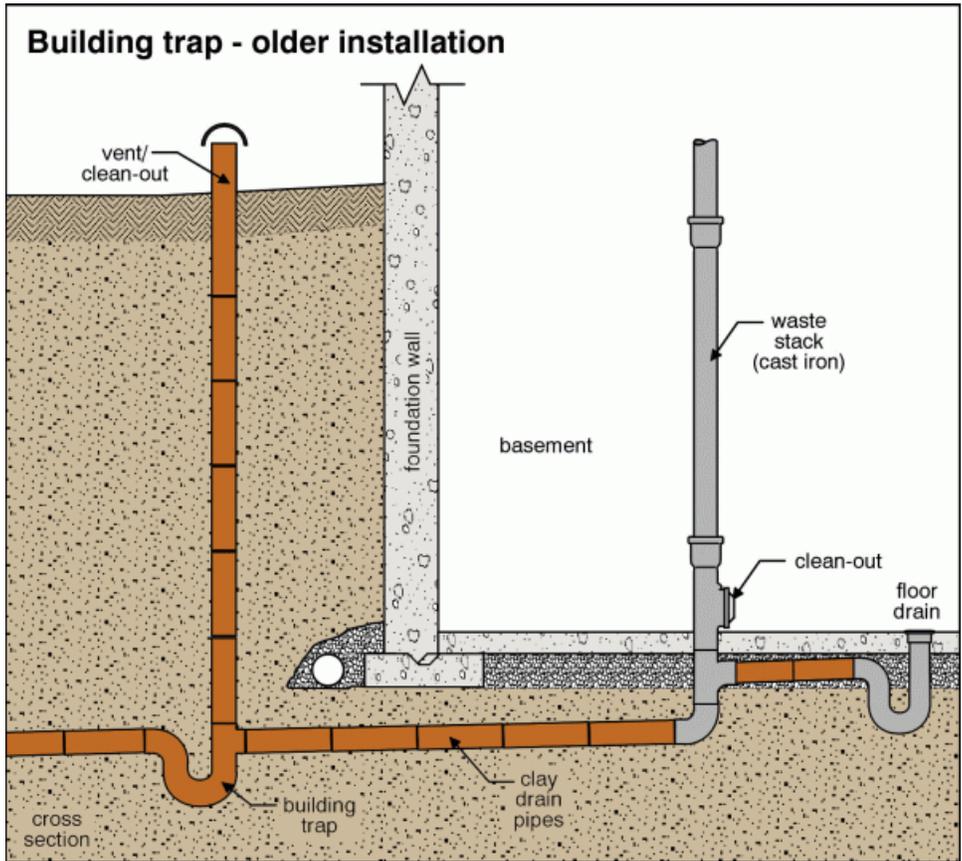
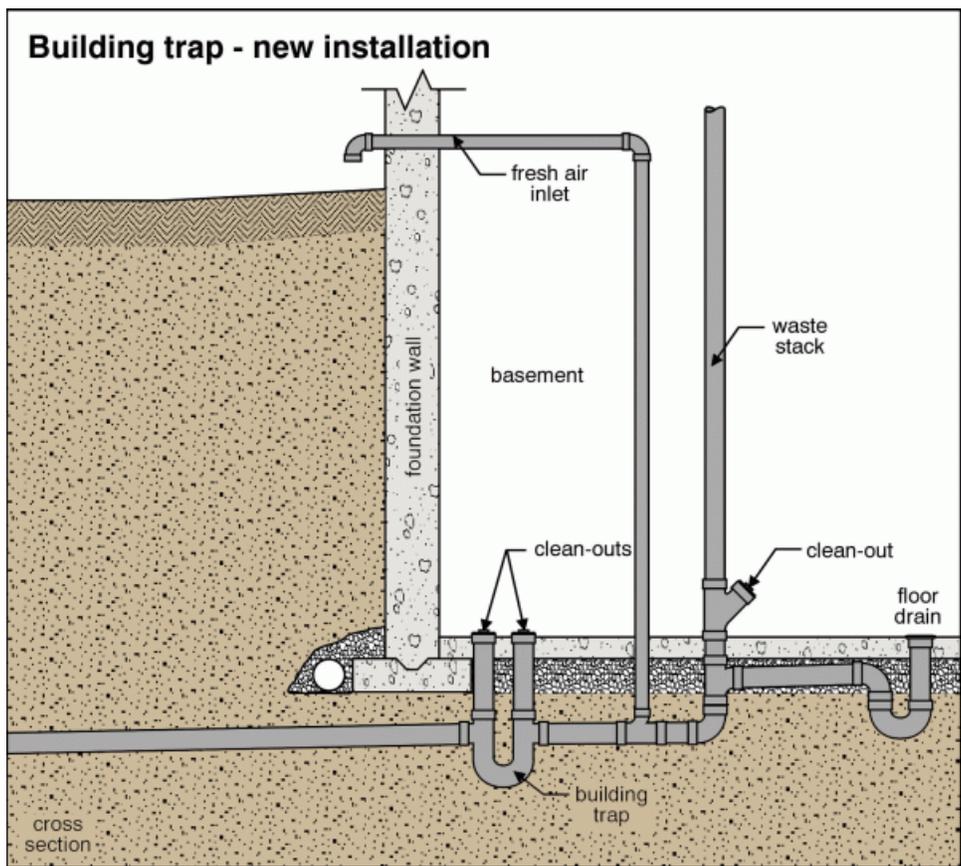
**Condition:** • Clean-outs missing or inaccessible  
May be concealed.

**Task:** Locate, or provide if missing

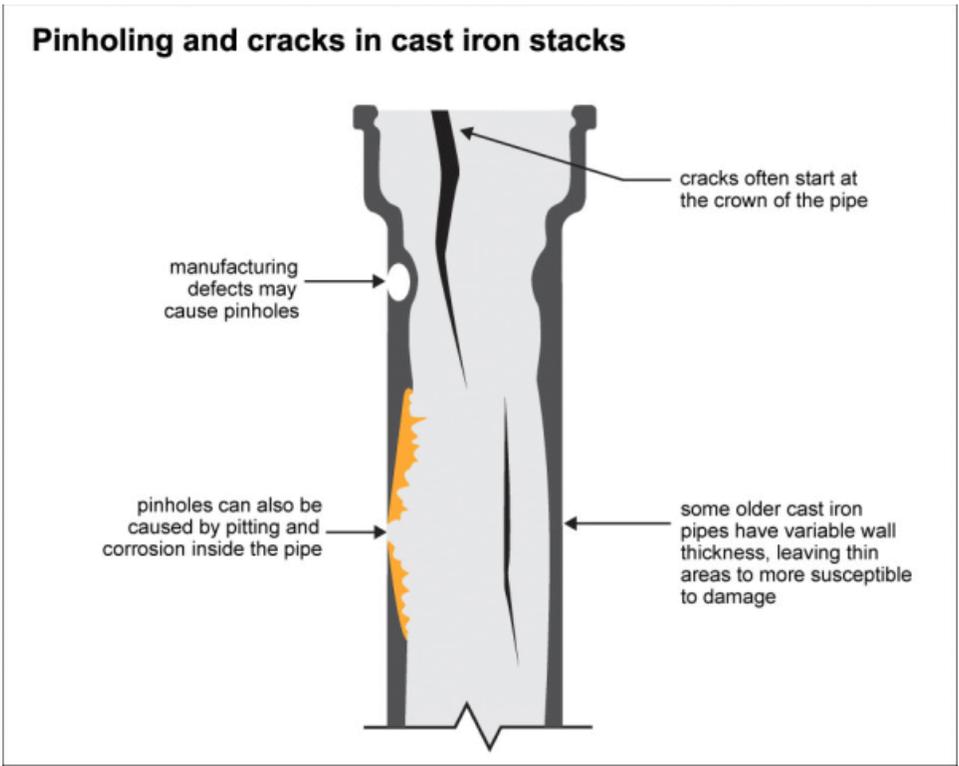
**Condition:** • The cast iron waste piping is near the end of its normal life expectancy and is prone to rusting through or splitting. Replacement may be required in the near future.

**Task:** Further evaluation Replace

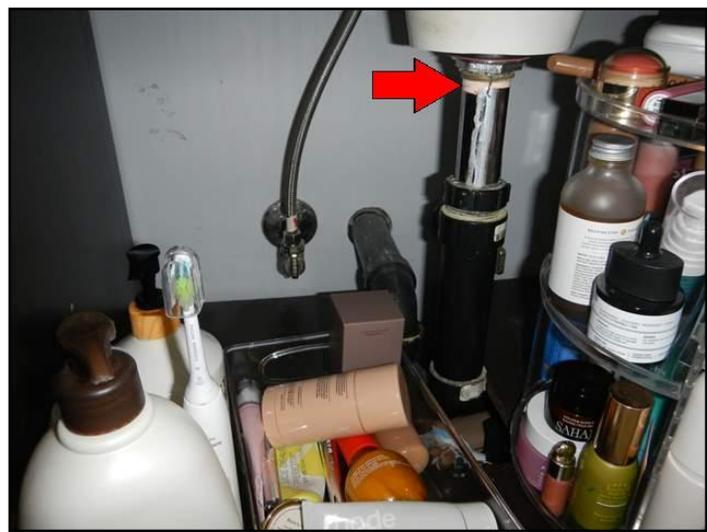
**Condition:** • [Leak](#)

*Leak*

**Task:** Improve

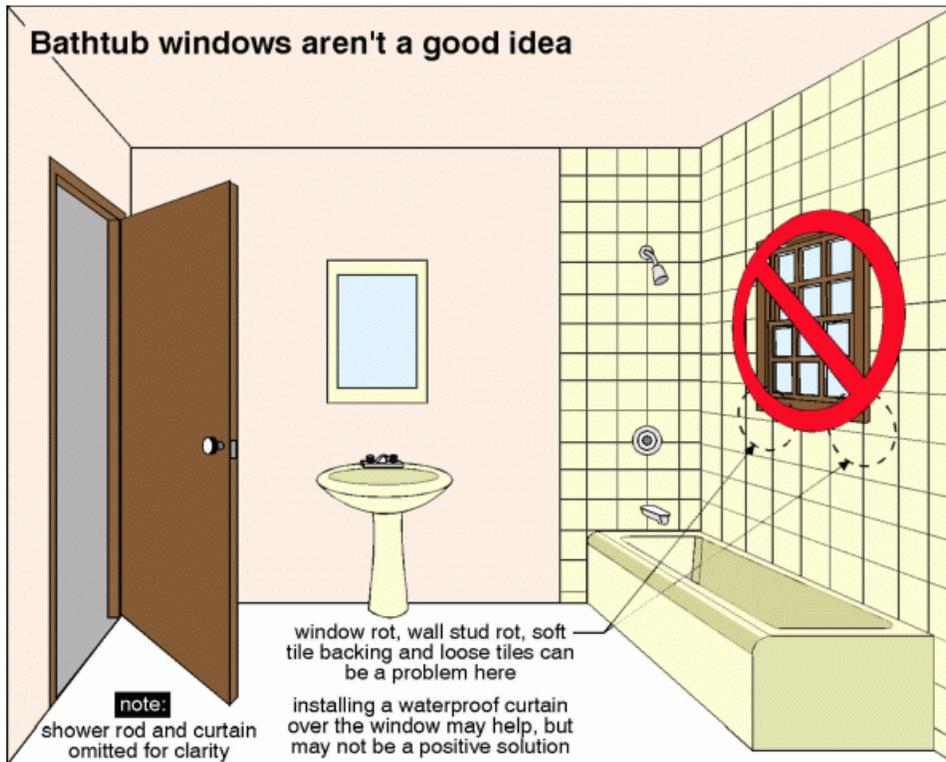
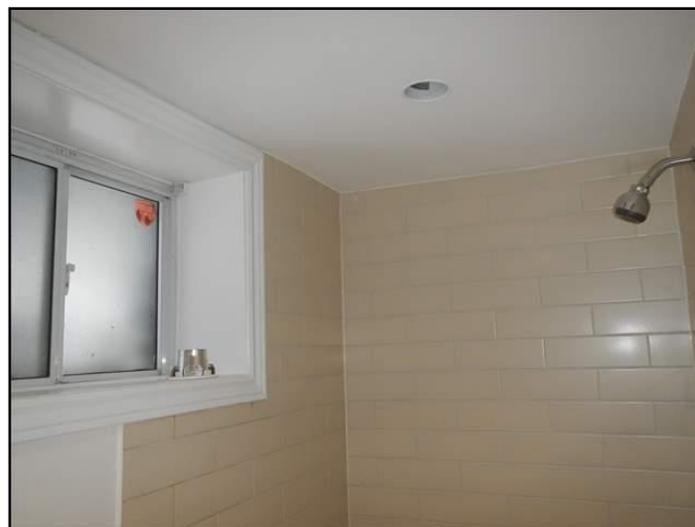
**Condition:** • Window - vulnerable area for leaks

*Shower - Window vulnerable -*

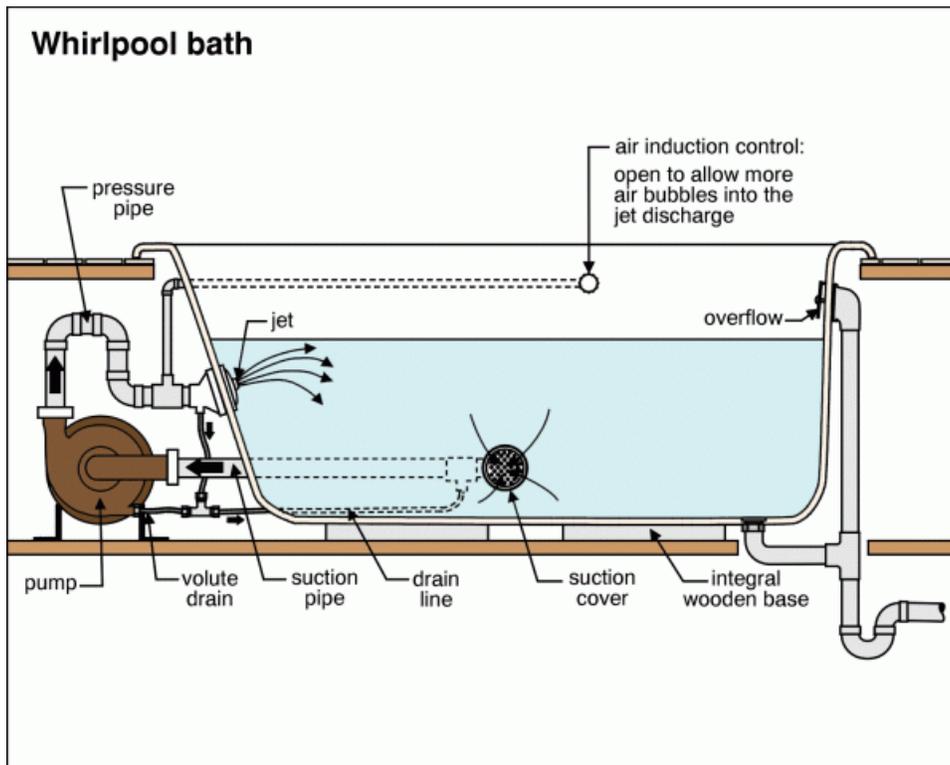
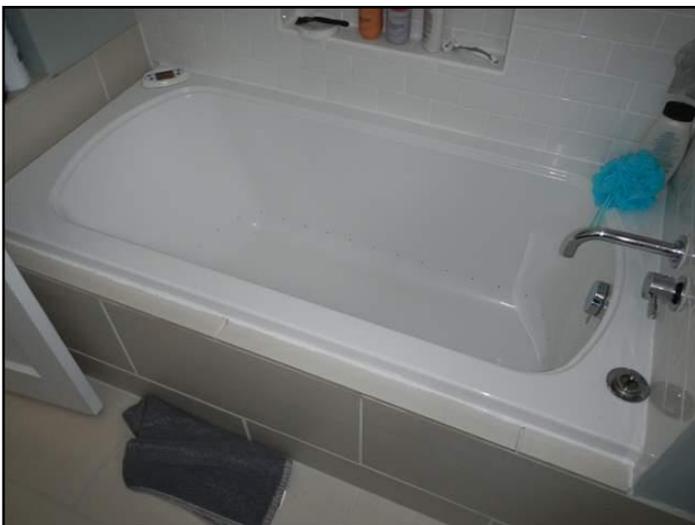
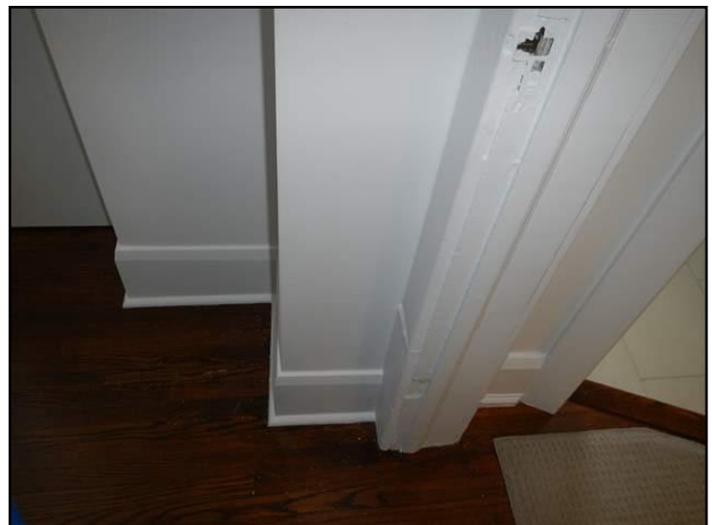
**Condition:** • No pump access

No pump access

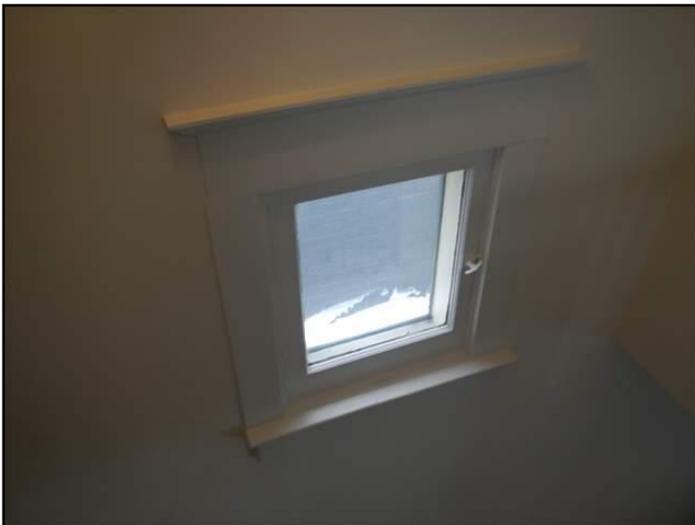
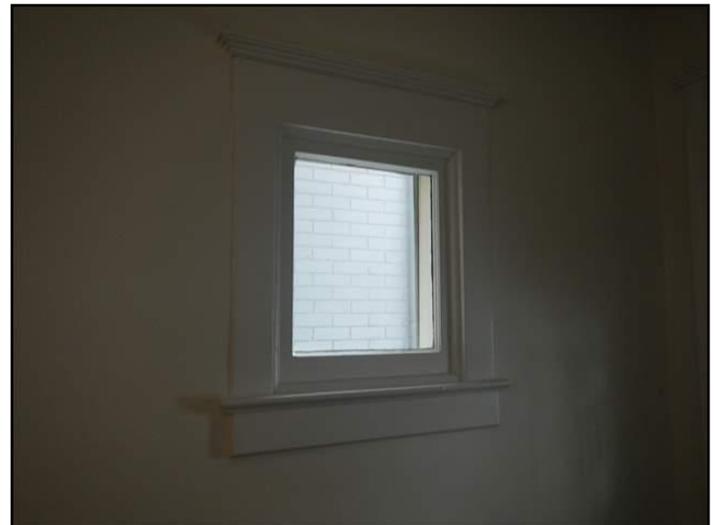
**Condition:** • [Original lower quality units](#)

*Original lower quality units*

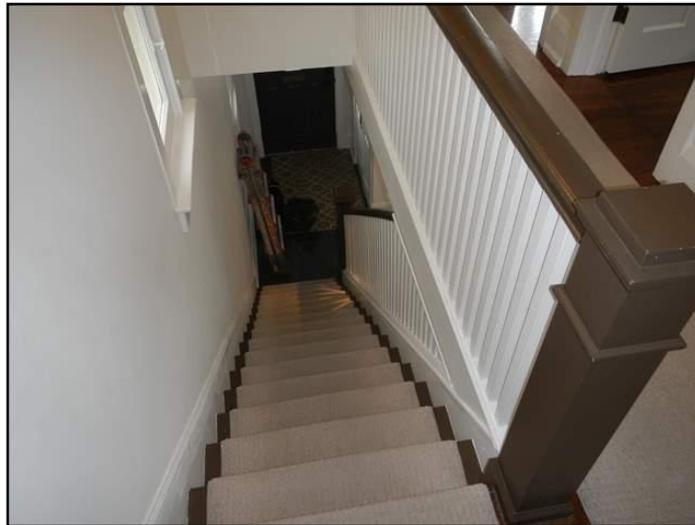
**Condition:** • Incomplete or not continuous railing

*Incomplete or not continuous railing*

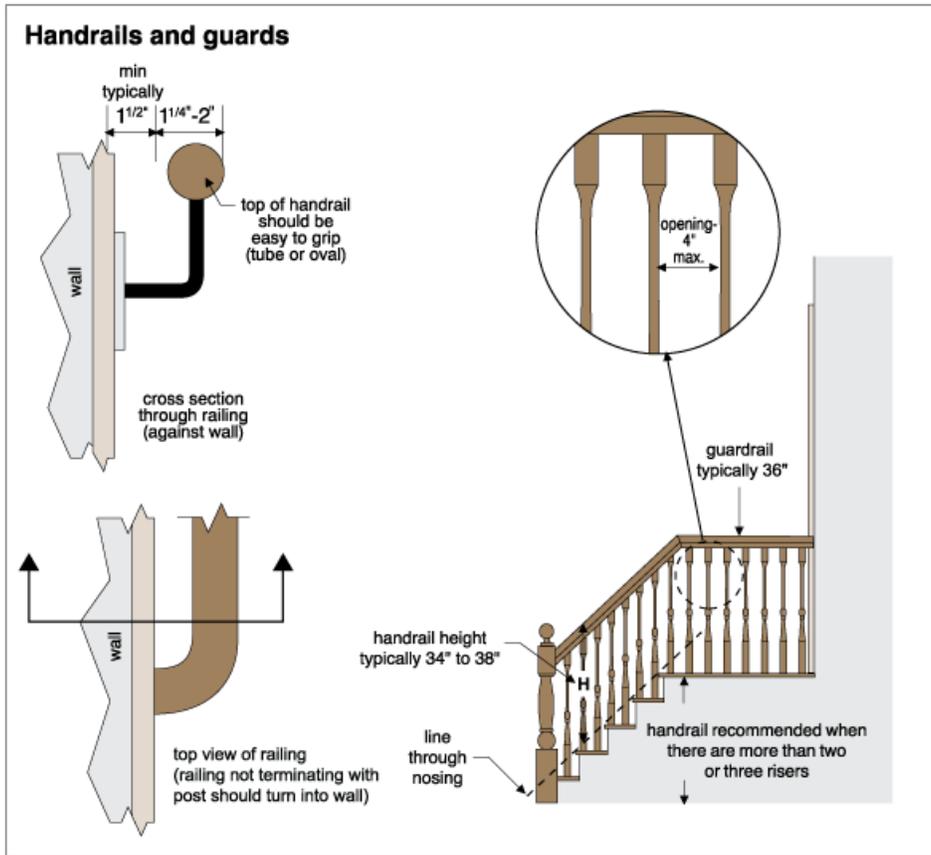
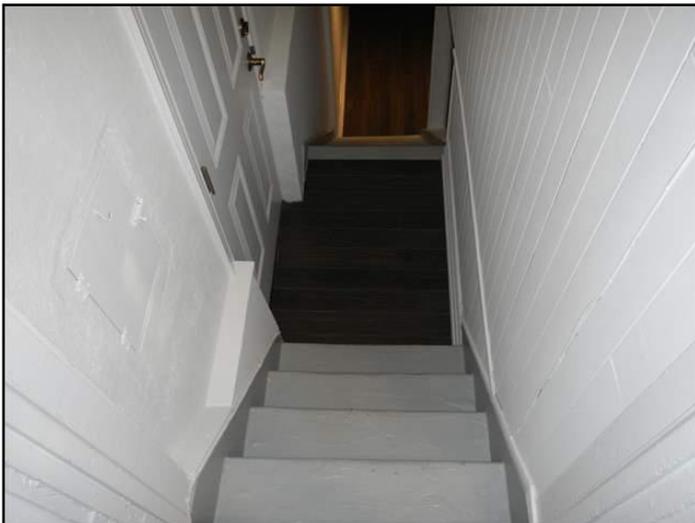
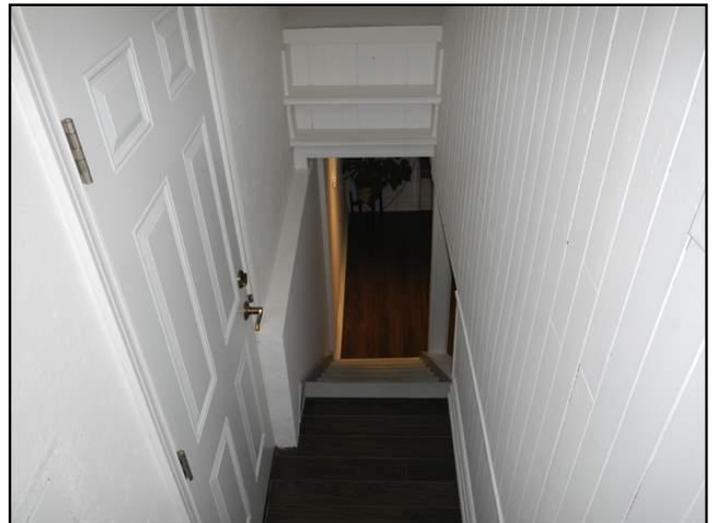
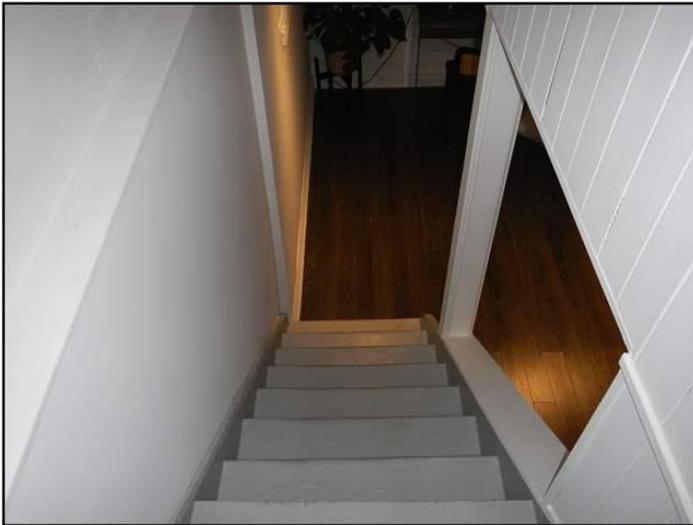
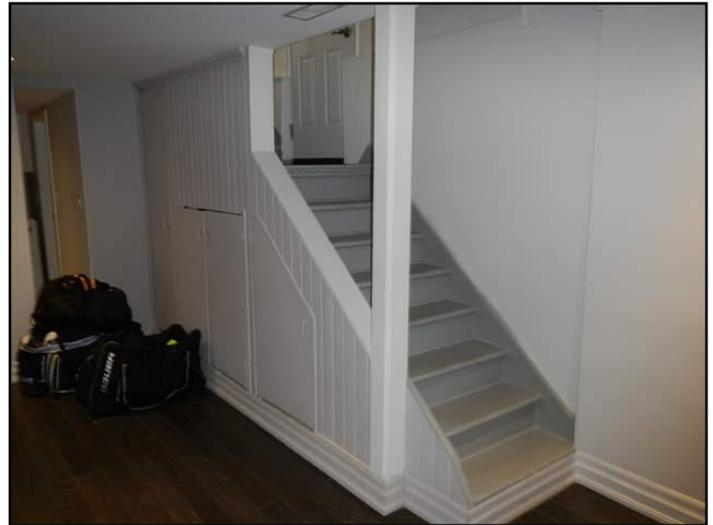
**Condition:** • [Missing](#)

Missing

*Missing*

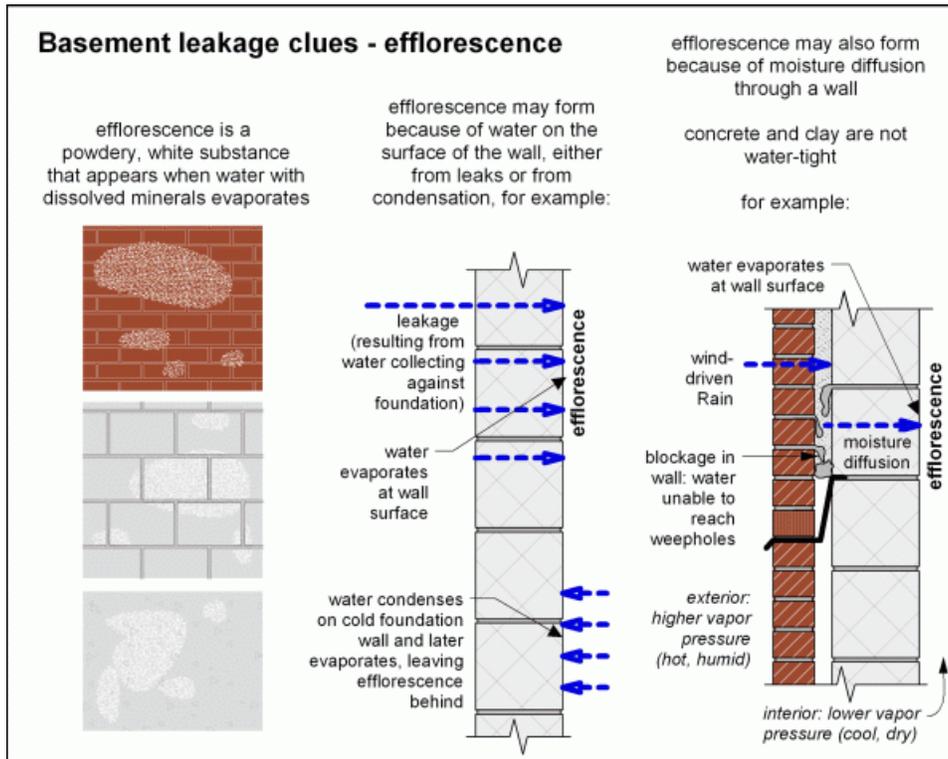
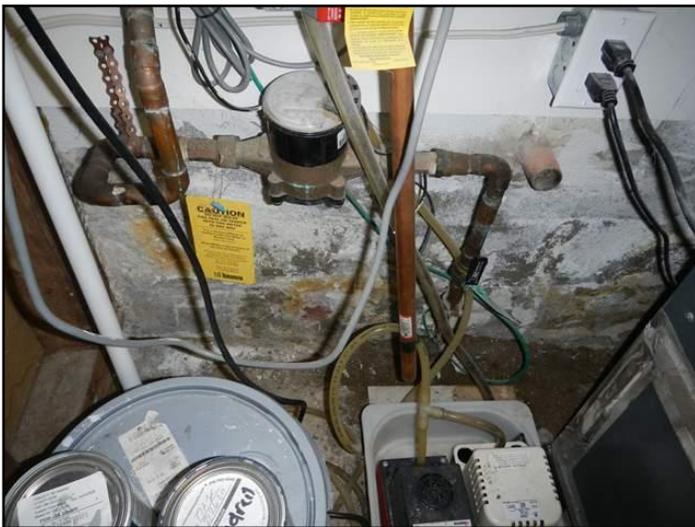
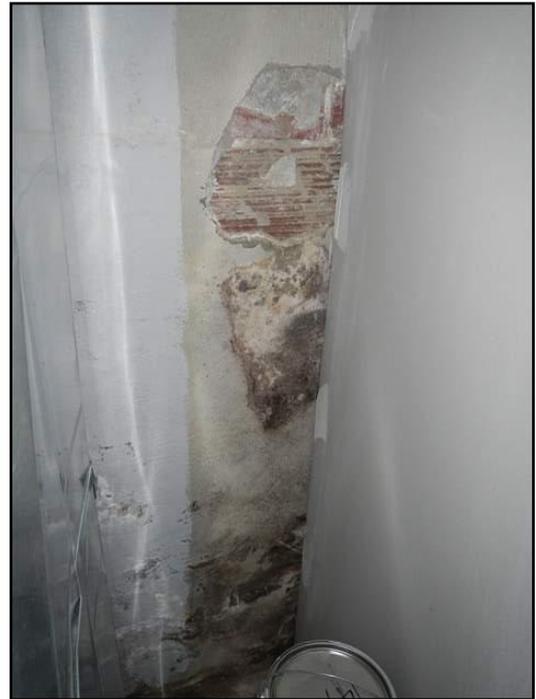
**Condition:** • Efflorescence

This is typical of most old foundations.

Efflorescence

*Efflorescence*

**Task:** Further evaluation / Improve
