HOME INSPECTION REPORT

22 La Rose Ave Unit 7

Prepared for: Adam Costello

Inspection Date: March 17 2026

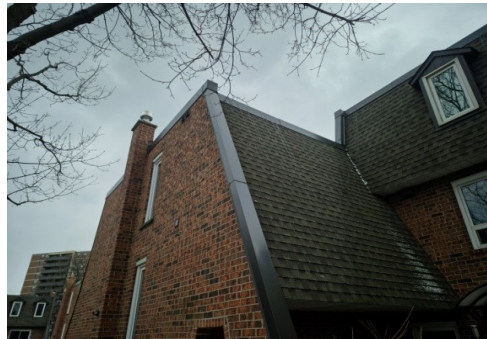
Roofing: [limited access due to height](#)
[overall surface in good repair where visible](#)

[Note: Recommend Annual Maintenance Contract for Roof Surface, Flashing Details and Chimney\(s\)](#)

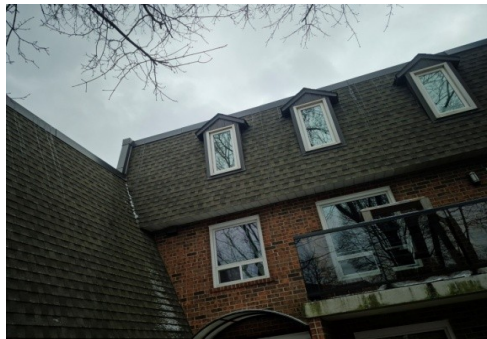
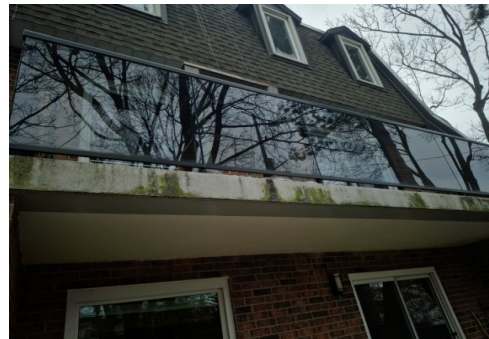
WALL SURFACES: overall in good repair
 DOORS/WINDOWS: overall in good repair
 PORCH overall in good repair

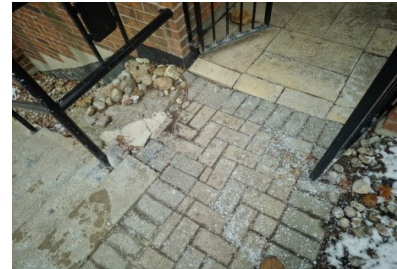
**Walk(s): minor settlement - minor repair

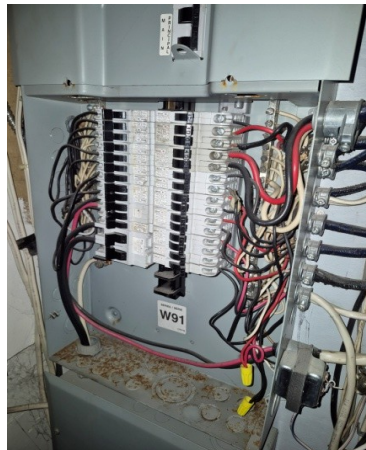
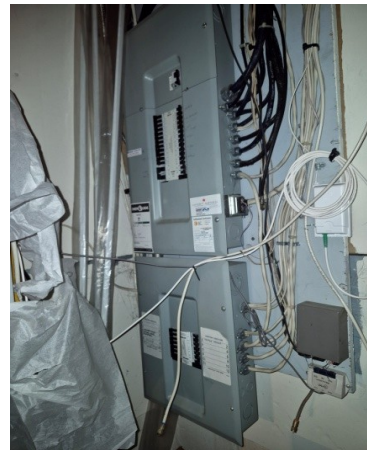
SERVICE PANEL: **overall in good repair**

Auxiliary Panel: **overall in good repair**

Note 2: Please ensure accurate labelling on panels.

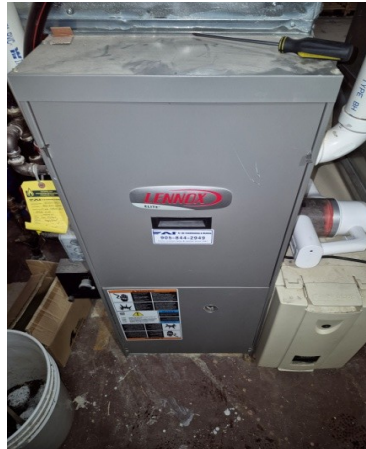
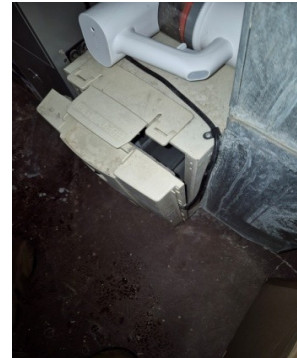
FORCED AIR FURNACE: [service annually, could not remove cabinet cover](#)
[recommend obtaining replacement parts/servicing contract](#)
Filter: [recommend properly sized filter for cabinet](#)

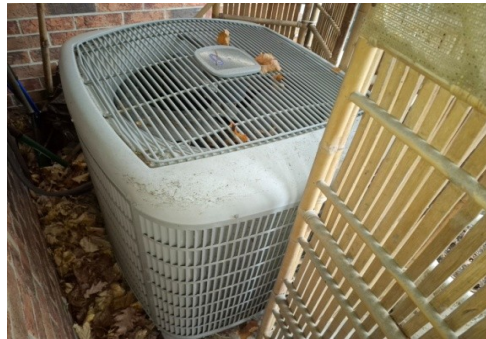
AIR CONDITIONER: [not tested: should be serviced before using aging unit, continue servicing until replacement becomes necessary](#)
