HOME INSPECTION REPORT

29 Richland Cres

Toronto

Inspection Date: [March 17 2026](#)

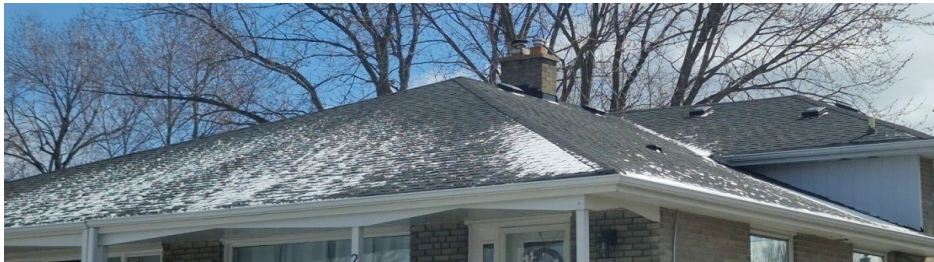
Roofing: overall surface in good repair where visible

Note: Recommend Annual Maintenance Contract for Roof Surface, Flashing Details and Chimney(s)

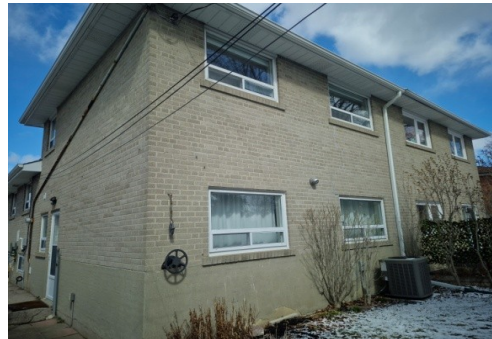
WALL SURFACES: overall in good repair
DOORS/WINDOWS: overall in good repair

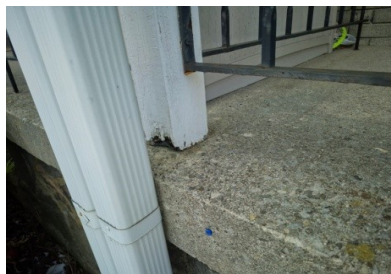
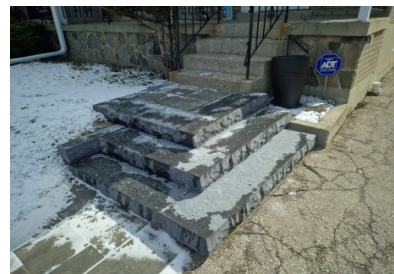
PORCH

Column(s) monitor/budget to repair/replace
Step(s): settlement: monitor/repair

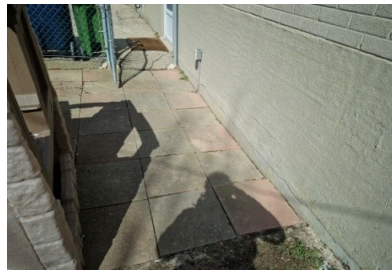
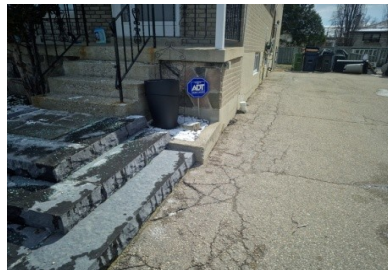
**Grading: re-grade pavers away from house

**Driveway(s): budget to resurface, gas line: contact utility to install collision post for gas line

Note: Maintain Gutters & Downspouts annually. Extend Downspouts at least 6-feet away from the house

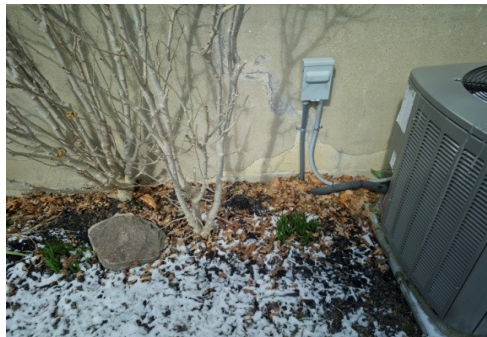
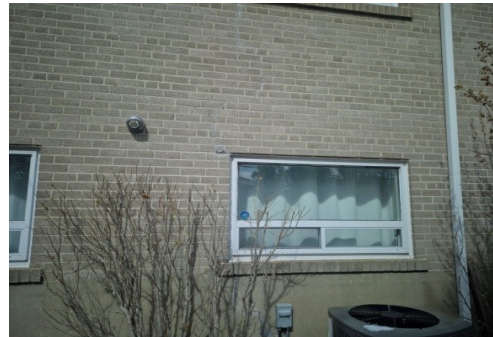
FOUNDATIONS: typical settlement cracks/mortar repairs - continue to monitor, repair parging

Masonry: typical settlement cracks/mortar repairs - continue to monitor

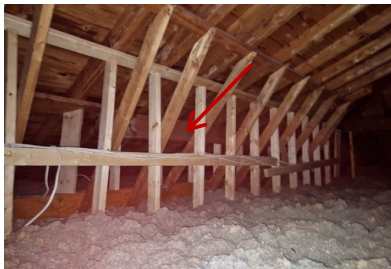
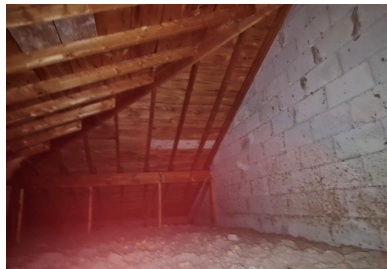
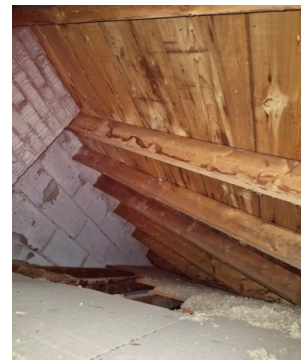
ROOF: overall in good repair

Comments: main level: ceiling was modified to open concept and roof/ceiling structure was reinforced, overall performance appears adequate

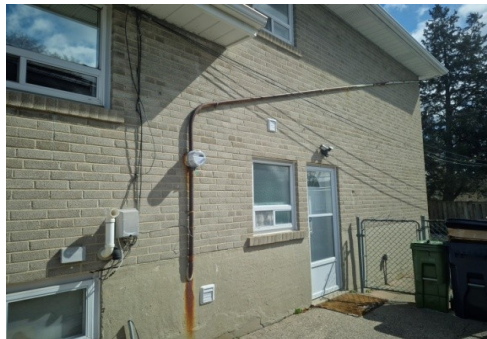
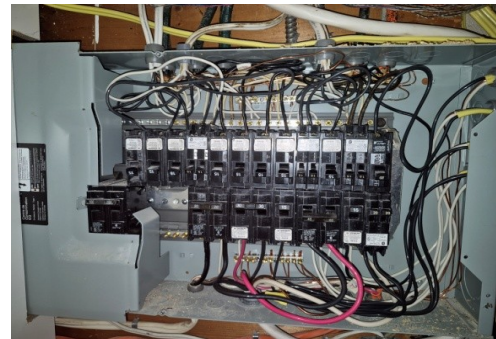
Mast: **rusting, maintenance as required**

SERVICE PANEL: **overall in good repair**

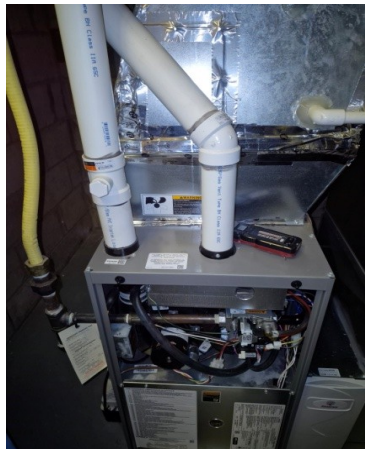
FORCED AIR FURNACE: service annually
 Filter: replace 1-per-6 to 12 months

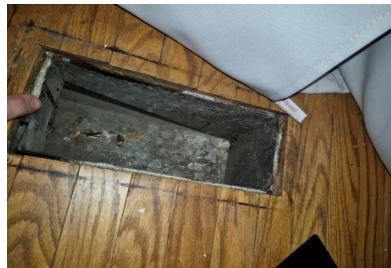
Registers: insulation around registers may contain asbestos
 encapsulating the insulation is often the best approach
 Environmental Consultants can assist if this is a concern

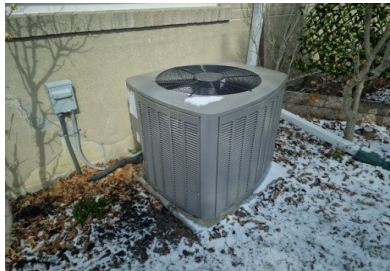
AIR CONDITIONER: not tested: should be serviced before using

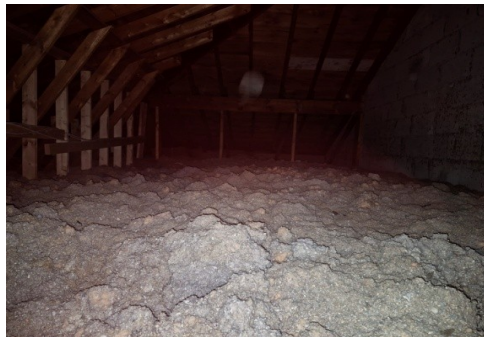
ROOF SPACE:
 Main Slope Roof: [lower roof:](#)
[insulation has been upgraded which will improve comfort and efficiency](#)

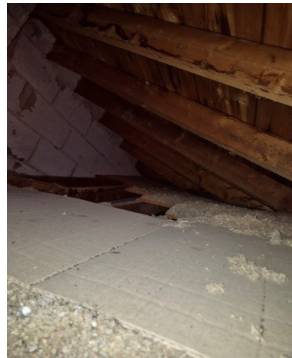
2nd Slope Roof: [limited access: insulation not determined](#)
