# HOME INSPECTION REPORT

355 Windermere Ave  
Toronto

Inspection Date: [Feb 26 2026](#)

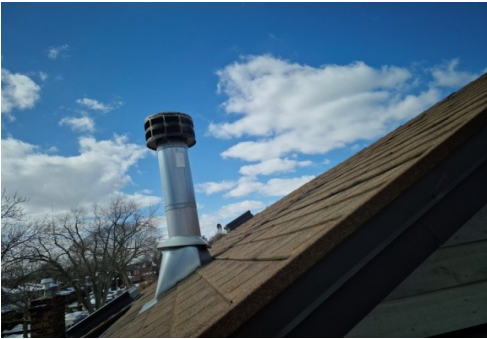
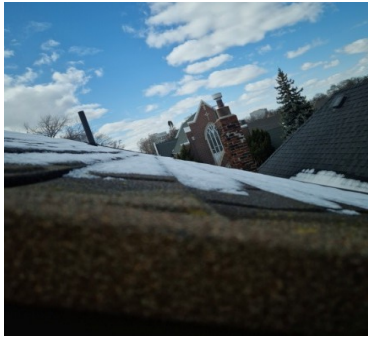
Roofing: [high quality metal shingles \(with granular finish\) in good repair](#)

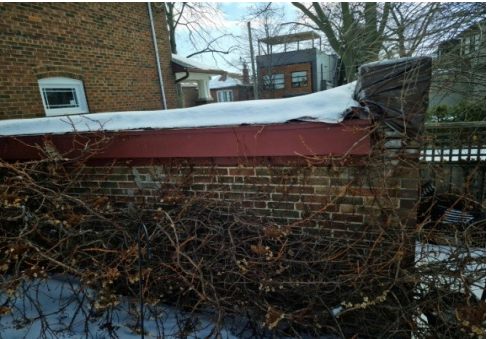
Garage: [not visible, requires further evaluation/repair/replacement](#)

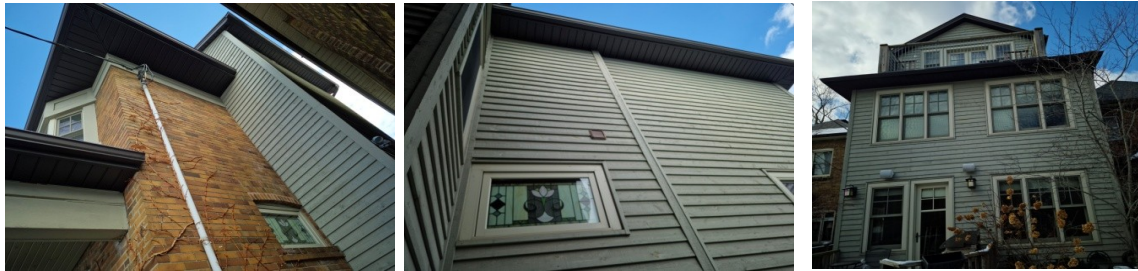
WALL SURFACES:  
 Brick: overall in good repair  
 Wood siding: overall in good repair  
 DOORS/WINDOWS: overall in good repair

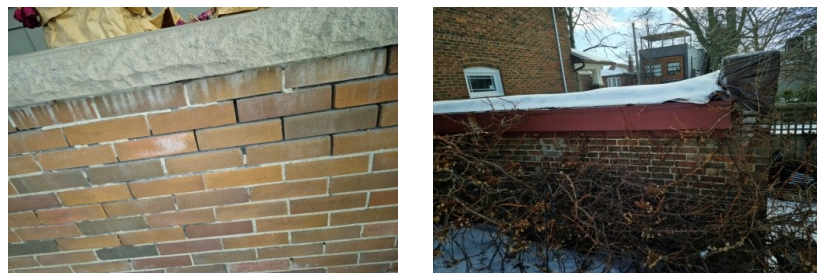
PORCH: general mortar repairs and maintenance as required  
 DETACHED GARAGE: inside not accessed, older, typically ongoing repairs

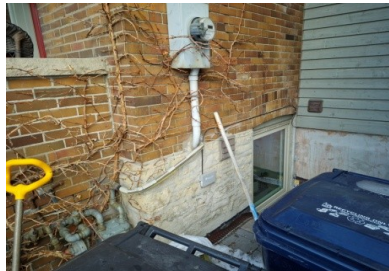
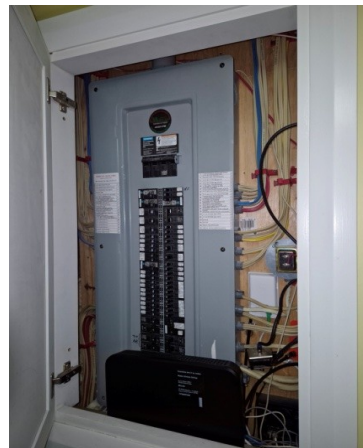
SERVICE ENTRANCE: **newer installations, overall in good repair**  
 SERVICE PANEL: **newer installations, overall in good repair**  
**panel obstructed - cover not removed**

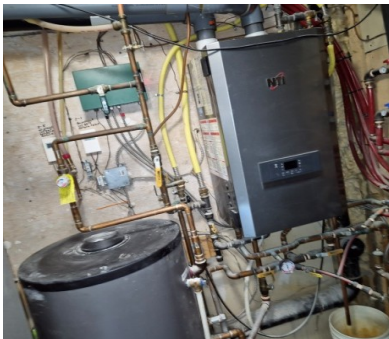
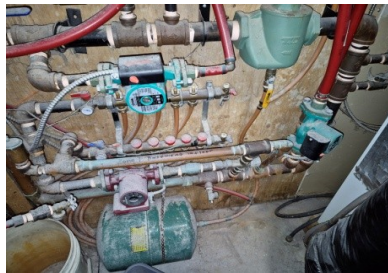
Piping: manifold - replace flow valves as required

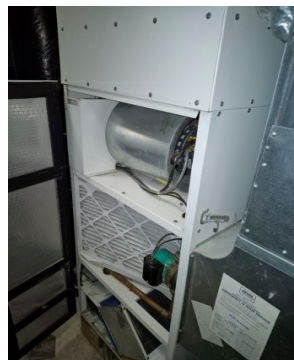
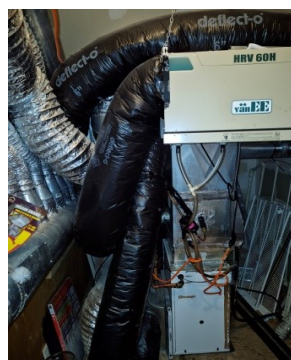
Comments: 2 forced air handlers in basement and 3rd level: boiler connected to heat exchangers, service annually

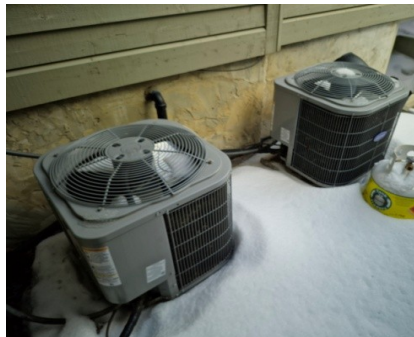
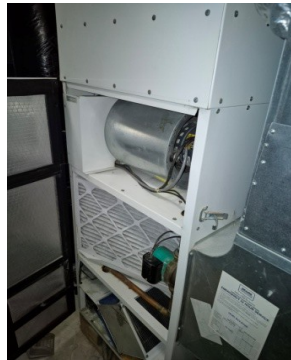
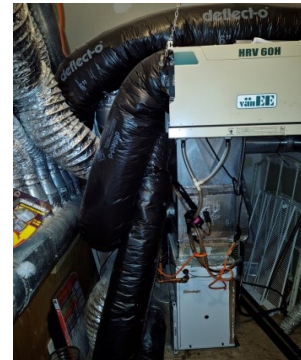
AIR CONDITIONER: two units (with air handlers and ducts) servicing lower and upper areas not tested: should be serviced before using replace filters as required

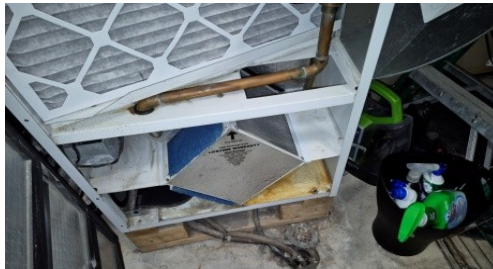
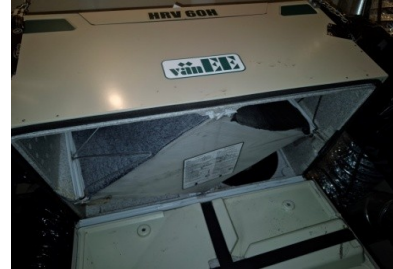
Heat Recover Ventilator: [two units](#)  
provides house with better air quality and efficiency  
see owners manual for proper use and maintenance
