HOME INSPECTION REPORT

45 Montye Ave & Lane House Toronto

Prepared by: Bob Papadopoulos P.Eng., RHI *

Inspection Date: [March 10 2026](#)

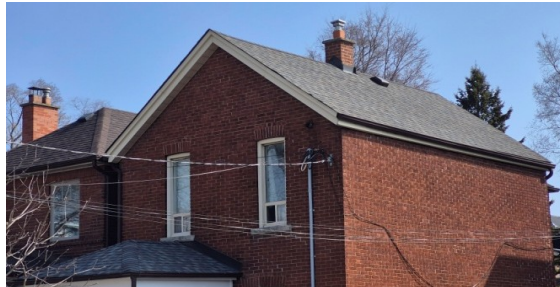
Sloped Surface: [overall surface in good repair](#)

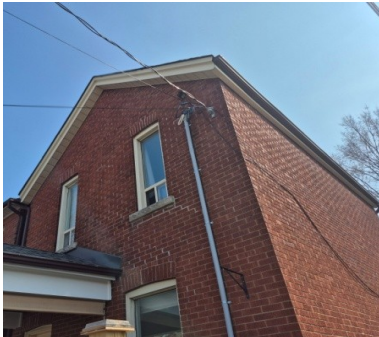
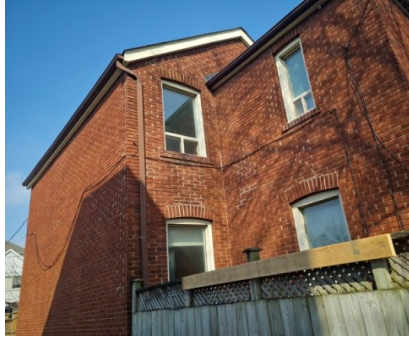
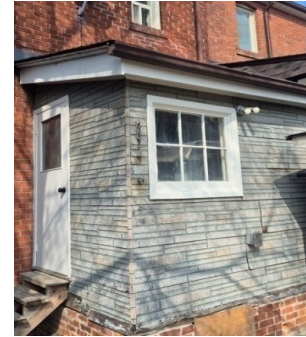
Brick: overall in good repair

Artificial Stone: may require covering with metal siding for insurance
repair seams as required, budget to cover/replace with metal siding

DOORS/WINDOWS: overall in good repair

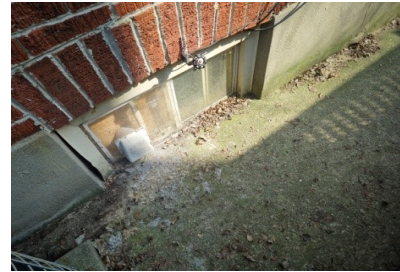
Windows: low to grade - prone to leaking

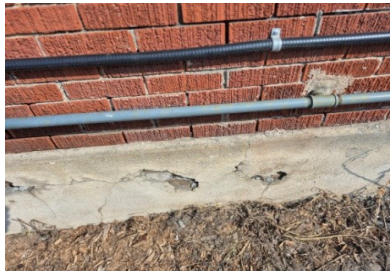
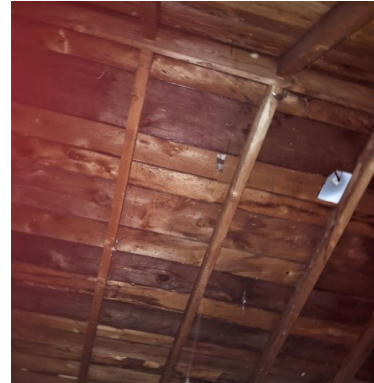
FOOTINGS/FOUNDATIONS basement floor has been lowered
basement: support column added to support main level floor

WALLS:
Masonry: mortar repairs as required

FOUNDATIONS: general parging maintenance as required

ROOF: overall in good repair

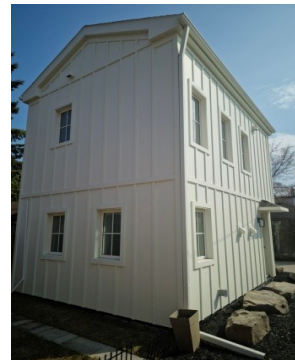
overall well built new Lane House

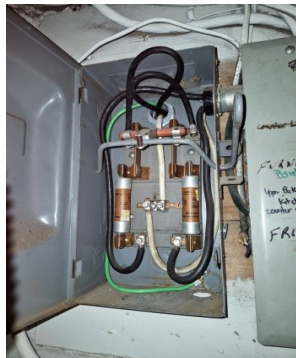
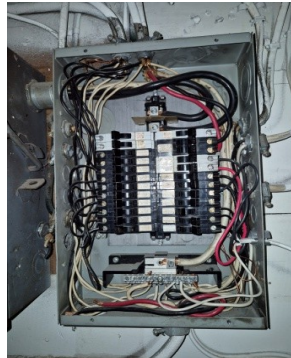
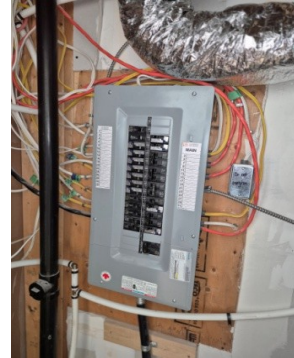
SERVICE ENTRANCE: **overall in good repair**
 Main Disconnect: **older, overall in good repair**
 SERVICE PANEL: **overall in good repair**
 Auxiliary Panel: **Lane House: newly installed**

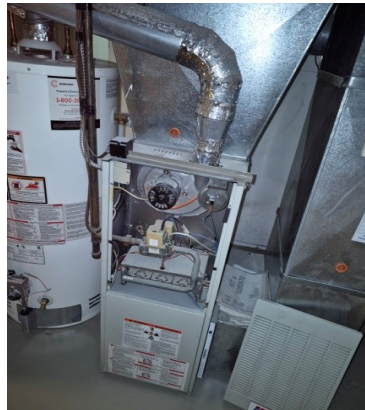
FORCED AIR FURNACE: continue servicing until replacement becomes necessary
 recommend obtaining replacement parts/servicing contract
 consider upgrading to high efficiency unit

Humidifier: old, replace

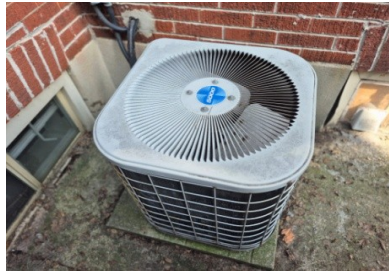
AIR CONDITIONER: not tested: should be serviced before using

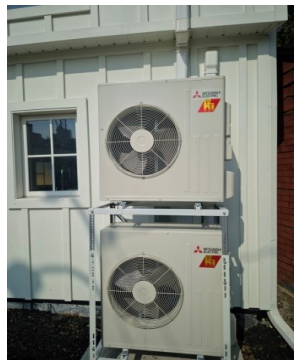
DUCTLESS HEAT PUMP: Lane House
 newly installed
 unit provides cooling and supplemental heating
 refer to owners manual

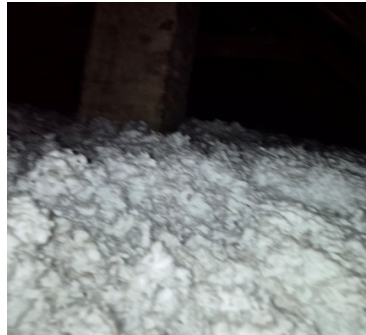
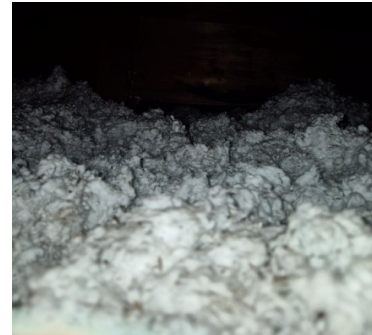
ROOF SPACE: insulation (upgraded) and ventilation is adequate

Comments: Lane House: newly built: visible insulation in roof space

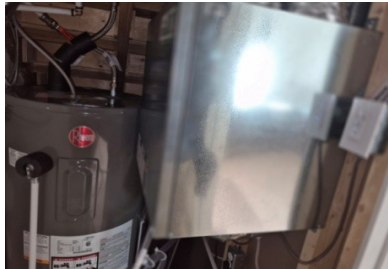
Heat Recover Ventilator: Lane House: provides house with better air quality and efficiency
 see owners manual for proper use and maintenance
