# Your Inspection Report

582 Runnymede Rd  
Toronto, ON M6S 2Z7

**INSPECTION DATE:**  
Wednesday, March 25, 2026

RE: Report No. 96627  
582 Runnymede Rd  
Toronto, ON  
M6S 2Z7

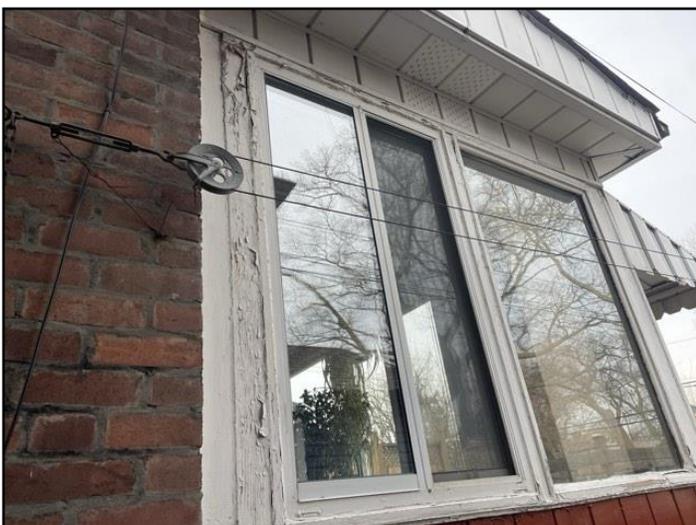
**Condition:** • Paint or stain needed

Garage doors and soffit and some of the wood trimmed windows, have peeling paint.

*Loose paint - Rear addition*

**Task:** Clean and re-paint

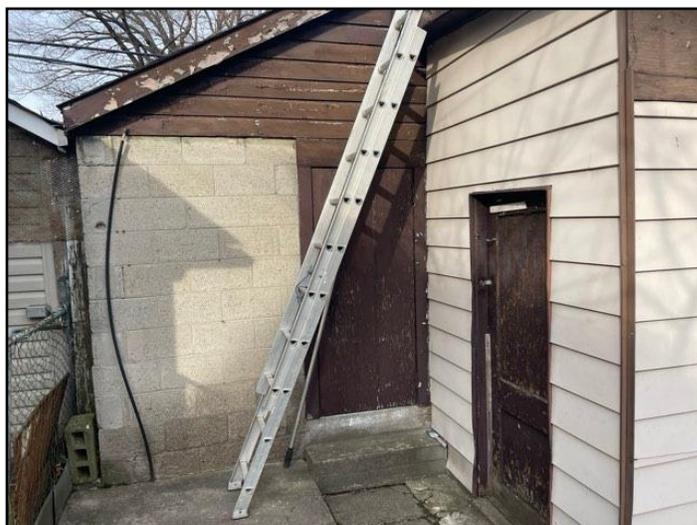
*Paint or stain needed*

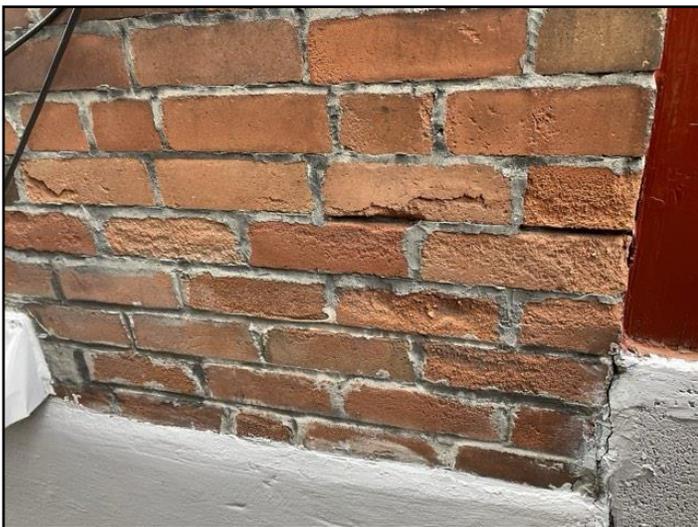
Spalling and mortar deterioration was noted in localized areas, this is typical of older brick homes. Overall the brick has been very well maintained.

Spalling

**Task:** Re-point/repair

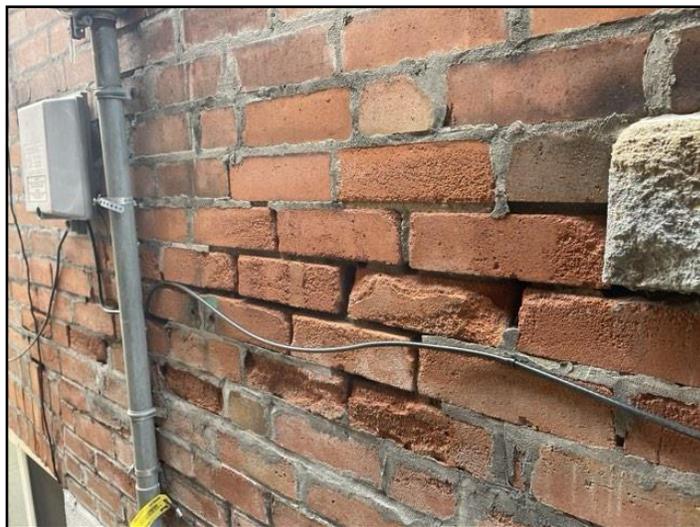
Spalling

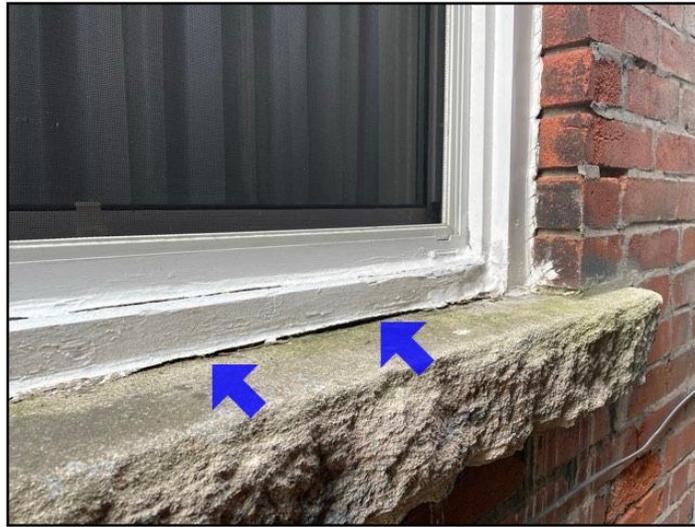
**Condition:** • Caulking deteriorated

*Caulking deteriorated*

**Task:** Re-caulk

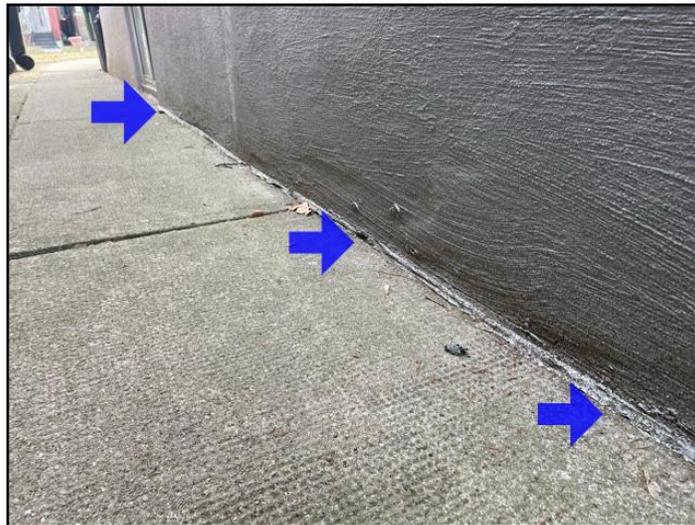
Seal between house and walkway is deteriorating and needs replacement.

*Unsealed gap at building*

**Task:** Re-seal

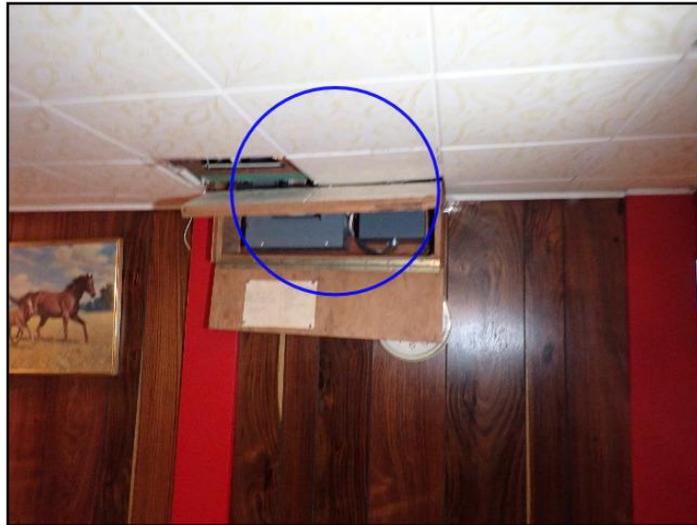
**Condition:** • [Box location poor](#)

*Box location poor*

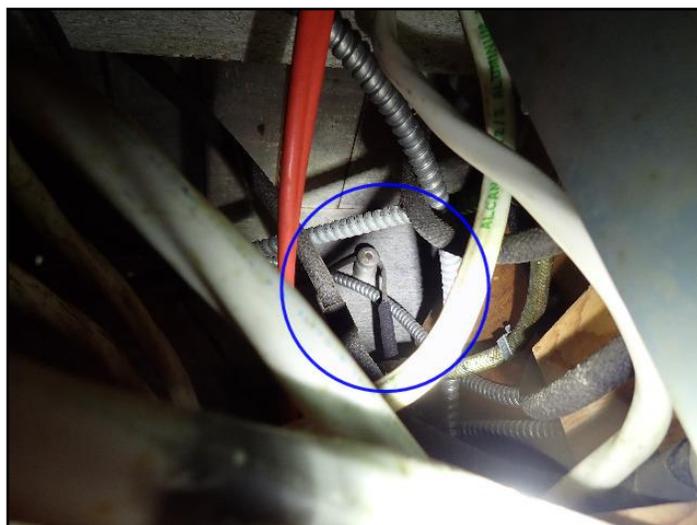
**Condition:** • [Active knob and tube was noted in the home. The extent of the knob and tube could not be determined at the inspection.](#) Click here to see the Ontario Electrical Safety Authority's position on this wiring system.

*Active knob and tube was noted in the home*

**Task:** Replace when remodeling. In the short term, ground fault circuit interrupters (GFCIs) are an inexpensive way to help protect against electric shocks. Further evaluation.

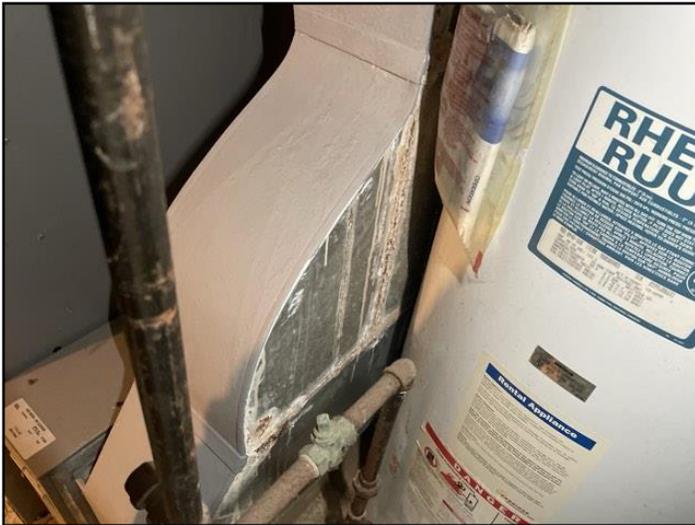
Mineral buildup was noted below the humidifier, this may be due to a leak, unable to determine if leak is still active, no signs of wetness.

Mineral stains and rust

**Task:** Remove/Replace

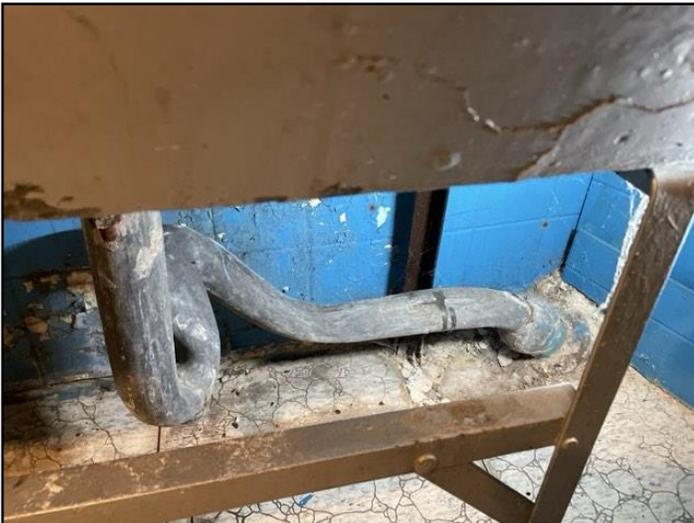
**Condition:** • Piping (Lead) - near end of lifespan / old

*Piping (Lead) - old -*

**Task:** Replace

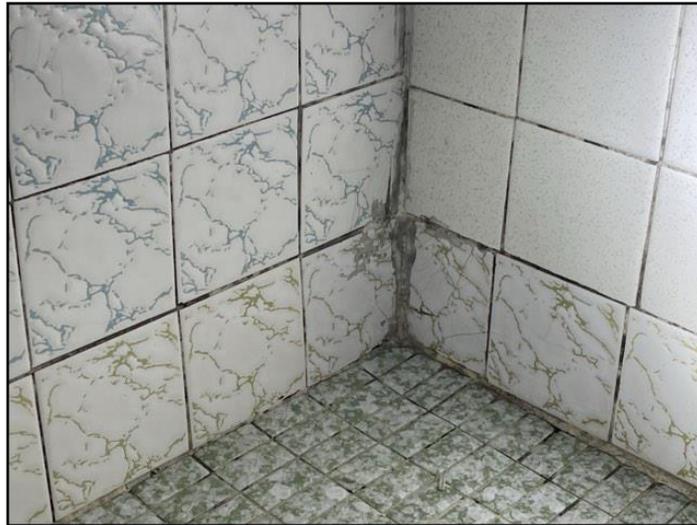
**Condition:** • Tiles, loose, cracked or broken

Tiles, loose, cracked or broken

**Task:** Repair, caulk, or replace shower

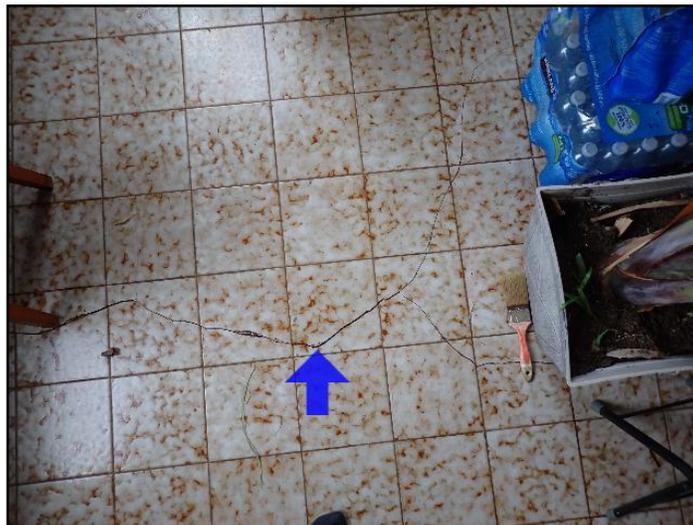
**Condition:** • Cracks

*Cracks*

**Task:** Replace tile

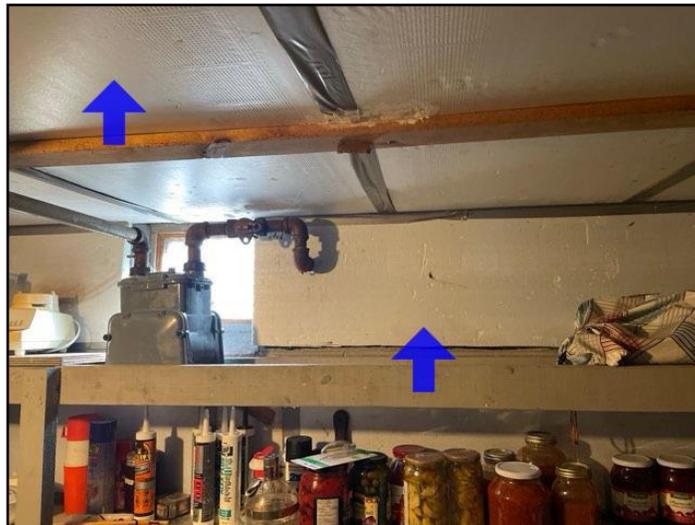
**Condition:** • Combustible insulation exposed

*Combustible insulation exposed*
