HOME INSPECTION REPORT

103 Galley Ave
Toronto

Prepared by: Bob Papadopoulos P.Eng., RHI *

Inspection Date: Sept 9 2025

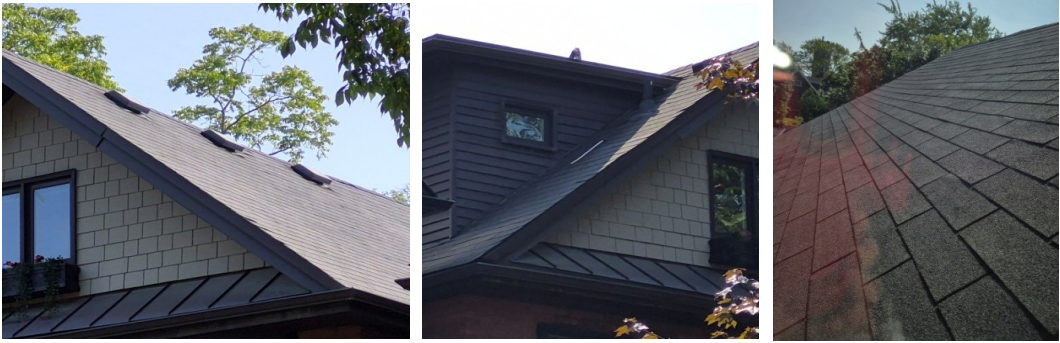
REFERENCE LINK	http://redbrickinspections.ca/docs/2_Roofing_Reference_Guide.pdf			
103 Galley Ave	ROOFING/Chimneys			Sept 9 2025
Description				
Roofing Material:	Location:	Leakage Probability:	Chimney(s) Type:	Location:
Asphalt Shingles:	Slope:	Medium	Metal:	South
Asphalt Shingles:	Garage:	Low	Brick Abandoned:	East
Metal:	Garage:			
Metal:	2nd Slope:	Low		
Limitations				
Roof Inspected By:	Access Limited By:	Chimney Access Limited By:		
From Edge	Height	Height		
From Grade	Tree			
Observations/Recommendations				
Tree Branches: retain arbourist for annual monitoring/trimming				
Sloped Surface: overall surface in good repair approx. 12-yrs-old, budget to replace within 5 yrs.

Dormer(s): north east not accessible, reported to be newly installed surface				
2nd Slope: overall surface in good repair

Note: Recommend Annual Maintenance Contract for Roof Surface, Flashing Details and Chimney(s)

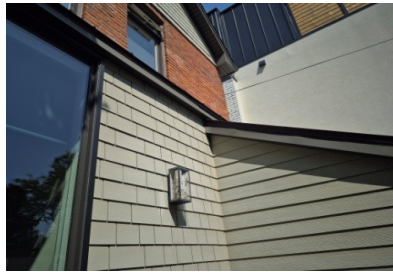
WALL SURFACES: overall in good repair
DOORS/WINDOWS: overall in good repair

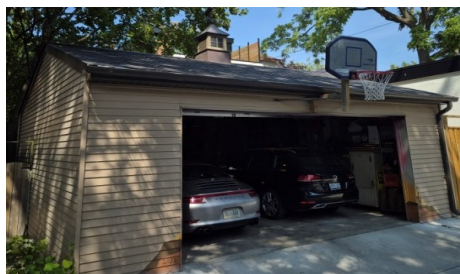
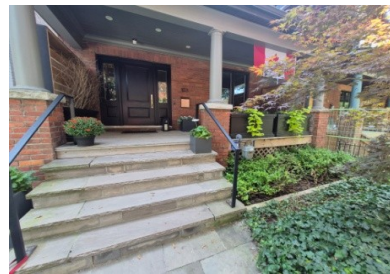
PORCH newer installations in good condition
DETACHED GARAGE: newer installations in good condition

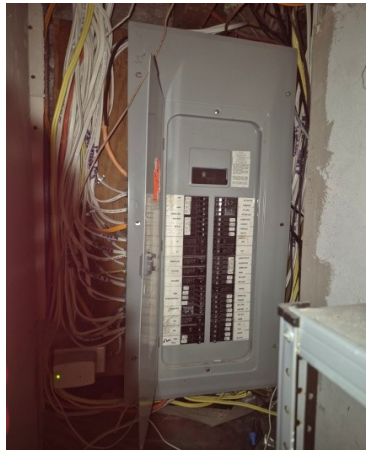
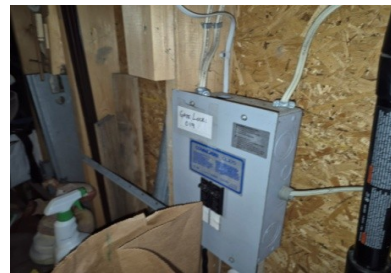
SERVICE ENTRANCE: **overall in good repair, cover not removed**
 SERVICE PANEL: **overall in good repair**
 Auxiliary Panel: **overall in good repair**

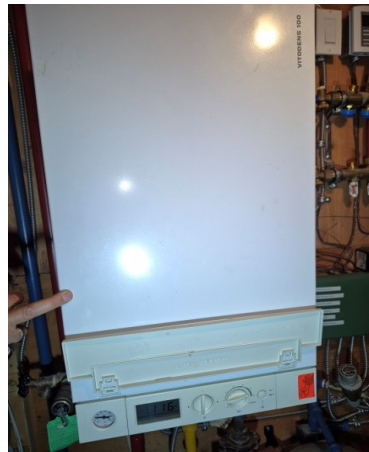
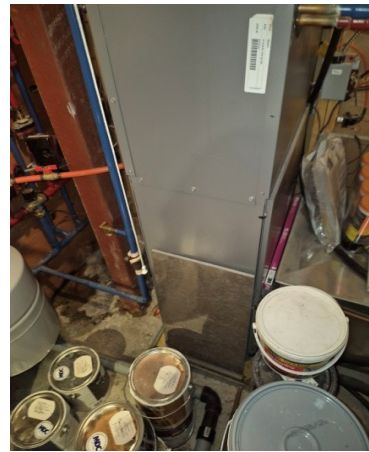
COMBINATION SYSTEM: provides house heating and domestic hot water

Comments: boiler provides heating to air handler (forced air), as above service annually

HOT WATER BOILER: service annually

recommend obtaining replacement parts/servicing contract

Filter: replace 1-per-3 months

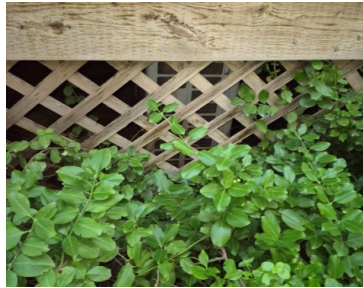
AIR CONDITIONER: [service annually](#)
 Outdoor Coil: [restricted access under porch](#)

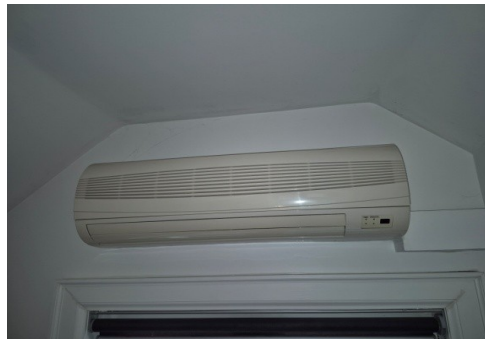
DUCTLESS A/C: [service annually](#)
 Outdoor Coil: [restricted access on top of roof](#)
