HOME INSPECTION REPORT

264 Pacific Ave
Toronto

Prepared by: Bob Papadopoulos P.Eng., RHI *

Inspection Date: [April 2 2026](#)

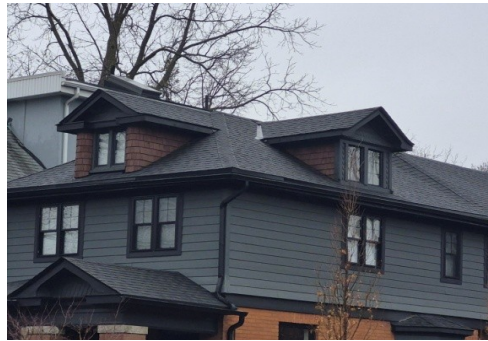
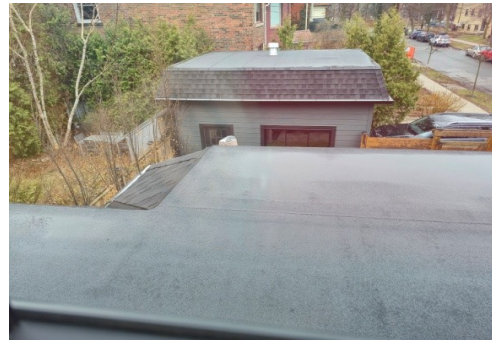
Sloped Surface: [overall surface in good repair](#)

Flat Surface: [overall surface in good repair](#)

Garage: [overall surface in good repair](#)

[Note: Recommend Annual Maintenance Contract for Roof Surface, Flashing Details and Chimney\(s\)](#)

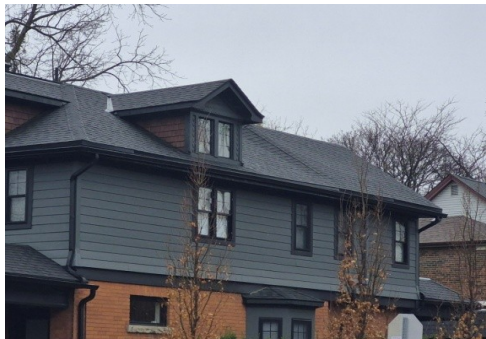
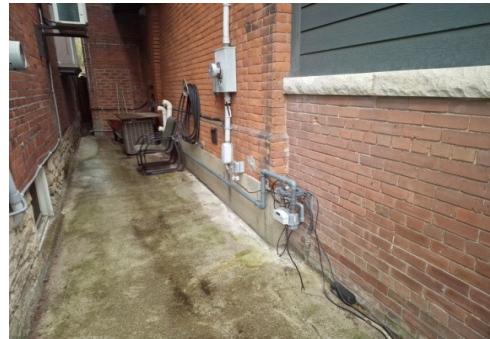
WALL SURFACES: overall in good repair
Soffit & Fascia: overall in good repair
DOORS/WINDOWS: overall in good repair

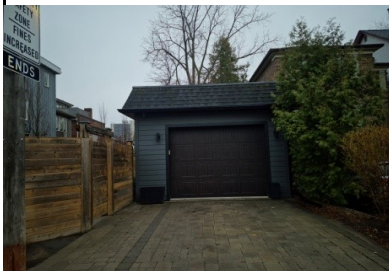
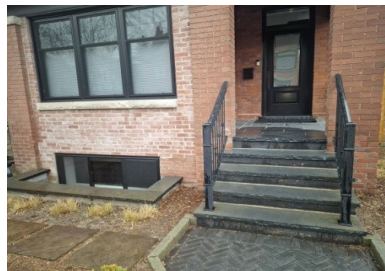
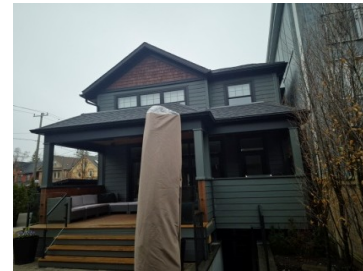
PORCH overall well built, in good repair
DECK overall well built, in good repair
DETACHED GARAGE: overall well built, in good repair
**Landscaping: overall good quality installations, in good repair
**BASEMENT WALKOUT: overall well built

Note: Maintain Gutters & Downspouts annually. Extend Downspouts at least 6-feet away from the house

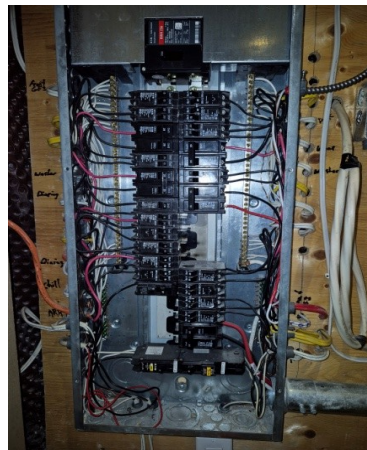
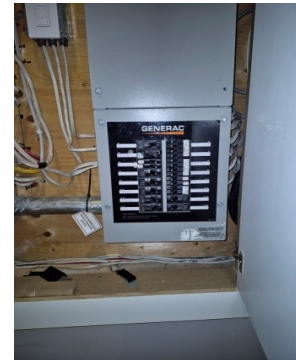
SERVICE ENTRANCE: overall in good repair
 SERVICE PANEL: overall in good repair
 Auxiliary Panel: roughed in for back up generator

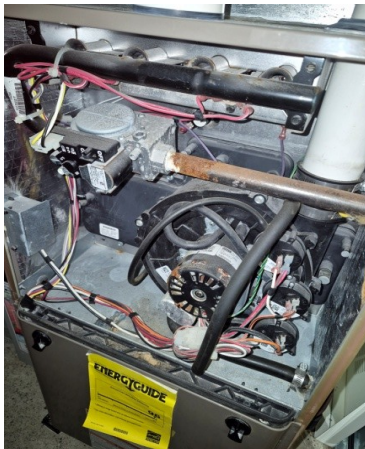
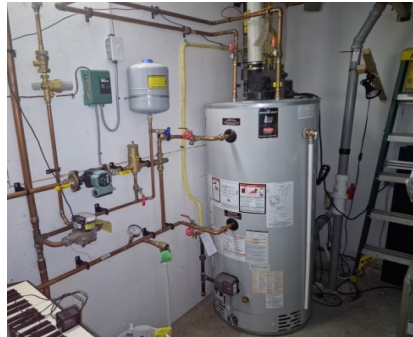
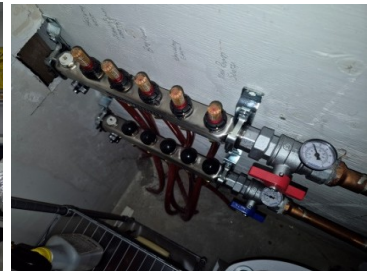
FORCED AIR FURNACE: [service annually](#)
[recommend obtaining replacement parts/servicing contract](#)
Filter: [replace 1-per-6 to 12 months](#)

HOT WATER BOILER:
COMBINATION SYSTEM: [provides basement floor heating and domestic hot water](#)

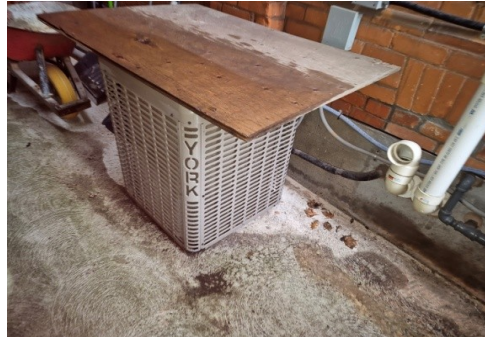
AIR CONDITIONER: not tested: should be serviced before using

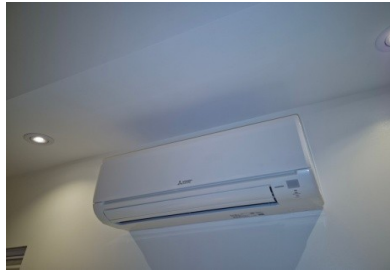
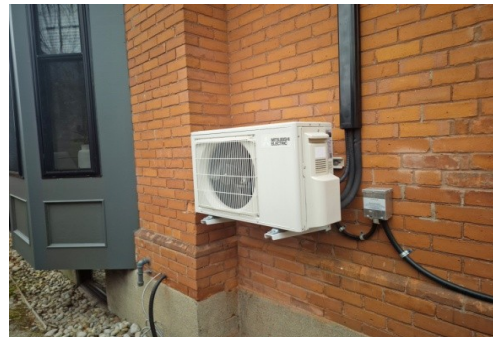
DUCTLESS A/C: service annually

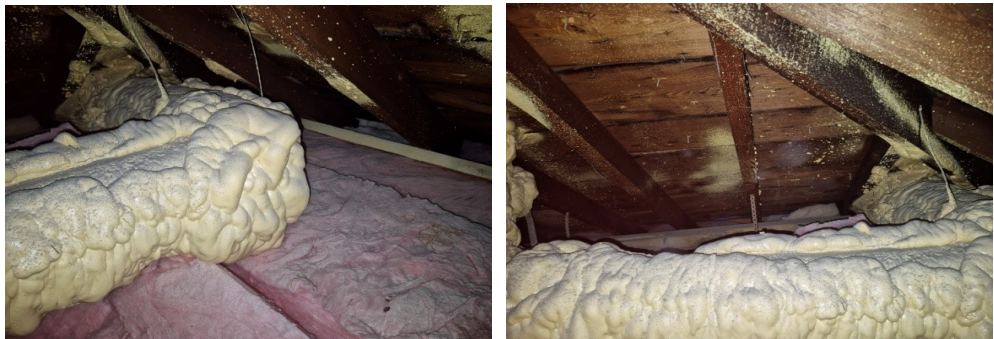
ROOF SPACE: spray foam and fiberglass insulation installed which is above average including around roof space ducts

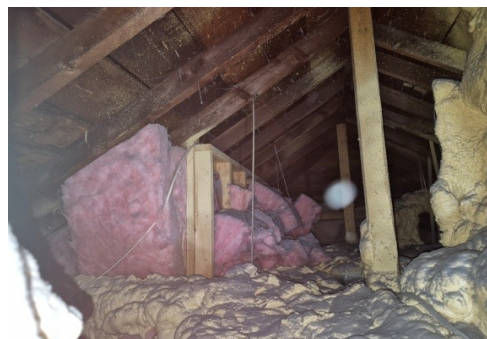
Skylight wells: falling insulation - repair

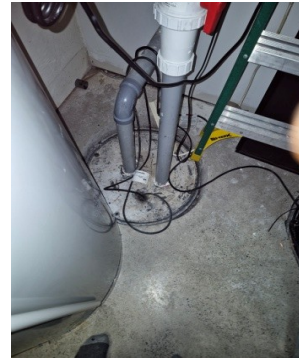
WASTE PIPING: [all piping examined was in good repair](#)
Solid Waste Pump: [service annually](#)

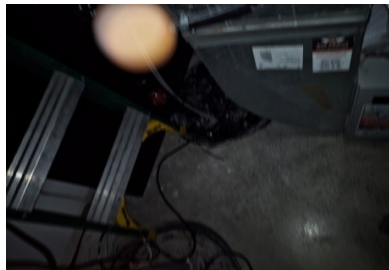
**Basement Leakage: foundation damp-proofed to minimize leaking risk
 service sump pump annually
