HOME INSPECTION REPORT

264 Pacific Ave
Toronto

Inspection Date: [April 2 2026](#)

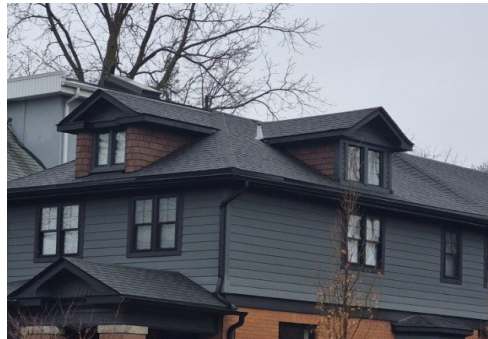
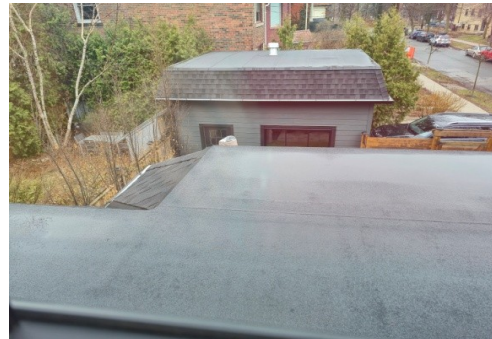
Sloped Surface: [overall surface in good repair](#)
Flat Surface: [overall surface in good repair](#)
Garage: [overall surface in good repair](#)

Note: [Recommend Annual Maintenance Contract for Roof Surface, Flashing Details and Chimney\(s\)](#)

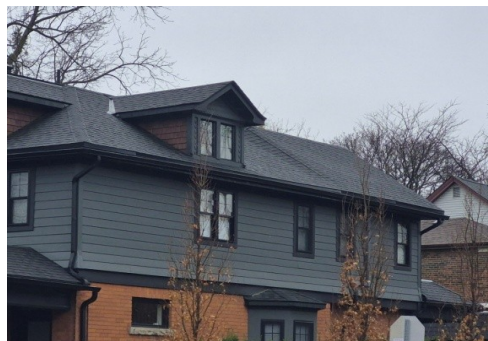
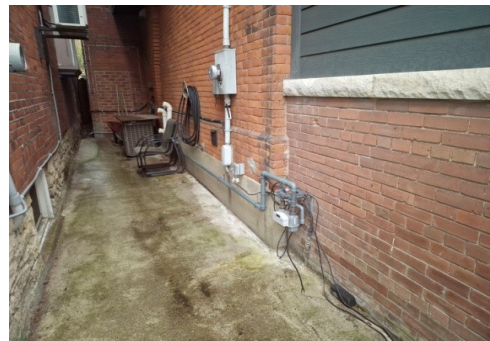
WALL SURFACES: overall in good repair
 Soffit & Fascia: overall in good repair
 DOORS/WINDOWS: overall in good repair

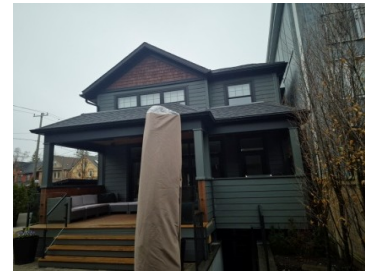
PORCH overall well built, in good repair
 DECK overall well built, in good repair
 DETACHED GARAGE: overall well built, in good repair
 **Landscaping: overall good quality installations, in good repair
 **BASEMENT WALKOUT: overall well built

Comments: loose gutter, exposed framing at south east require repairs

Note: Maintain Gutters & Downspouts annually. Extend Downspouts at least 6-feet away from the house

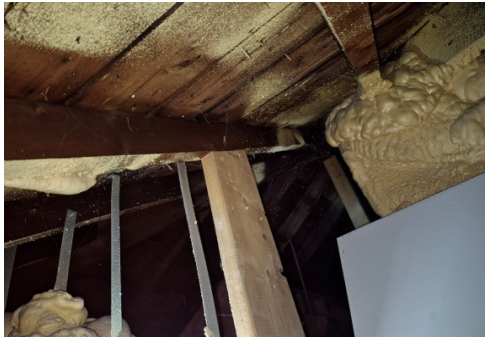
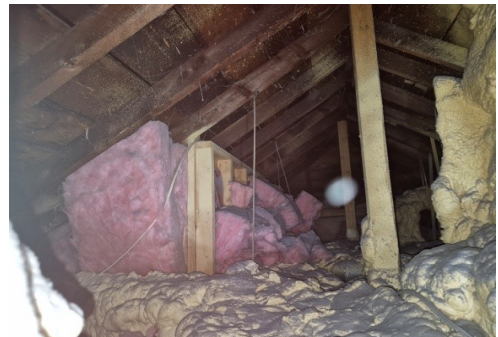
overall well built house with recent additions

ROOF: overall in good repair with additions

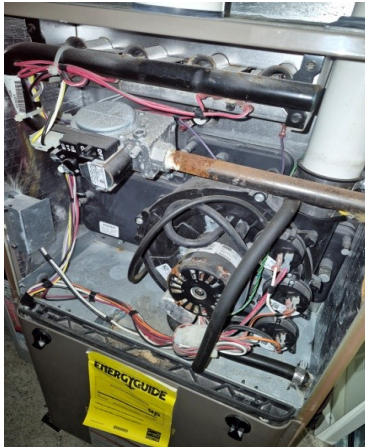
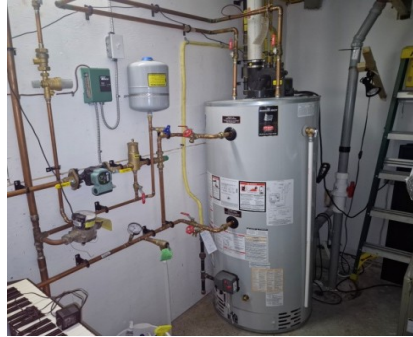
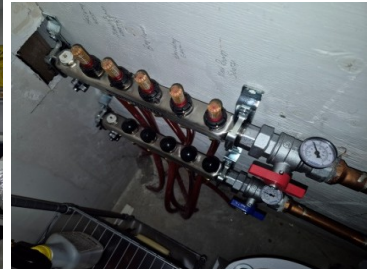
FORCED AIR FURNACE: [service annually](#)
[recommend obtaining replacement parts/servicing contract](#)
Filter: [replace 1-per-6 to 12 months](#)

HOT WATER BOILER:
COMBINATION SYSTEM: [provides basement floor heating and domestic hot water](#)

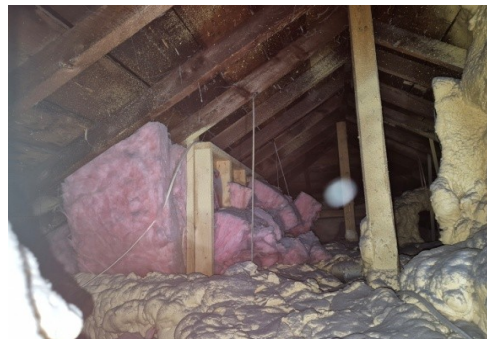
Skylight wells: falling insulation - repair

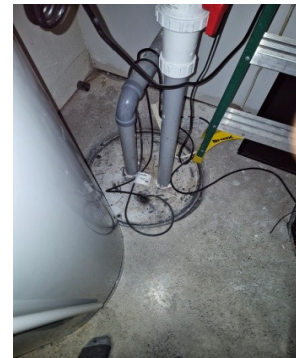
WASTE PIPING: [all piping examined was in good repair](#)
 Solid Waste Pump: [service annually](#)
